City of Reno

2023-24

**FACILITY CONDITION
ASSESSMENT REPORT**

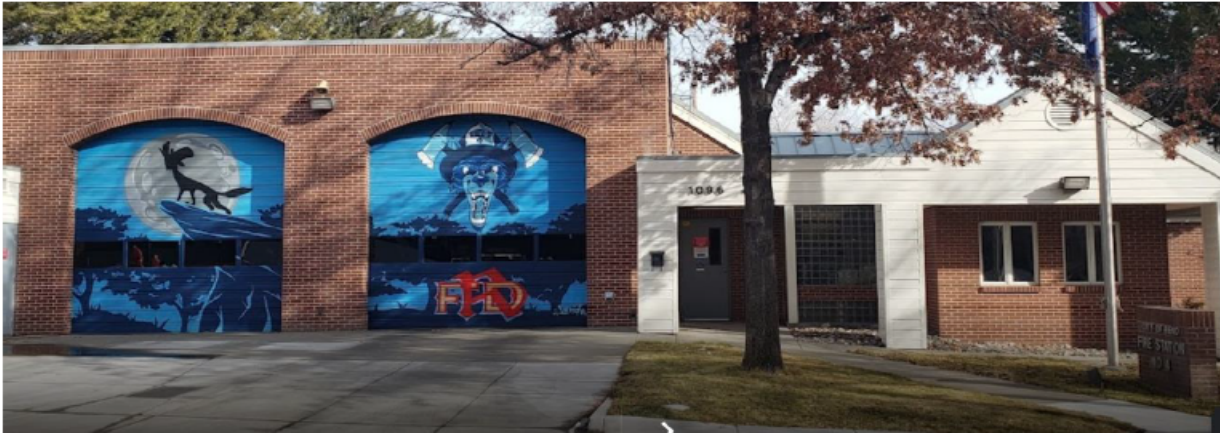
FIRE STATION 4 #033

Due to poor soil conditions the foundation of the building is unevenly settling. This is leading to cracking and separation down the north-south middle of the building.

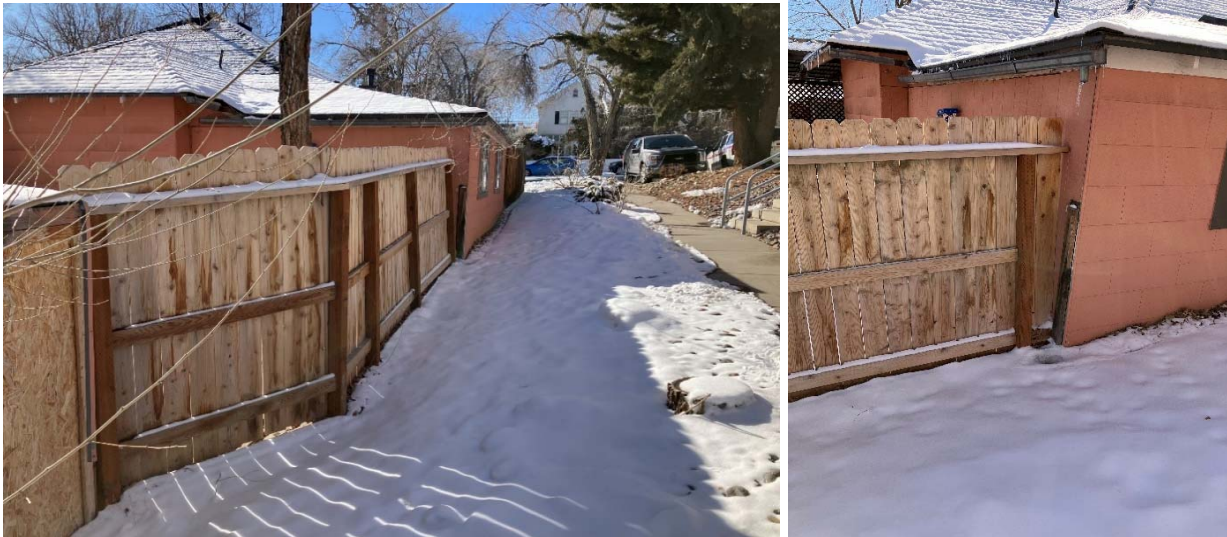
Pictured is Fire Station 4's neighbor and the fence that we replaced a couple of years ago is already seeing the effects of the settling.

FOUNDATION STABILIZATION **Cost: \$850,000.00**

Cracks in the masonry have been monitored since 2008 and have not grown. A Certified Structural Engineer briefly examined the building to prioritize the needs in determining the cause and proposed solution to stabilize the station's foundation. The foundation must be stabilized before other improvements can be made to roofing, treatment of building envelope, interior fixtures, and mechanical/plumbing.

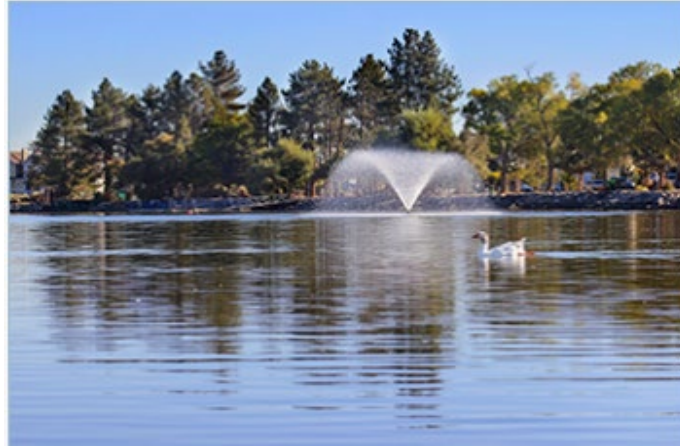
VIRGINIA LAKE PARK
 Location: 1980 Lakeside Drive
 37.28 acres (Developed)

PRELIMINARY CONDITION ASSESSMENT: POOR

PRIORITY CLASS 1 PROJECTS	Total Cost for Priority 1 Projects:	\$1,600,000.00
Currently Critical	Immediate (0-2 years)

IMPROVE VIRGINIA LAKE PARK	Cost:	\$1,600,000.00
Improve Virginia Lake Park (Phase II-b- West Shoreline)

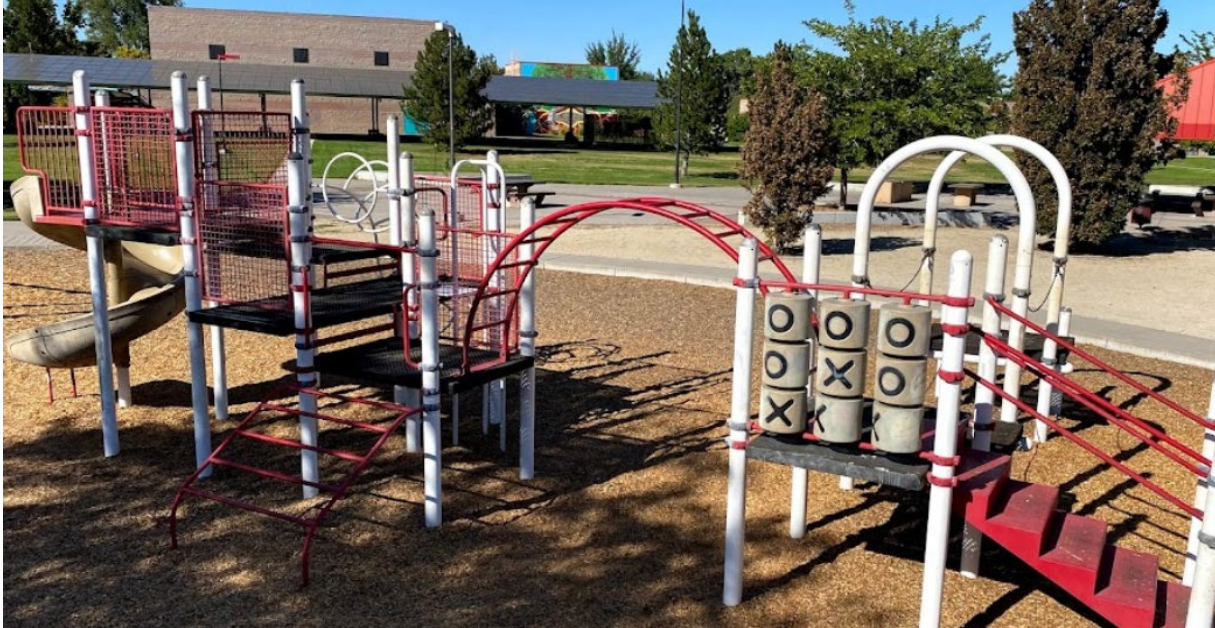
MIGUEL RIBERA PARK
Location: 3925 Neil Road
19.29 acres (Developed)

PRELIMINARY CONDITION ASSESSMENT: POOR

PRIORITY CLASS 1 PROJECTS	Total Cost for Priority 1 Projects:	\$1,136,000.00
Currently Critical	Immediate (0-2 years)	
UPGRADE PLAYGROUND EQUIPMENT AND SURFACE	Cost:	\$336,000.00
Upgrade the playground equipment and playground surface CIP		
UPGRADE PLAYGROUND EQUIPMENT AND SURFACE	Cost:	\$100,000.00
Upgrade the playground equipment and playground surface 400k		
REPLACE PLAYGROUND EQUIPMENT AND SURFACE	Cost:	\$700,000.00
Upgrade the playground equipment and playground surface CDBG		
PRIORITY CLASS 2 PROJECTS	Total Cost for Priority 2 Projects:	\$0.00
Necessary	Not Yet Critical (2-4 years)	
	Cost:	\$0.00
PRIORITY CLASS 3 PROJECTS	Total Cost for Priority 3 Projects:	\$220,000.00
Needs	Long-Term (4-10 years)	
RESURFACE BB/VB COURTS	Cost:	\$220,000.00
Total estimated cost of priority 1 projects:		\$1,136,000.00
Total estimated cost of priority 2 projects:		\$0.00
Total estimated cost of priority 3 projects:		\$220,000.00

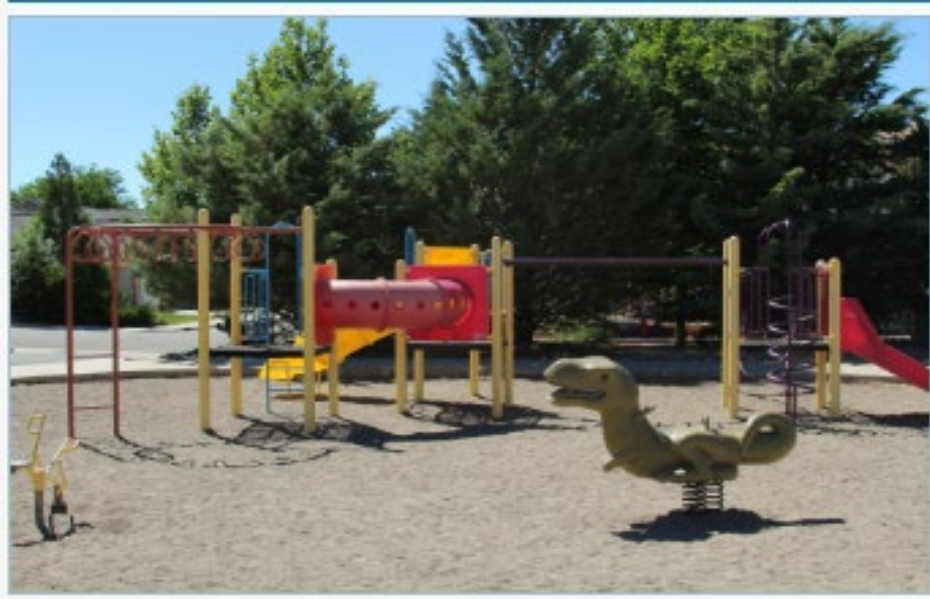
SKY COUNTRY PARK
3290 SNAKE RIVER DR
5.03 acres (Developed)

PRELIMINARY CONDITION ASSESSMENT: CRITICAL

PRIORITY CLASS 1 PROJECTS	Total Cost for Priority 1 Projects:	\$1,180,000.00
Currently Critical	Immediate (0-2 years)

PARK EXPANSION AND RECONFIGURATION	\$1,180,000.00
Expand park and reconfigure with RCT fund

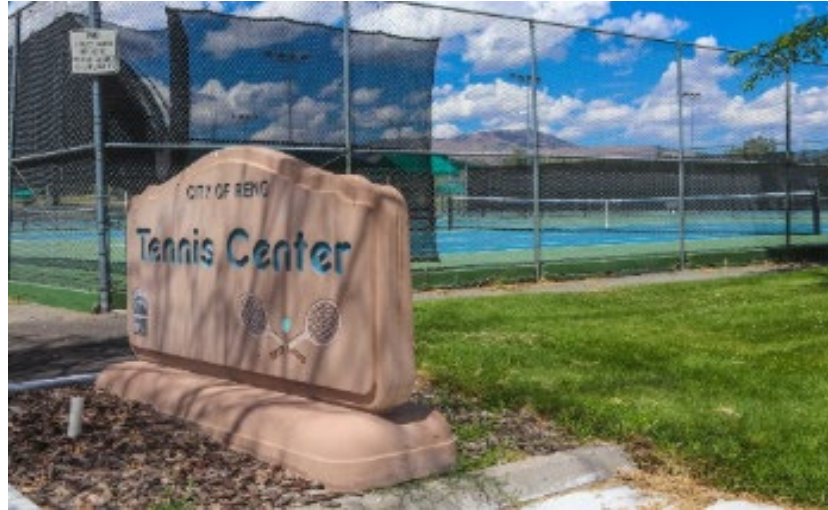
RENO TENNIS CENTER
5.30 acres (Developed)
PRELIMINARY CONDITION ASSESSMENT: POOR

REPLACE TENNIS COURTS WITH PTC (4 EA YR)	Cost:	\$438,000.00
--	-------	--------------

REPLACE CONCESSIONAIRE BUILDING	Cost:	\$340,000.00
---------------------------------	-------	--------------

REPLACE TENNIS COURTS WITH PTC (4 EA YR)	Cost:	\$750,000.00
--	-------	--------------

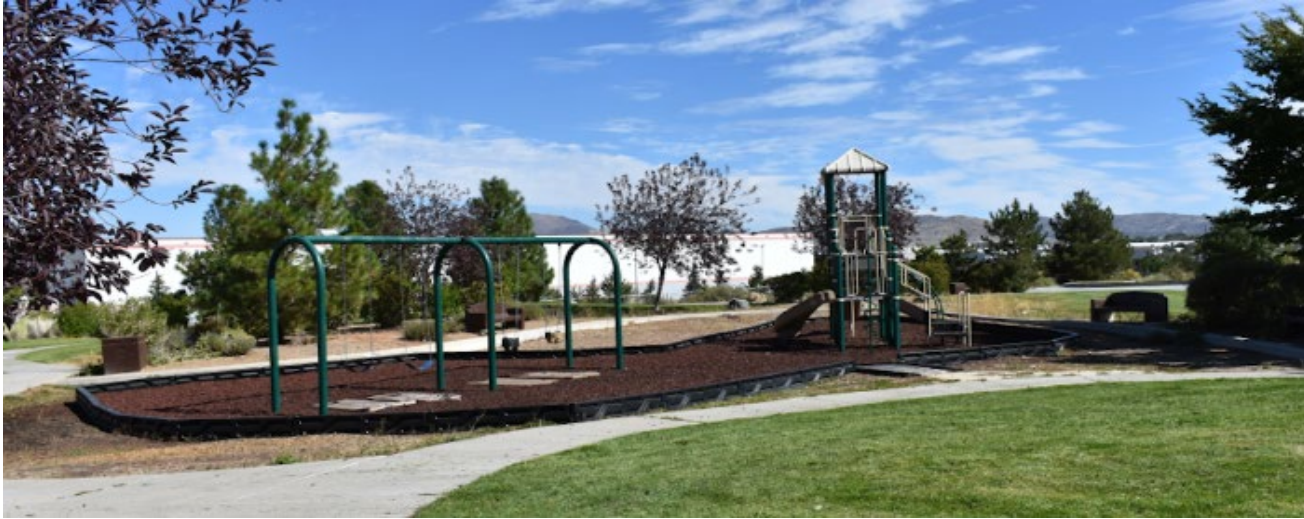
SILVER LAKE PARK
10.50 acres (Developed)
PRELIMINARY CONDITION ASSESSMENT: POOR

PRIORITY CLASS 1 PROJECTS	Total Cost for Priority 1 Projects:	\$0.00
	Cost:	\$0.00
PRIORITY CLASS 2 PROJECTS	Total Cost for Priority 2 Projects:	\$15,000.00
Necessary Not Yet Critical		
RESURFACE WATER SPRAY PAD	Cost:	\$15,000.00
PRIORITY CLASS 3 PROJECTS	Total Cost for Priority 3 Projects:	\$1,060,000.00
Needs Long - Term		
REPLACE PLAYGROUND EQUIPMENT	Cost:	\$1,025,000.00
RESURFACE WATER SPRAY PAD	Cost:	\$35,000.00
	Total estimated cost of priority 1 projects:	\$0.00
	Total estimated cost of priority 2 projects:	\$15,000.00
	Total estimated cost of priority 3 projects:	\$1,060,000.00
	Total estimated cost of all projects:	\$1,075,000.00

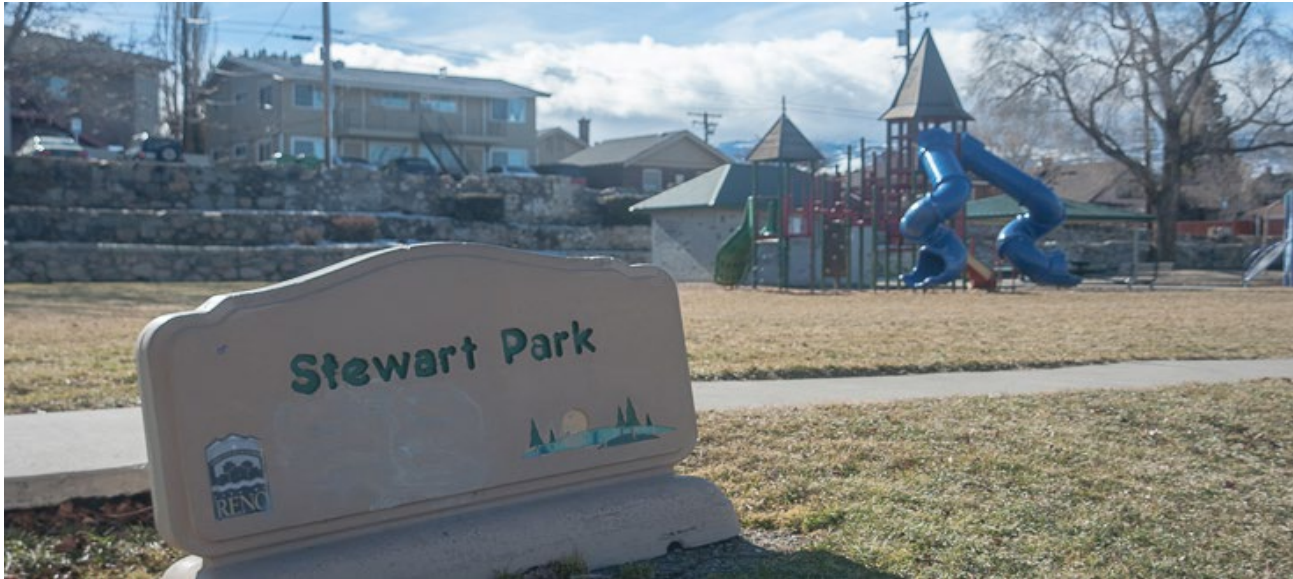
STEWART PARK
 1.46 acres (Developed)
PRELIMINARY CONDITION ASSESSMENT: POOR

PRIORITY CLASS 1 PROJECTS	Total Cost for Priority 1 Projects:	\$0.00
	Cost:	\$0.00
PRIORITY CLASS 2 PROJECTS	Total Cost for Priority 2 Projects:	\$0.00
Necessary	Not Yet Critical	
	Cost:	\$0.00
PRIORITY CLASS 3 PROJECTS	Total Cost for Priority 3 Projects:	\$825,000.00
Needs	Long - Term	
REPAIR/REPLACE ROCK RETAINING WALLS	Cost:	\$35,000.00
REPLACE BASKETBALL COURT (1 CT)	Cost:	\$55,000.00
REPLACE PLAYGROUND EQUIPMENT AND SURFACE	Cost:	\$625,000.00
RENOVATE IRRIGATION SYSTEM	Cost:	\$110,000.00
Total estimated cost of priority 1 projects:		\$0.00
Total estimated cost of priority 2 projects:		\$0.00
Total estimated cost of priority 3 projects:		<u>\$825,000.00</u>
Total estimated cost of all projects:		\$825,000.00

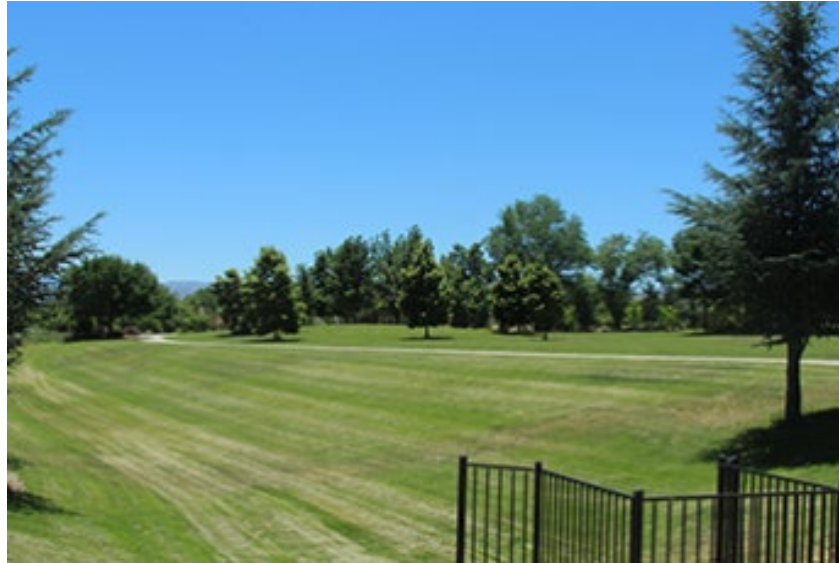
WHEATLAND PARK
6.08 acres (Developed)
PRELIMINARY CONDITION ASSESSMENT: POOR

Total Cost for Priority 1 Projects:		\$0.00
	Cost:	\$0.00
PRIORITY CLASS 2 PROJECTS		Total Cost for Priority 2 Projects: \$10,000.00
Necessary	Not Yet Critical	
RESURFACE WATER SPRAY PAD	Cost:	\$10,000.00
Total Cost for Priority 3 Projects:		\$1,545,000.00
Needs	Long - Term	
REPLACE PLAYGROUND EQUIPMENT	Cost:	\$1,400,000.00
Replace playground equipment and surface		
RESURFACE WATER SPRAY PAD	Cost:	\$145,000.00
400k Fund		
Total estimated cost of priority 1 projects:		\$0.00
Total estimated cost of priority 2 projects:		\$10,000.00
Total estimated cost of priority 3 projects:		<u>\$1,545,000.00</u>
Total estimated cost of all projects:		\$1,555,000.00

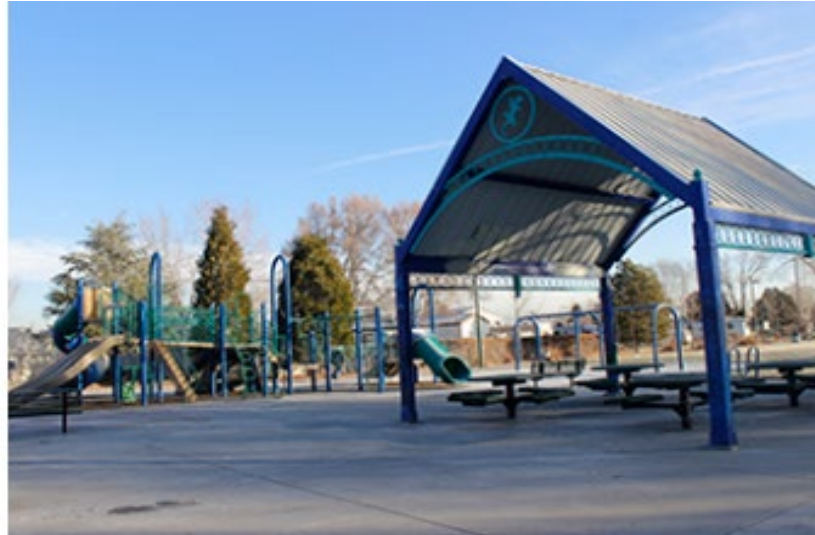
WHITAKER PARK 6.72 acres (Developed) PRELIMINARY CONDITION ASSESSMENT: POOR

REPLACE PLAYGROUND EQUIPMENT			\$950,000.00
Replace playground equipment and surface

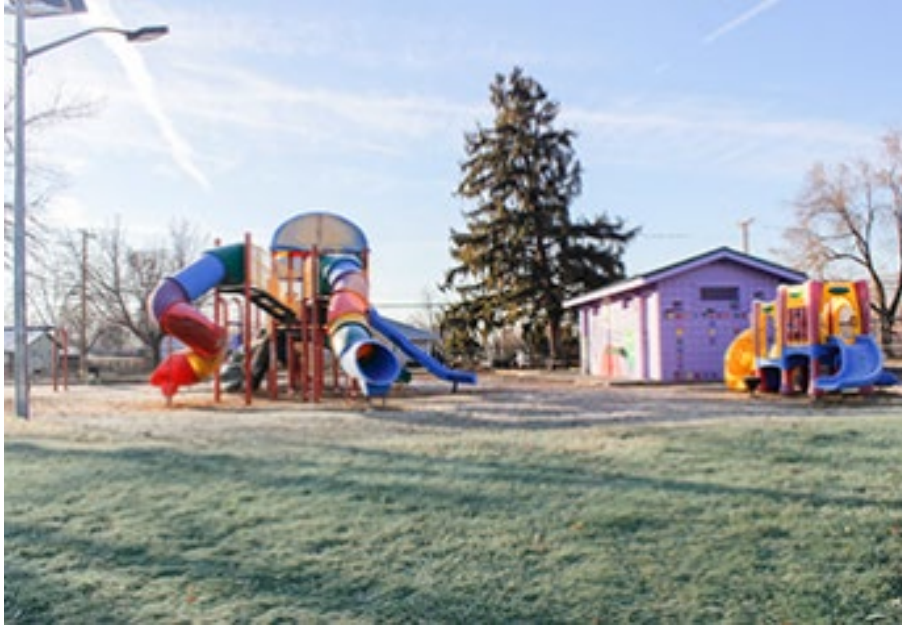
WILKINSON PARK
4.29 acres (Developed)
PRELIMINARY CONDITION ASSESSMENT: POOR

REPLACE PLAYGROUND EQUIPMENT Replace playground and resurface with CDBG/RCT Funds	Cost:	\$827,000.00
---	--------------	---------------------

REPLACE PLAYGROUND EQUIPMENT Replace playground and resurface with 400K Fund	Cost:	\$370,000.00
--	--------------	---------------------

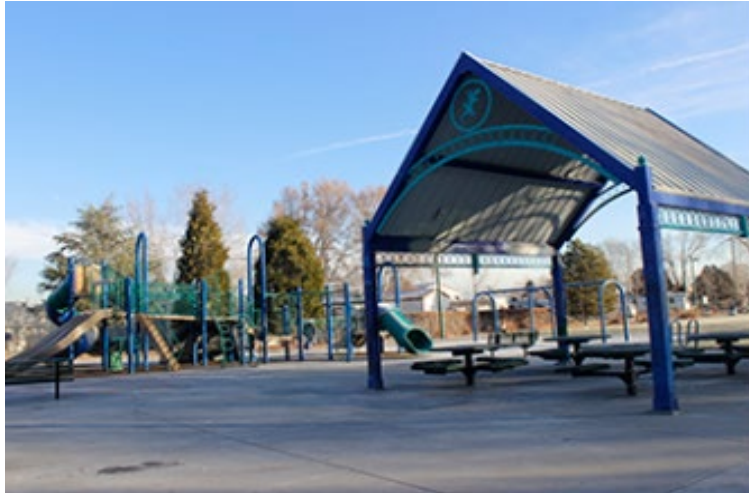
YORI PARK 3.13 acres (Developed) PRELIMINARY CONDITION ASSESSMENT: POOR

REPLACE PLAYGROUND EQUIPMENT	Cost:	\$650,000.00
-------------------------------------	--------------	---------------------

Replace playground equipment and resurface

REPLACE SKATE ELEMENTS	Cost:	\$65,000.00
-------------------------------	--------------	--------------------

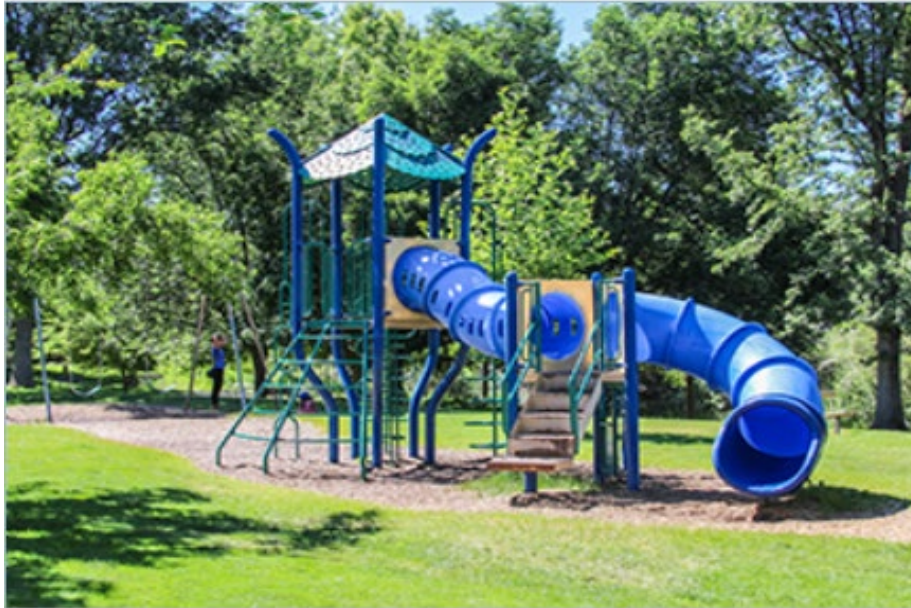
CRISSIE CAUGHLIN PARK
5.00 acres (Developed)
PRELIMINARY CONDITION ASSESSMENT: FAIR

REPLACE PICNIC SHELTER	Cost:	\$85,000.00
------------------------	--------------	--------------------

REPLACE PLAYGROUND AND SAFETY SURFACE	Cost:	\$550,000.00
---------------------------------------	--------------	---------------------

REPLACE SMALL PEDESTRIAN BRIDGE	Cost:	\$50,000.00
---------------------------------	--------------	--------------------

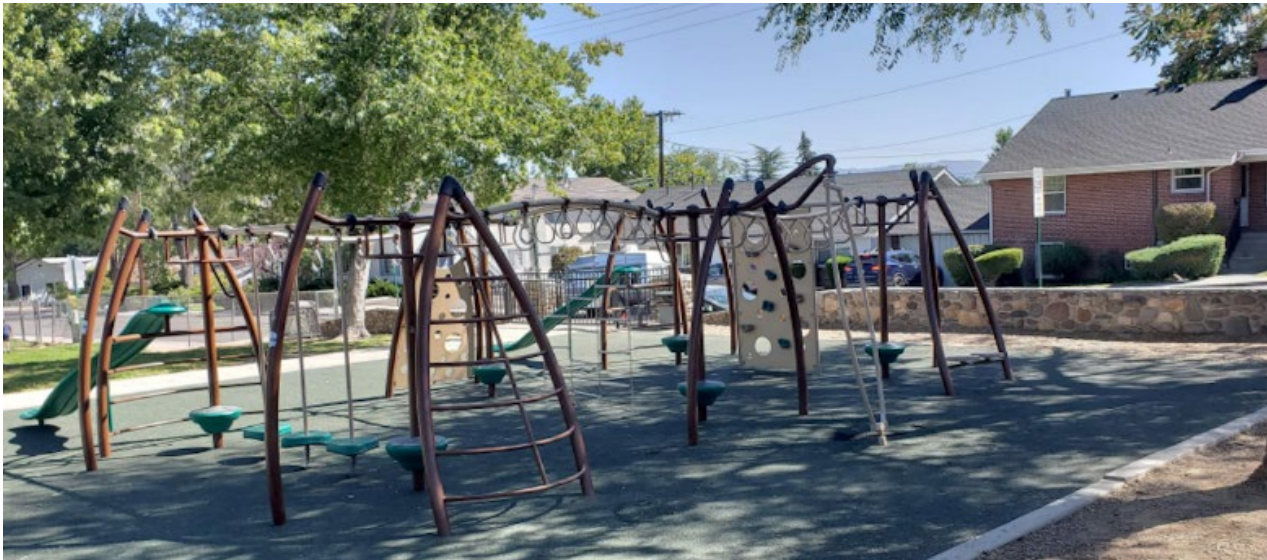
PLUMAS PARK
4.80 acres (Developed)
PRELIMINARY CONDITION ASSESSMENT: FAIR

Needs	Long - Term		
RENOVATE TURF		Cost:	\$75,000.00
RENOVATE IRRIGATION SYSTEM		Cost:	\$317,000.00
REPAIR/REPLACE ROCK RETAINING WALLS		Cost:	\$35,000.00
REPLACE PERIMETER FENCING		Cost:	\$275,000.00

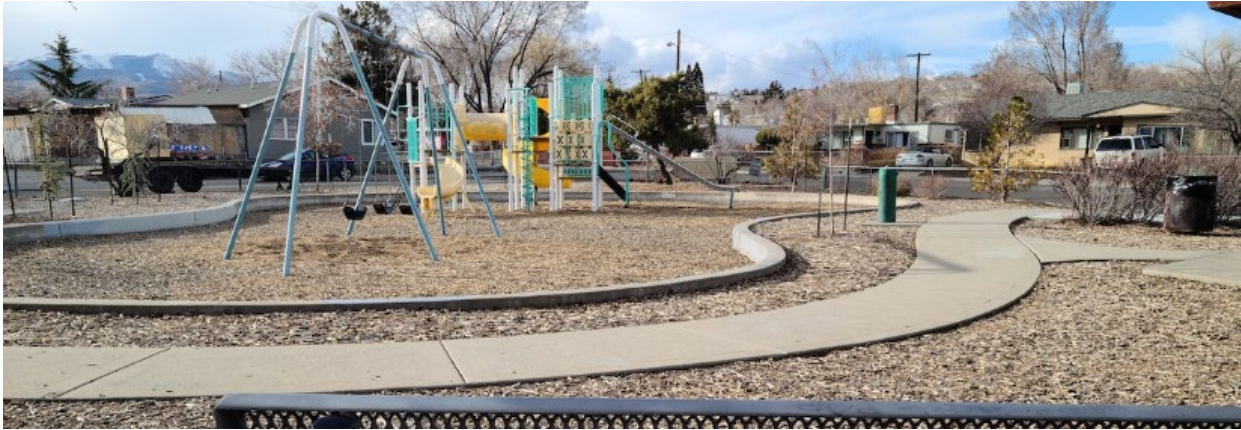
STERLING VILLAGE
0.23 acres (Developed)
PRELIMINARY CONDITION ASSESSMENT: CRITICAL

REPLACE PICNIC SHELTER	Cost:	\$100,000.00
------------------------	-------	---------------------

REPLACE PLAYGROUND EQUIPMENT AND SURFACE	Cost:	\$0.00
--	-------	---------------

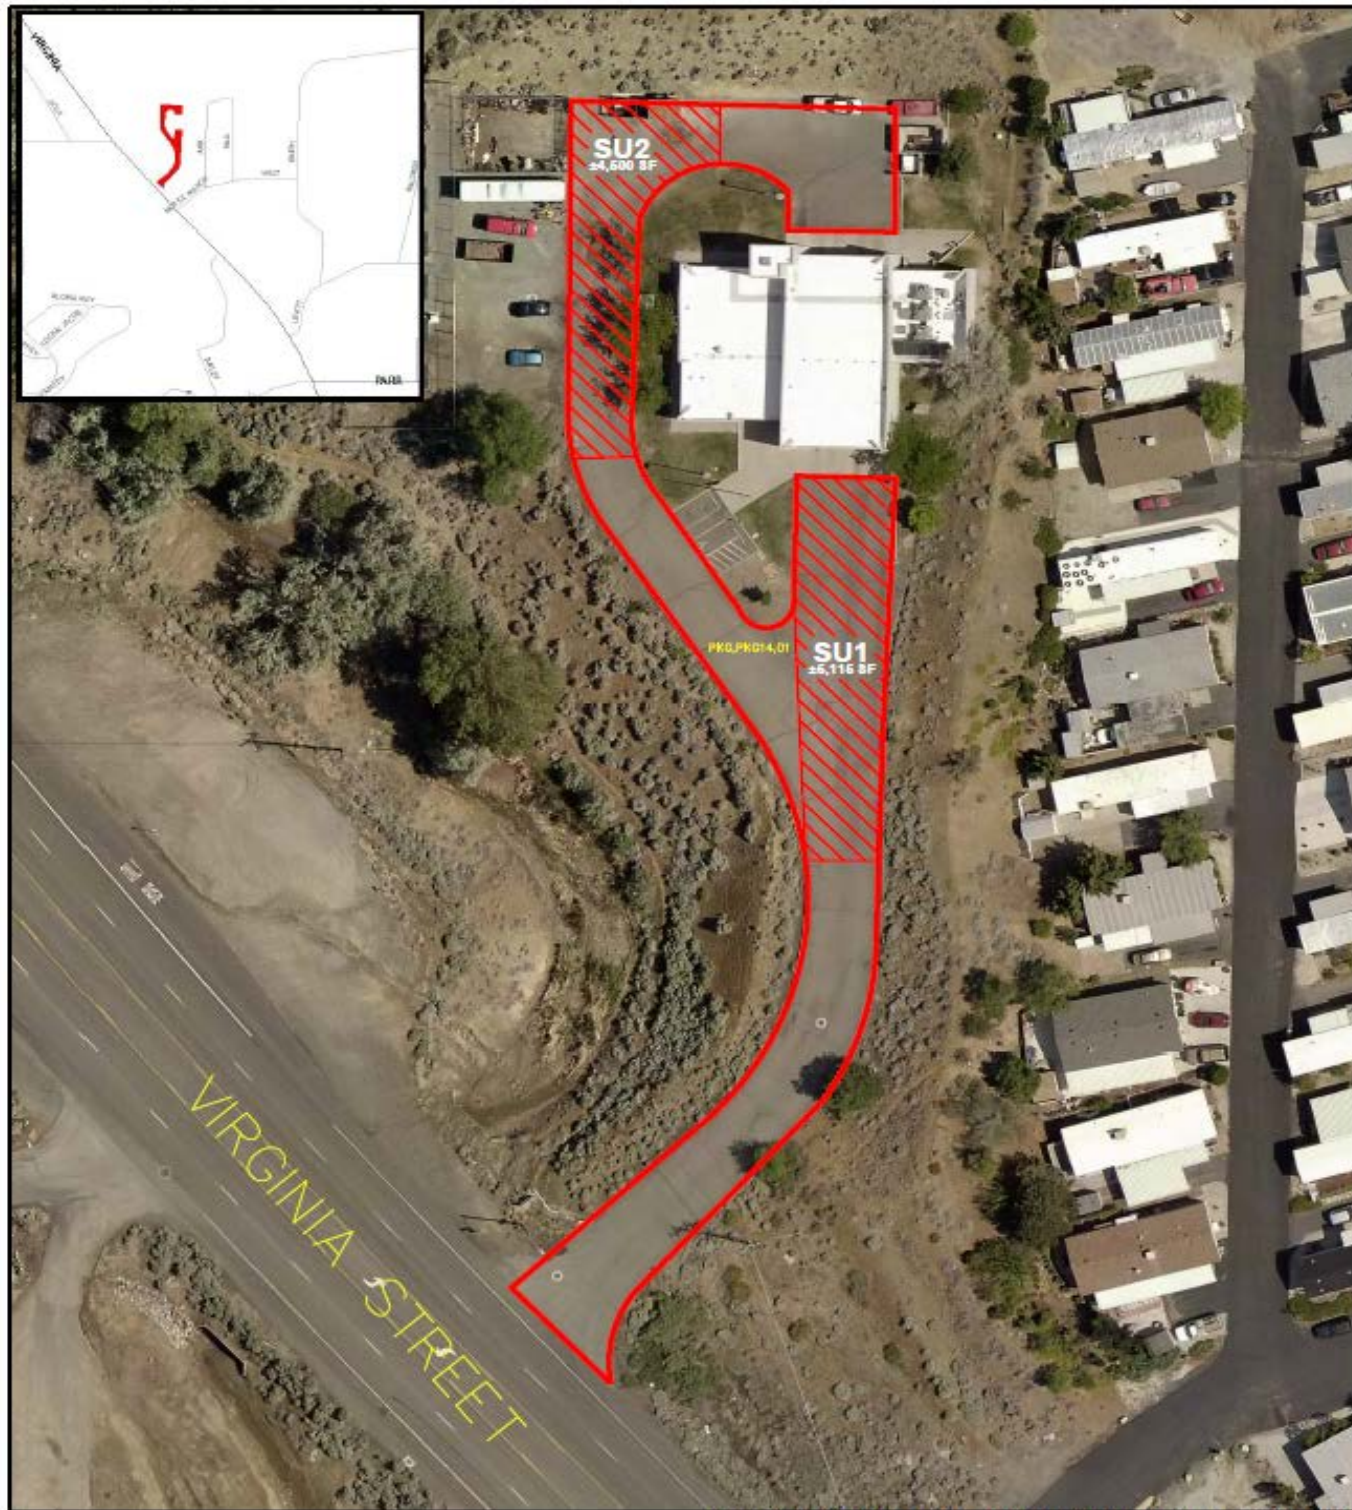
FIRE STATION #10 - NORTH VIRGINIA, PKG 14
SECTION 01
JANUARY 2018

FIRE STATION # 10 - North Virginia St.					
PARKING LOT INVENTORY :PKG #		14	PAVEMENT TYPE		AC
ORIGINAL CONSTRUCTION DATE		3/2/1983	LAST WORK DATE		NA
LAST INSPECTION DATE		9/12/2019	LAST INSPECTED PCI		20
			PREDICTED PCI (2022)		13
	UNIT	QUANTITY	COMMENTS	UNIT COST	TOTAL
PAVEMENT AREA	SF	24885	Section 1	\$ 15.00	\$ 373,275.00
CURB	FEET	543		\$ 24.00	\$ 13,032.00
CURB AND GUTTER	FEET				
VALLEY GUTTER	SF				
SIDEWALK	SF				
PED RAMP	EACH				
LIGHT POLE SINGLE	EACH	1		\$ 1,800.00	\$ 1,800.00
LIGHT POLE DOUBLE	EACH				
LIGHT POLE PIER	EACH	1		\$ 500.00	\$ 500.00
CATCH BASIN	EACH				
MANHOLE	EACH	1		\$ 10,000.00	\$ 10,000.00
AC WOOD 2X RETAINER	FT	90		\$ 3.00	\$ 270.00
VALVE, WATER	EACH				
SIGN	EACH	1		\$ 150.00	\$ 150.00
GATE POST	EACH	4		\$ 150.00	\$ 600.00
PCC TRASH APRON	SF	100		\$ 13.00	\$ 1,300.00
WHEEL STOP	EACH	2		\$ 150.00	\$ 300.00
BOLLARDS	EACH	3		\$ 750.00	\$ 2,250.00
SPACES, HANDICAP	EACH	1		\$ 225.00	\$ 225.00

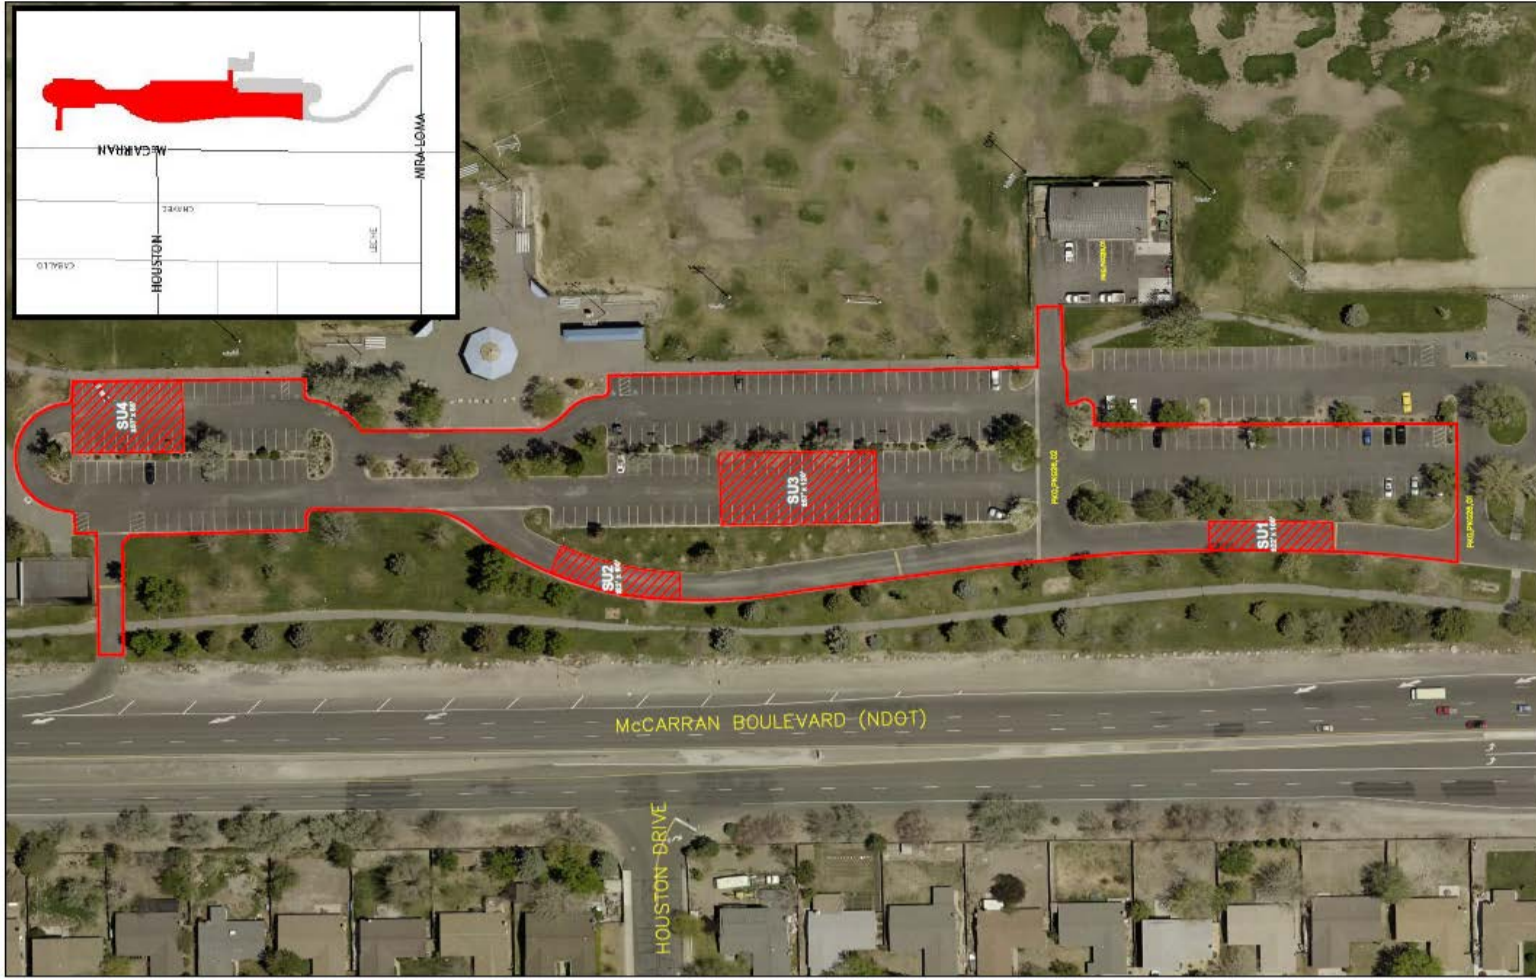
MIRA LOMA PARK, PKG 26
SECTION 02
JANUARY 2018

MIRA LOMA PKG LOT					
PARKING LOT INVENTORY :PKG #		26	PAVEMENT TYPE		AC
ORIGINAL CONSTRUCTION DATE		12/21/1982	LAST WORK DATE		7/7/2019
LAST INSPECTION DATE		8/29/2022	PREDICTED PCI (2022)		20
	UNIT	QUANTITY	COMMENTS	UNIT COST	TOTAL
PAVEMENT AREA	SF	142559	Sections 1 and 2	\$ 15.00	\$ 2,138,385.01
CURB	FEET	4776		\$ 24.00	\$ 114,624.00
CURB AND GUTTER	FEET	3256		\$ 65.00	\$ 211,640.00
VALLEY GUTTER	SF	879	293 X3'	\$ 18.00	\$ 15,822.00
SIDEWALK	SF				
PED RAMP	EACH	8		\$ 8,300.00	\$ 66,400.00
LIGHT POLE SINGLE	EACH	8		\$ 1,800.00	\$ 14,400.00
LIGHT POLE DOUBLE	EACH	5		\$ 2,200.00	\$ 11,000.00
LIGHT POLE PIER	EACH	5		\$ 500.00	\$ 2,500.00
CATCH BASIN	EACH	2		\$ 1,200.00	\$ 2,400.00
MANHOLE	EACH				
VALVE, GAS	EACH				
VALVE, WATER	EACH				
SIGN	EACH	17		\$ 150.00	\$ 2,550.00
SPEED BUMP	EACH	4		\$ 150.00	\$ 600.00
VAULT	EACH				
WHEEL STOP	EACH				
ROOT MITIGATION	EACH				
SPACES, HANDICAP	EACH	8		\$ 225.00	\$ 1,800.00

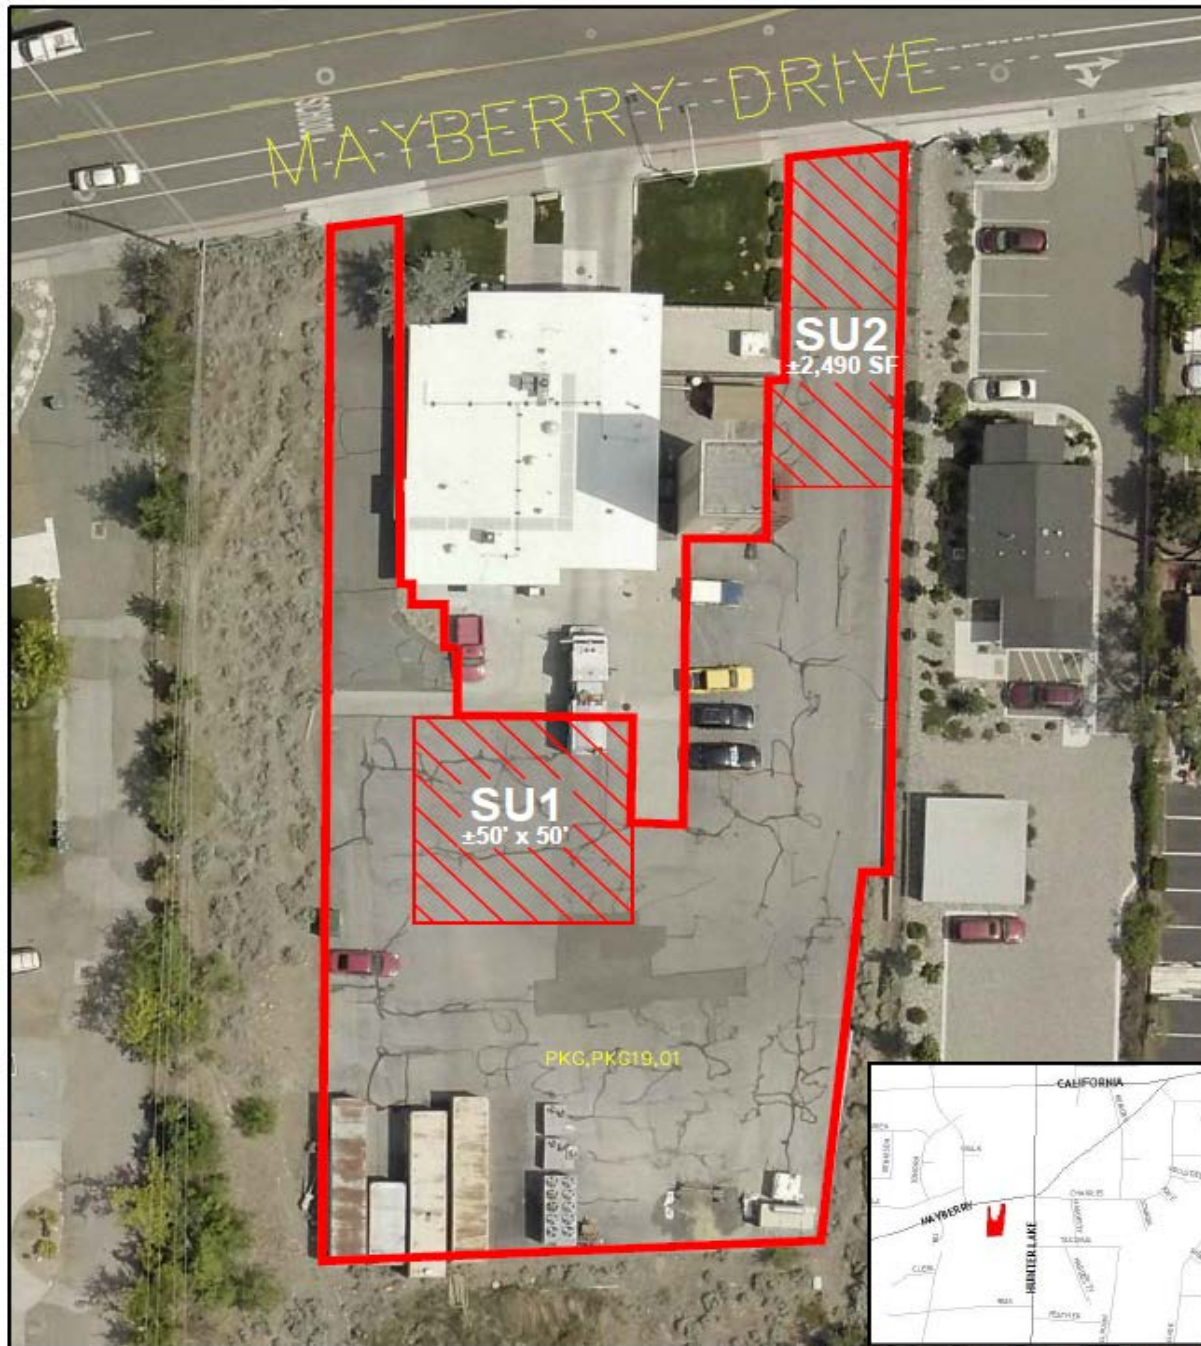
FIRE STATION #5 - MAYBERRY, PKG 19
SECTION 01
JANUARY 2018

PARKING LOT INVENTORY :PKG #		19	PAVEMENT TYPE		AC/PCC
ORIGINAL CONSTRUCTION DATE	SEC 1	10/2/1998	LAST WORK DATE	SEC 1	NA
LAST INSPECTION DATE	SEC 1	1/5/2018	LAST INSPECTED PCI	SEC 1	43
			PREDICTED PCI (2022)	SEC 1	29
ORIGINAL CONSTRUCTION DATE	SEC 2	9/2/1961	LAST WORK DATE	SEC 2	1/0/1900
LAST INSPECTION DATE	SEC 2	1/5/2018	LAST INSPECTED PCI	SEC 2	34
			PREDICTED PCI (2022)	SEC 2	28
	UNIT	QUANTITY	COMMENTS	UNIT COST	TOTAL
PAVEMENT AREA-AC	SF	23226	Section 1	\$ 15.00	\$ 348,390.00
PAVEMENT AREA-PCC	SF	2184	Section 2	\$ 28.00	\$ 61,152.00
CURB	FEET				
CURB AND GUTTER	FEET				
VALLEY GUTTER	SF	498	6 X 83'	\$ 18.00	\$ 8,964.00
SIDEWALK	SF	40		\$ 16.00	\$ 640.00
PED RAMP	EACH				
LIGHT POLE SINGLE	EACH				
LIGHT POLE DOUBLE	EACH				
LIGHT POLE PIER	EACH				
CATCH BASIN	EACH	2		\$ 1,200.00	\$ 2,400.00
MANHOLE	EACH				
VALVE, GAS	EACH				
VALVE, WATER	EACH				
SIGN	EACH				
SPEED BUMP	EACH				
VAULT	EACH				
WHEEL STOP	EACH

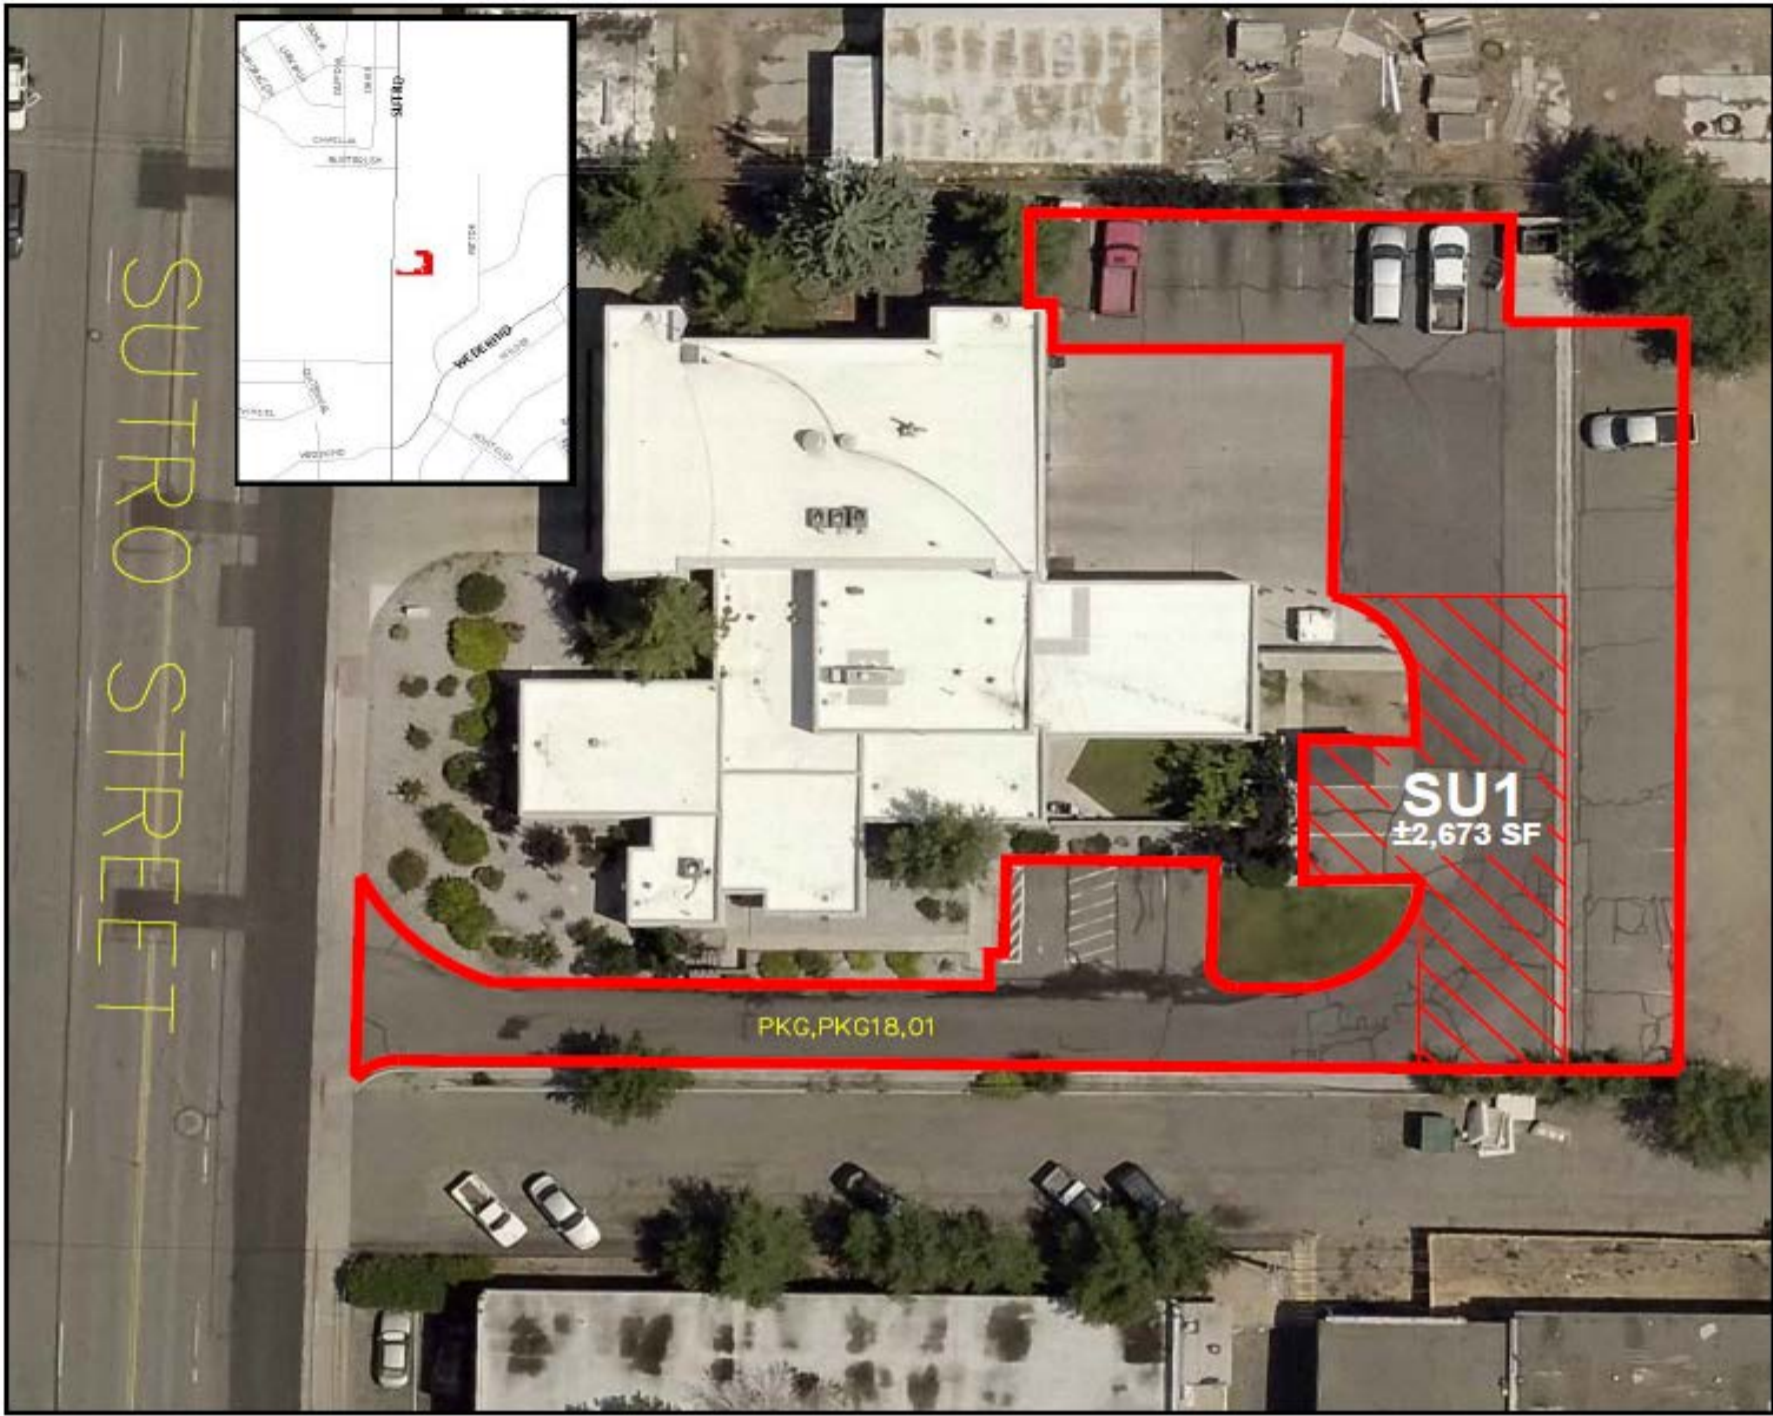
FIRE STATION #02, PKG 18
SECTION 01
JANUARY 2018

FIRE STATION #2					
PARKING LOT INVENTORY :PKG #		18	PAVEMENT TYPE		AC
ORIGINAL CONSTRUCTION DATE		9/2/1987	LAST WORK DATE		NA
LAST INSPECTION DATE		9/23/2019	LAST INSPECTED PCI		39
			PREDICTED PCI (2022)		33
	UNIT	QUANTITY	COMMENTS	UNIT COST	TOTAL
PAVEMENT AREA	SF	14166	Section 1	\$ 15.00	\$ 212,490.00
CURB	FEET	245		\$ 24.00	\$ 5,880.00
CURB AND GUTTER	FEET	242		\$ 65.00	\$ 15,730.00
VALLEY GUTTER	SF	426	142 X 3'	\$ 18.00	\$ 7,668.00
SIDEWALK	SF	84		\$ 16.00	\$ 1,344.00
PED RAMP	EACH				
LIGHT POLE SINGLE	EACH				
LIGHT POLE DOUBLE	EACH				
LIGHT POLE PIER	EACH				
CATCH BASIN	EACH	3		\$ 1,200.00	\$ 3,600.00
MANHOLE	EACH	1		\$ 10,000.00	\$ 10,000.00
VALVE, GAS	EACH				
VALVE, WATER	EACH				
STEP PCC	SF	24		\$ 16.00	\$ 384.00
SPEED BUMP	EACH				
HC/RAMP PCC WITH SW	SF	102	6X17'	\$ 20.00	\$ 2,040.00
STEP PCC	SF	24	3X5' ,3X3'	\$ 16.00	\$ 384.00
ROOT MITIGATION	EACH				
SPACES, HANDICAP	EACH	1		\$ 225.00	\$ 225.00

SPACES, REGULAR	EACH	26		\$ 9.00	\$ 234.00
CURB WITH CHAIN LINK	FEET	51		#N/A	\$ -
PCC TRASH APRON	SF	121		\$ 13.00	\$ 1,573.00
FT W/BLOCK PLANTER	EACH	78		\$ 25.00	\$ 1,950.00
			TOTAL		\$ 263,502.00

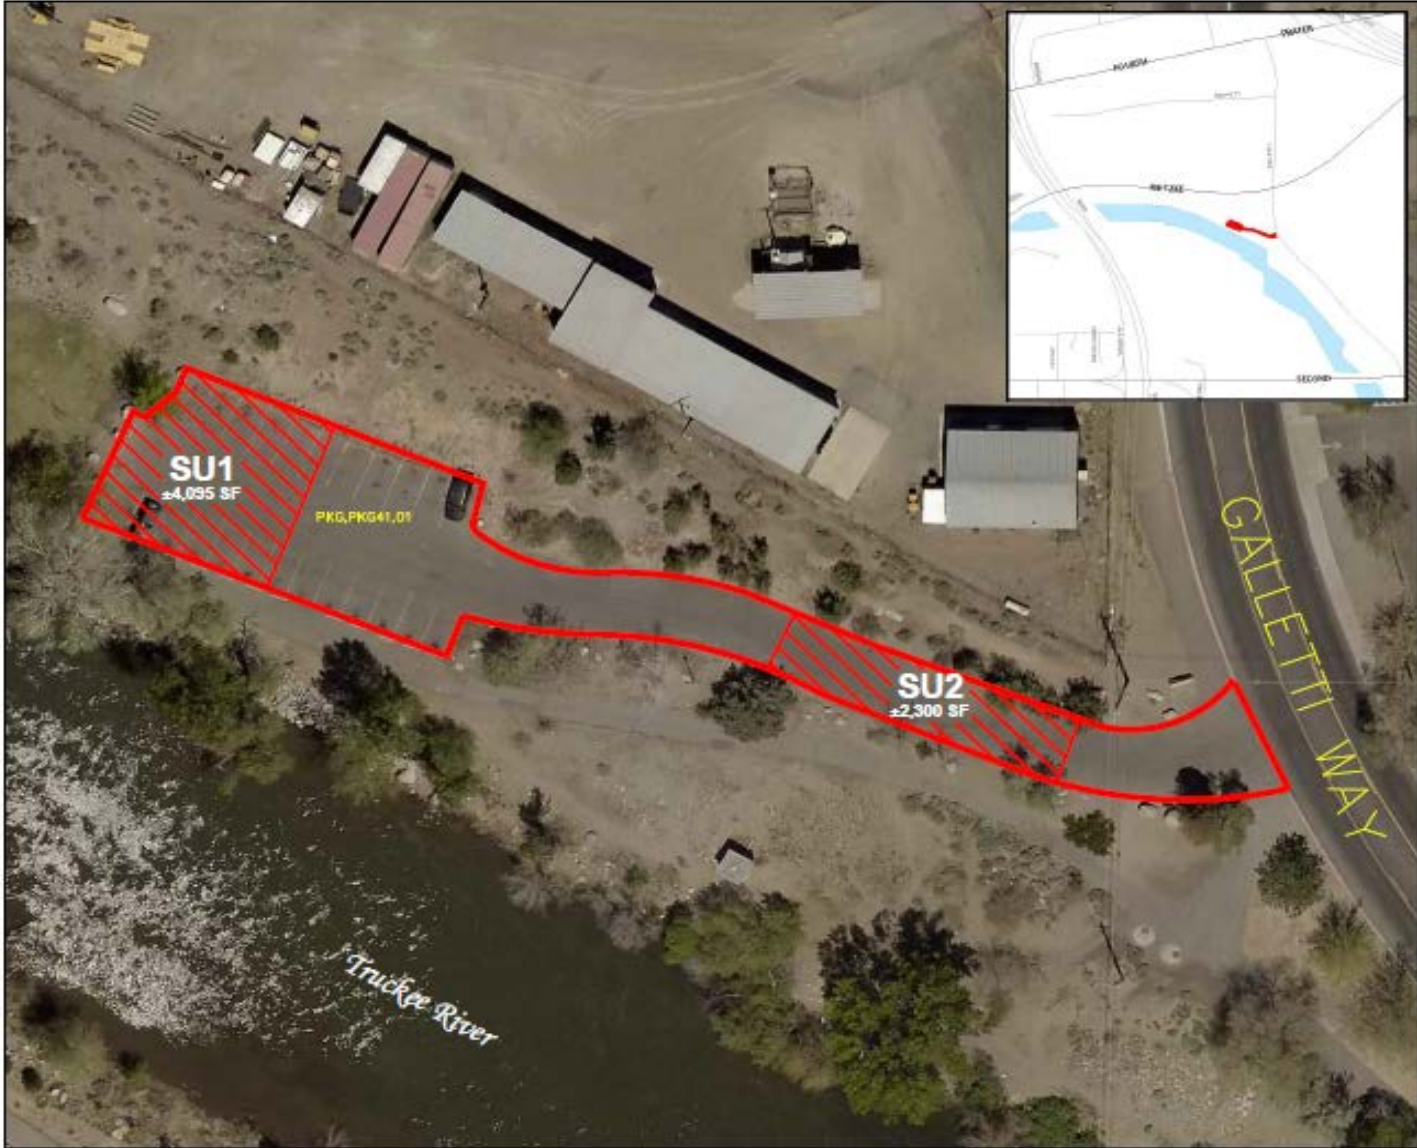
FISHERMAN'S PARK (I), PKG 41
SECTION 01
JANUARY 2018

FISHERMANS PARK 1+2					
PARKING LOT INVENTORY :PKG #		41	PAVEMENT TYPE		AC
ORIGINAL CONSTRUCTION DATE	SEC 1	12/2/1984	LAST WORK DATE	SEC 1	7/7/2010
LAST INSPECTION DATE	SEC 1	8/17/2022	LAST INSPECTED PCI	SEC 1	32
ORIGINAL CONSTRUCTION DATE	SEC 2	6/2/1986	LAST WORK DATE	SEC 2	7/7/2010
LAST INSPECTION DATE	SEC 2	8/17/2022	LAST INSPECTED PCI	SEC 2	37
	UNIT	QUANTITY	COMMENTS	UNIT COST	TOTAL
PAVEMENT AREA	SF	18850	Section 1 and 2	\$ 15.00	\$ 282,750.00
CURB	FEET				
CURB AND GUTTER	FEET				
VALLEY GUTTER	SF				
SIDEWALK	SF				
PED RAMP	EACH				
LIGHT POLE SINGLE	EACH	2		\$ 1,800.00	\$ 3,600.00
LIGHT POLE DOUBLE	EACH				
LIGHT POLE PIER	EACH				
CATCH BASIN	EACH				
MANHOLE	EACH				
VALVE, GAS	EACH				
VALVE, WATER	EACH				
SIGN	EACH	2		\$ 150.00	\$ 300.00
SPEED BUMP	EACH				
VAULT	EACH	3	SMALL ON EDGE OF DW	\$ 400.00	\$ 1,200.00
WHEEL STOP	EACH	34	11RR TIES E/11RR TIES W	\$ 150.00	\$ 5,100.00
ROOT MITIGATION	EACH

SPACES, HANDICAP	EACH	2		\$ 225.00	\$ 450.00
SPACES, REGULAR	EACH	32		\$ 9.00	\$ 288.00
WHEEL STOP	EACH	13	NOT FOR DESIGNATED PARK	\$ 150.00	\$ 1,950.00
REDWOOD 2X? RETAINER	FEET	420	APPX 420' LF 2X REDWOOD	\$ 3.00	\$ 1,260.00
			TOTAL		\$ 296,898.00
