City of Reno

2023-24

**FACILITY CONDITION
ASSESSMENT REPORT**

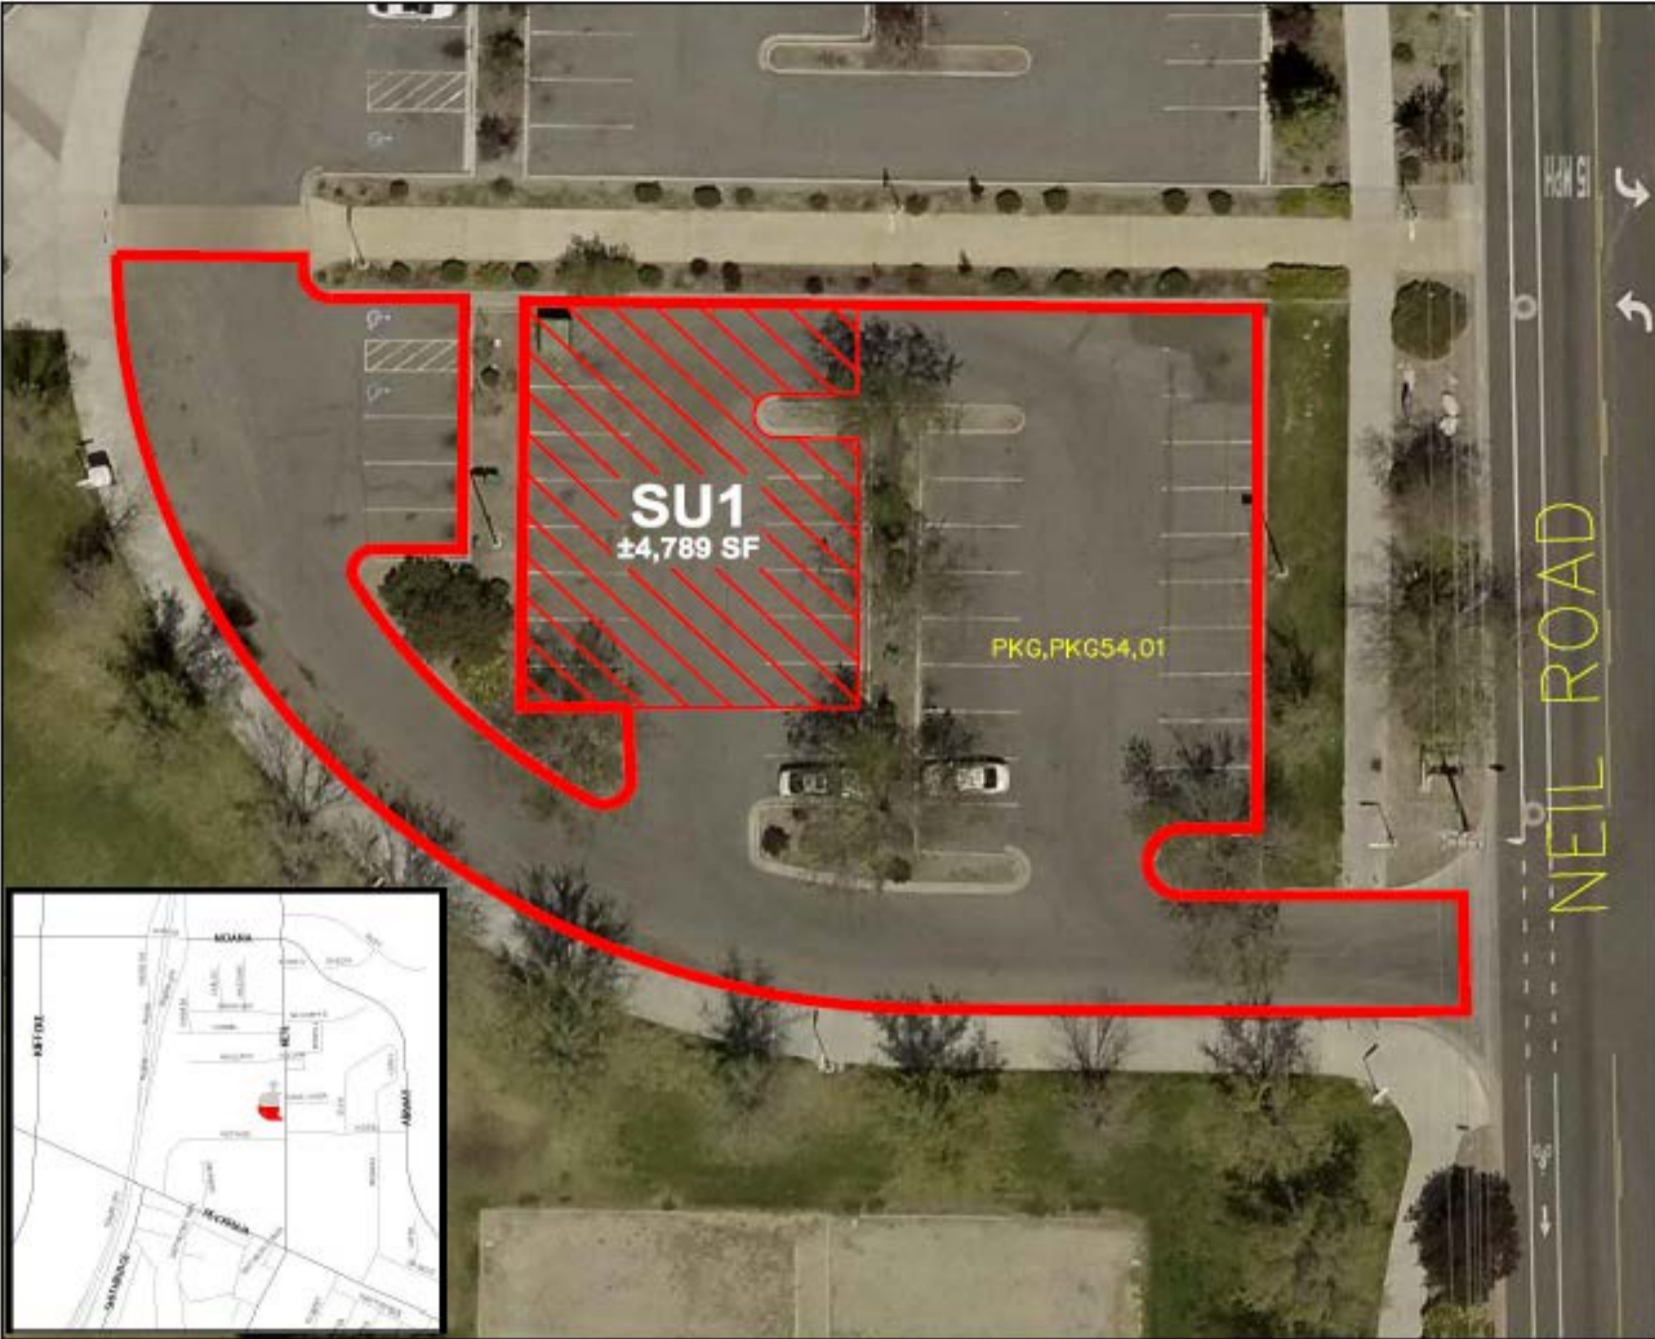
MIGUEL RIBERA PARK, PKG 54
SECTION 01
JANUARY 2018

MIGUEL RIBERA PARK					
PARKING LOT INVENTORY :PKG #		54-01	PAVEMENT TYPE		AC
ORIGINAL CONSTRUCTION DATE		7/7/1995	LAST WORK DATE		7/7/2018
LAST INSPECTION DATE		9/1/2022	LAST INSPECTED PCI		43
	UNIT	QUANTITY	COMMENTS	UNIT COST	TOTAL
PAVEMENT AREA	SF	20723	Section 1	\$ 15.00	\$ 310,845.00
CURB	FEET	72		\$ 24.00	\$ 1,728.00
CURB AND GUTTER	FEET	1015		\$ 65.00	\$ 65,975.00
VALLEY GUTTER	SF	72	24X3'	\$ 18.00	\$ 1,296.00
SIDEWALK	SF	5340		\$ 16.00	\$ 85,440.00
PED RAMP	EACH	2		\$ 8,300.00	\$ 16,600.00
LIGHT POLE SINGLE	EACH	14		\$ 1,800.00	\$ 25,200.00
LIGHT POLE DOUBLE	EACH				
LIGHT POLE PIER	EACH	14		\$ 500.00	\$ 7,000.00
CATCH BASIN	EACH	4		\$ 1,200.00	\$ 4,800.00
MANHOLE	EACH	1		\$ 10,000.00	\$ 10,000.00
VALVE, GAS	EACH				
VALVE, WATER	EACH				
SIGN	EACH	8		\$ 150.00	\$ 1,200.00
SPEED BUMP	EACH				
VAULT	EACH				
WHEEL STOP	EACH				
ROOT MITIGATION	EACH				
SPACES, HANDICAP	EACH	4		\$ 225.00	\$ 900.00
SPACES, REGULAR	EACH	84		\$ 9.00	\$ 756.00

PCC ENTRANCE APRON	SF	1007		\$ 30.00	\$ 30,210.00
PCC X WALK	SF	330		\$ 13.00	\$ 4,290.00
BOLLARDS	EACH	4		\$ 750.00	\$ 3,000.00
			TOTAL		\$ 569,240.00

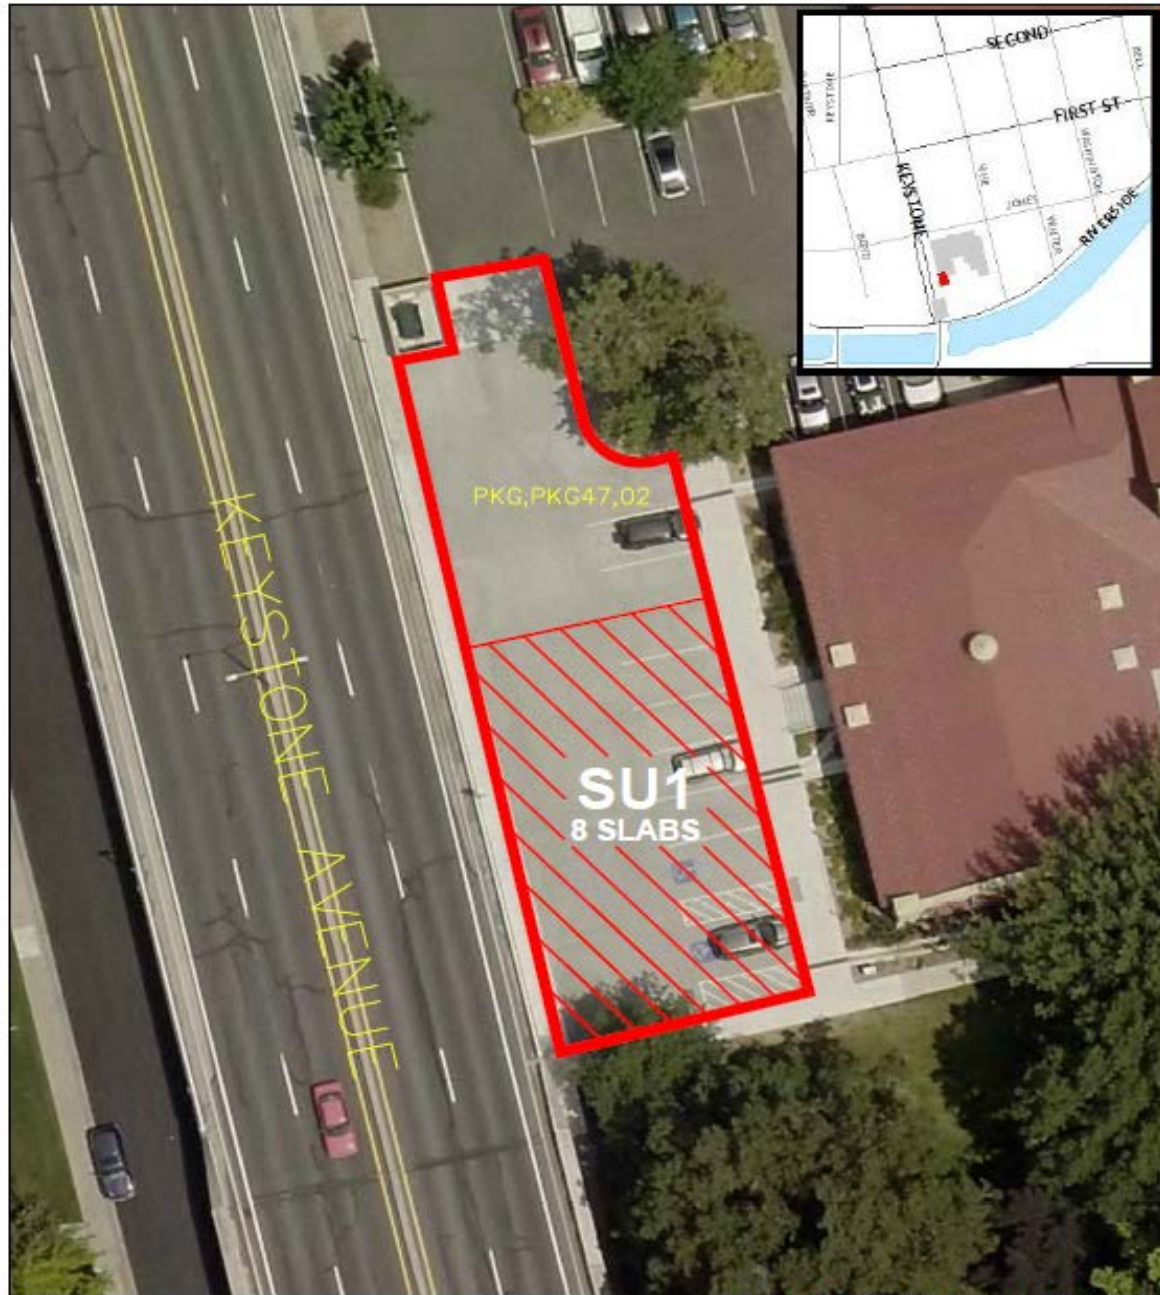
McKINLEY ART CENTER, PKG 47
SECTION 02
JANUARY 2018

PARKING LOT INVENTORY :PKG #		47	PAVEMENT TYPE		AC
ORIGINAL CONSTRUCTION DATE	SEC 2	7/7/2009	LAST WORK DATE	SEC 2	NA
LAST INSPECTION DATE	SEC 2	9/7/2021	LAST INSPECTED PCI	SEC 2	56
			PREDICTED PCI (2022)	SEC 2	52
ORIGINAL CONSTRUCTION DATE	SEC 3	7/7/1975	LAST WORK DATE	SEC 3	7/7/2011
LAST INSPECTION DATE	SEC 3	9/7/2021	LAST INSPECTED PCI	SEC 3	18
			PREDICTED PCI (2022)	SEC 3	16
	UNIT	QUANTITY	COMMENTS	UNIT COST	TOTAL
PAVEMENT AREA-AC	SF	5815	Section 3	\$ 15.00	\$ 87,225.00
PAVEMENT AREA-PCC	SF	5715	Section 2-Pervious Concrete	\$ 28.00	\$ 160,020.00
CURB	FEET	1654		\$ 24.00	\$ 39,696.00
CURB AND GUTTER	FEET	89		\$ 65.00	\$ 5,785.00
VALLEY GUTTER	SF	1983	661 X 3'	\$ 18.00	\$ 35,694.00
SIDEWALK	SF	836		\$ 16.00	\$ 13,376.00
PED RAMP	EACH	1		\$ 8,300.00	\$ 8,300.00
LIGHT POLE SINGLE	EACH	20		\$ 1,800.00	\$ 36,000.00
LIGHT POLE DOUBLE	EACH				
LIGHT POLE PIER	EACH	20		\$ 500.00	\$ 10,000.00
CATCH BASIN	EACH	4	3 GRT IN VG,1 GRT IN C+G	\$ 1,200.00	\$ 4,800.00

MANHOLE	EACH				
VALVE, GAS	EACH				
VALVE, WATER	EACH				
SIGN	EACH	9		\$ 150.00	\$ 1,350.00
SPEED BUMP	EACH				
VAULT	EACH				
WHEEL STOP	EACH	8		\$ 150.00	\$ 1,200.00
ROOT MITIGATION	EACH				
SPACES, HANDICAP	EACH	4		\$ 225.00	\$ 900.00
SPACES, REGULAR	EACH	91		\$ 9.00	\$ 819.00
BOLLARDS	EACH	2	4"	\$ 750.00	\$ 1,500.00
PCC TRASH APRON	SF	98	DUMPSTER	\$ 13.00	\$ 1,274.00
CURB GROUND LEVEL	FEET	16		\$ 24.00	\$ 384.00
			TOTAL		\$ 161,078.00

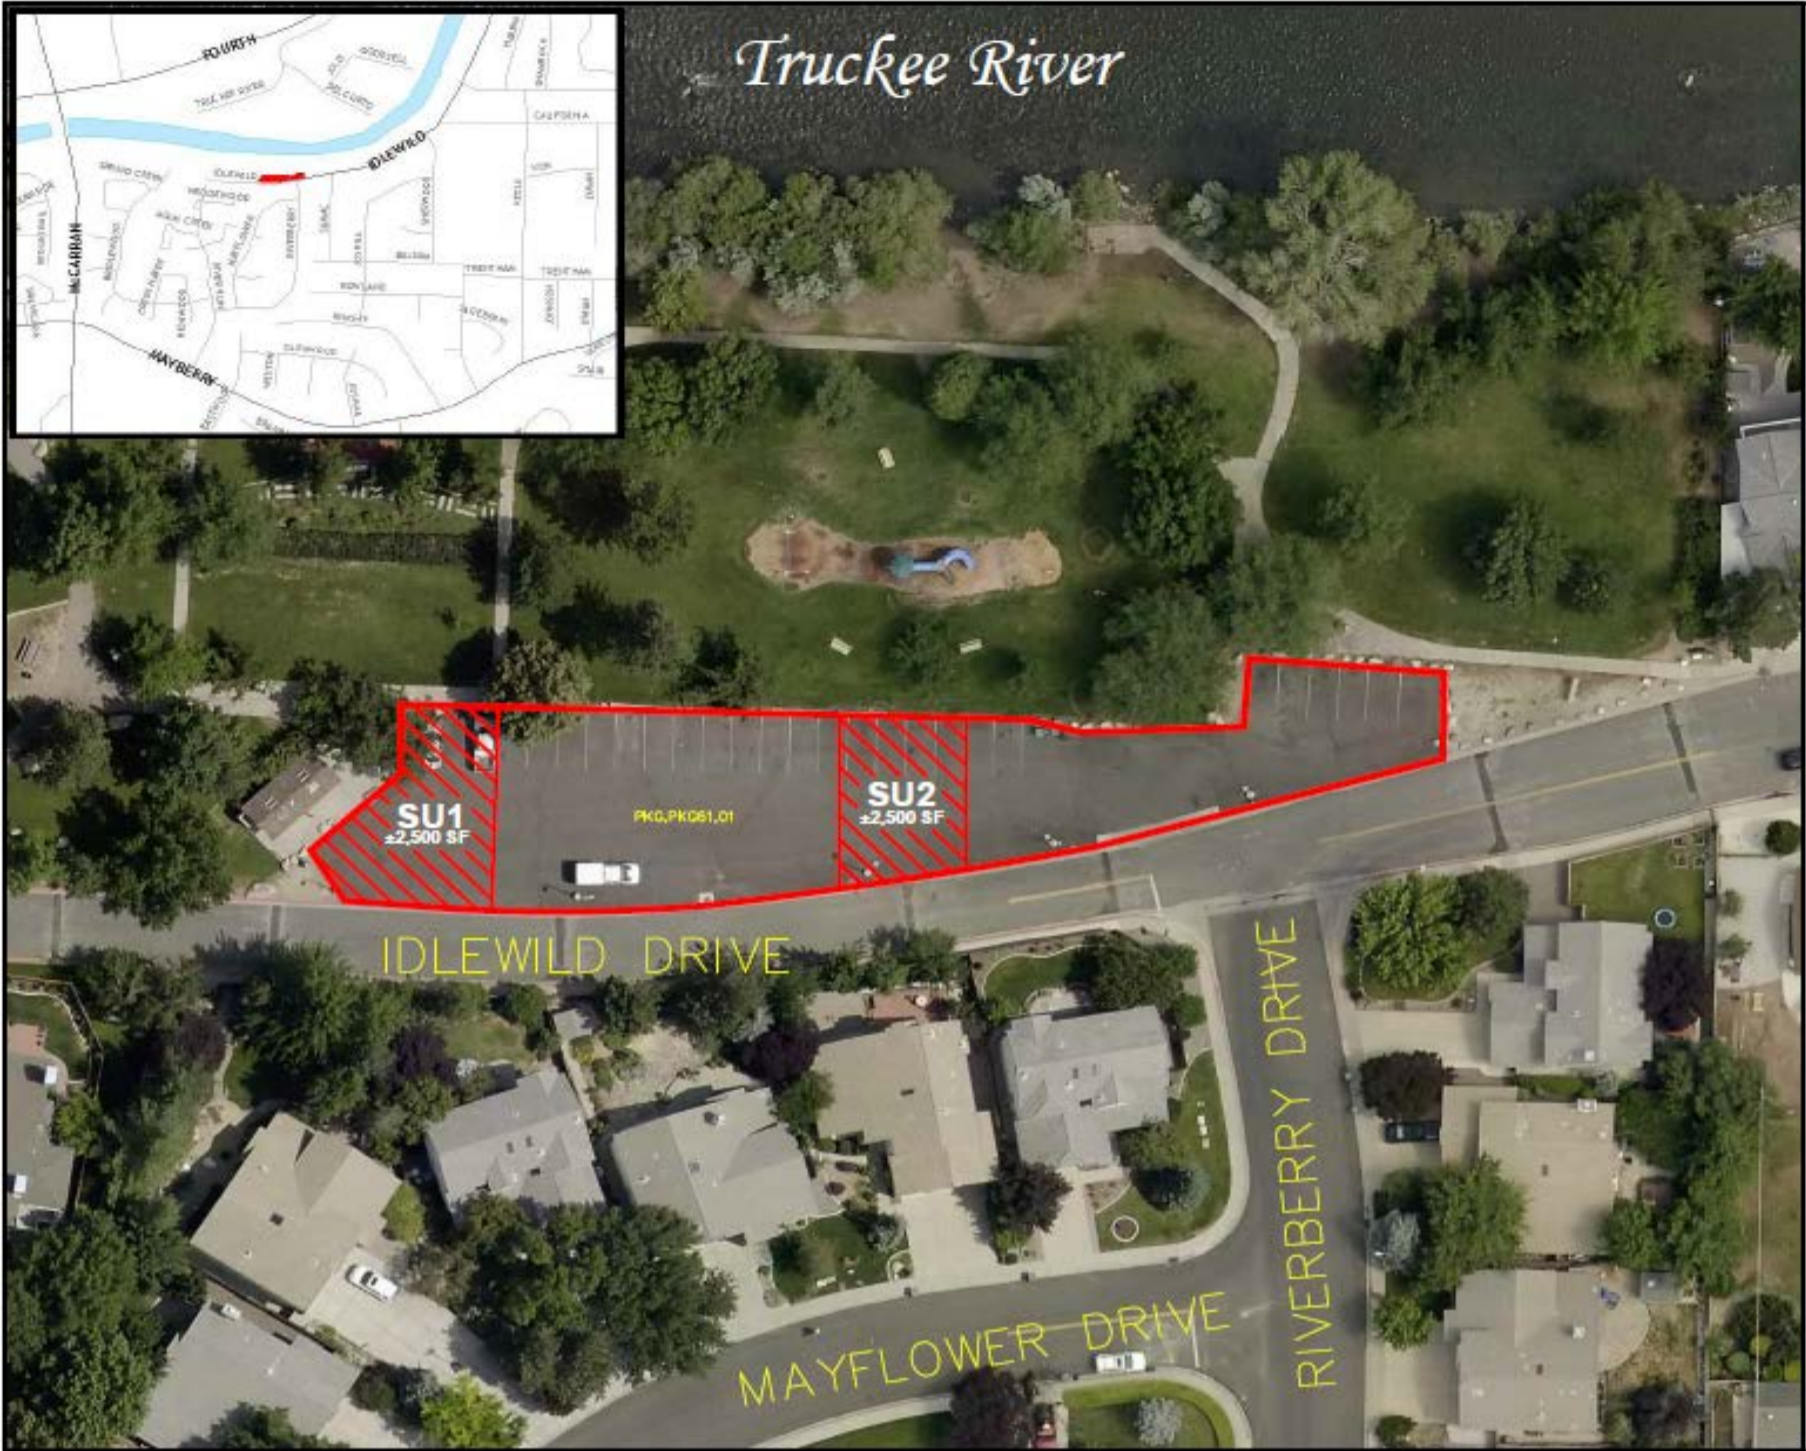
CRISSIE CAUGHLIN PARK, PKG 61
SECTION 01
JANUARY 2018

PARKING LOT INVENTORY :PKG #		61	PAVEMENT TYPE		AC
ORIGINAL CONSTRUCTION DATE		6/1/2001	LAST WORK DATE		7/7/2017
LAST INSPECTION DATE		1/5/2018	LAST INSPECTED PCI		62
			PREDICTED PCI (2022)		51
	UNIT	QUANTITY	COMMENTS	UNIT COST	TOTAL
PAVEMENT AREA	SF	17629	Section 1	\$ 15.00	\$ 264,435.00
CURB	FEET				
CURB AND GUTTER	FEET				
VALLEY GUTTER	SF				
SIDEWALK	SF	856		\$ 16.00	\$ 13,696.00
PED RAMP	EACH	1		\$ 8,300.00	\$ 8,300.00
LIGHT POLE SINGLE	EACH	6		\$ 1,800.00	\$ 10,800.00
LIGHT POLE DOUBLE	EACH				
LIGHT POLE PIER	EACH	6		\$ 500.00	\$ 3,000.00
CATCH BASIN	EACH	1		\$ 1,200.00	\$ 1,200.00
MANHOLE	EACH	2		\$ 10,000.00	\$ 20,000.00
VALVE, GAS	EACH				
VALVE, WATER	EACH				
SIGN	EACH	1		\$ 150.00	\$ 150.00
SPEED BUMP	EACH				
VAULT	EACH	8		\$ 400.00	\$ 3,200.00
WHEEL STOP	EACH				
ROOT MITIGATION	EACH				
SPACES, HANDICAP	EACH				
SPACES, REGULAR	EACH	28		\$ 9.00	\$ 252.00
PCC ENTRANCE APRON	SF	152		\$ 30.00	\$ 4,560.00

TOTAL		\$ 329,593.00

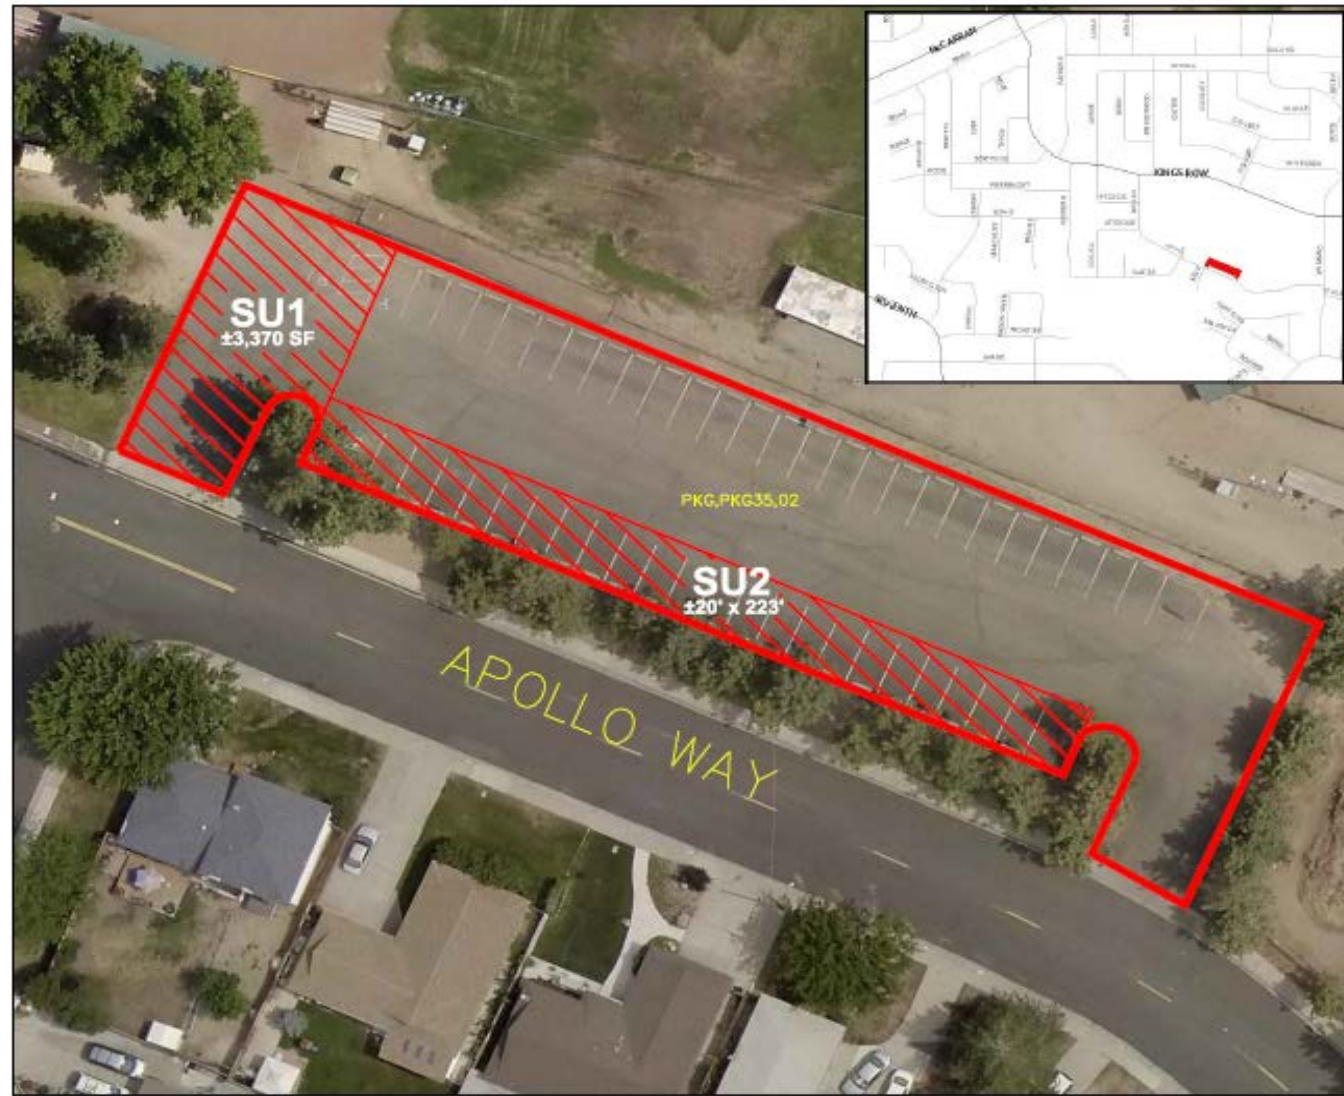
NORTHWEST POOL, PKG 35
SECTION 02
JANUARY 2018

NORTHWEST POOL					
PARKING LOT INVENTORY :PKG #		35	PAVEMENT TYPE		AC
ORIGINAL CONSTRUCTION DATE	SEC 1	9/2/1975	LAST WORK DATE	SEC 1	7/7/2018
LAST INSPECTION DATE	SEC 1	9/10/2021	LAST INSPECTED PCI	SEC 1	50
			PREDICTED PCI (2022)	SEC 1	49
ORIGINAL CONSTRUCTION DATE	SEC 2	9/1/1970	LAST WORK DATE	SEC 2	7/7/2018
LAST INSPECTION DATE	SEC 2	9/10/2021	LAST INSPECTED PCI	SEC 2	55
			PREDICTED PCI (2022)	SEC 2	54
	UNIT	QUANTITY	COMMENTS	UNIT COST	TOTAL
PAVEMENT AREA	SF	26954	Sections 1 and 2	\$ 15.00	\$ 404,310.00
CURB	FEET				
CURB AND GUTTER	FEET	345		\$ 65.00	\$ 22,425.00
VALLEY GUTTER	SF				
SIDEWALK	SF	1248		\$ 16.00	\$ 19,968.00
PED RAMP	EACH	2		\$ 8,300.00	\$ 16,600.00
LIGHT POLE SINGLE	EACH				
LIGHT POLE DOUBLE	EACH				
LIGHT POLE PIER	EACH				
CATCH BASIN	EACH				
MANHOLE	EACH	1		\$ 10,000.00	\$ 10,000.00
VALVE, GAS	EACH				
VALVE, WATER	EACH				
SIGN	EACH	6		\$ 150.00	\$ 900.00
SPEED BUMP	EACH				
VAULT	EACH

WHEEL STOP	EACH	60		\$ 150.00	\$ 9,000.00
ROOT MITIGATION	EACH				
SPACES, HANDICAP	EACH	6		\$ 225.00	\$ 1,350.00
SPACES, REGULAR	EACH	48		\$ 9.00	\$ 432.00
PCC ENTRANCE APRON	SF	662		\$ 30.00	\$ 19,860.00
			TOTAL		\$ 504,845.00

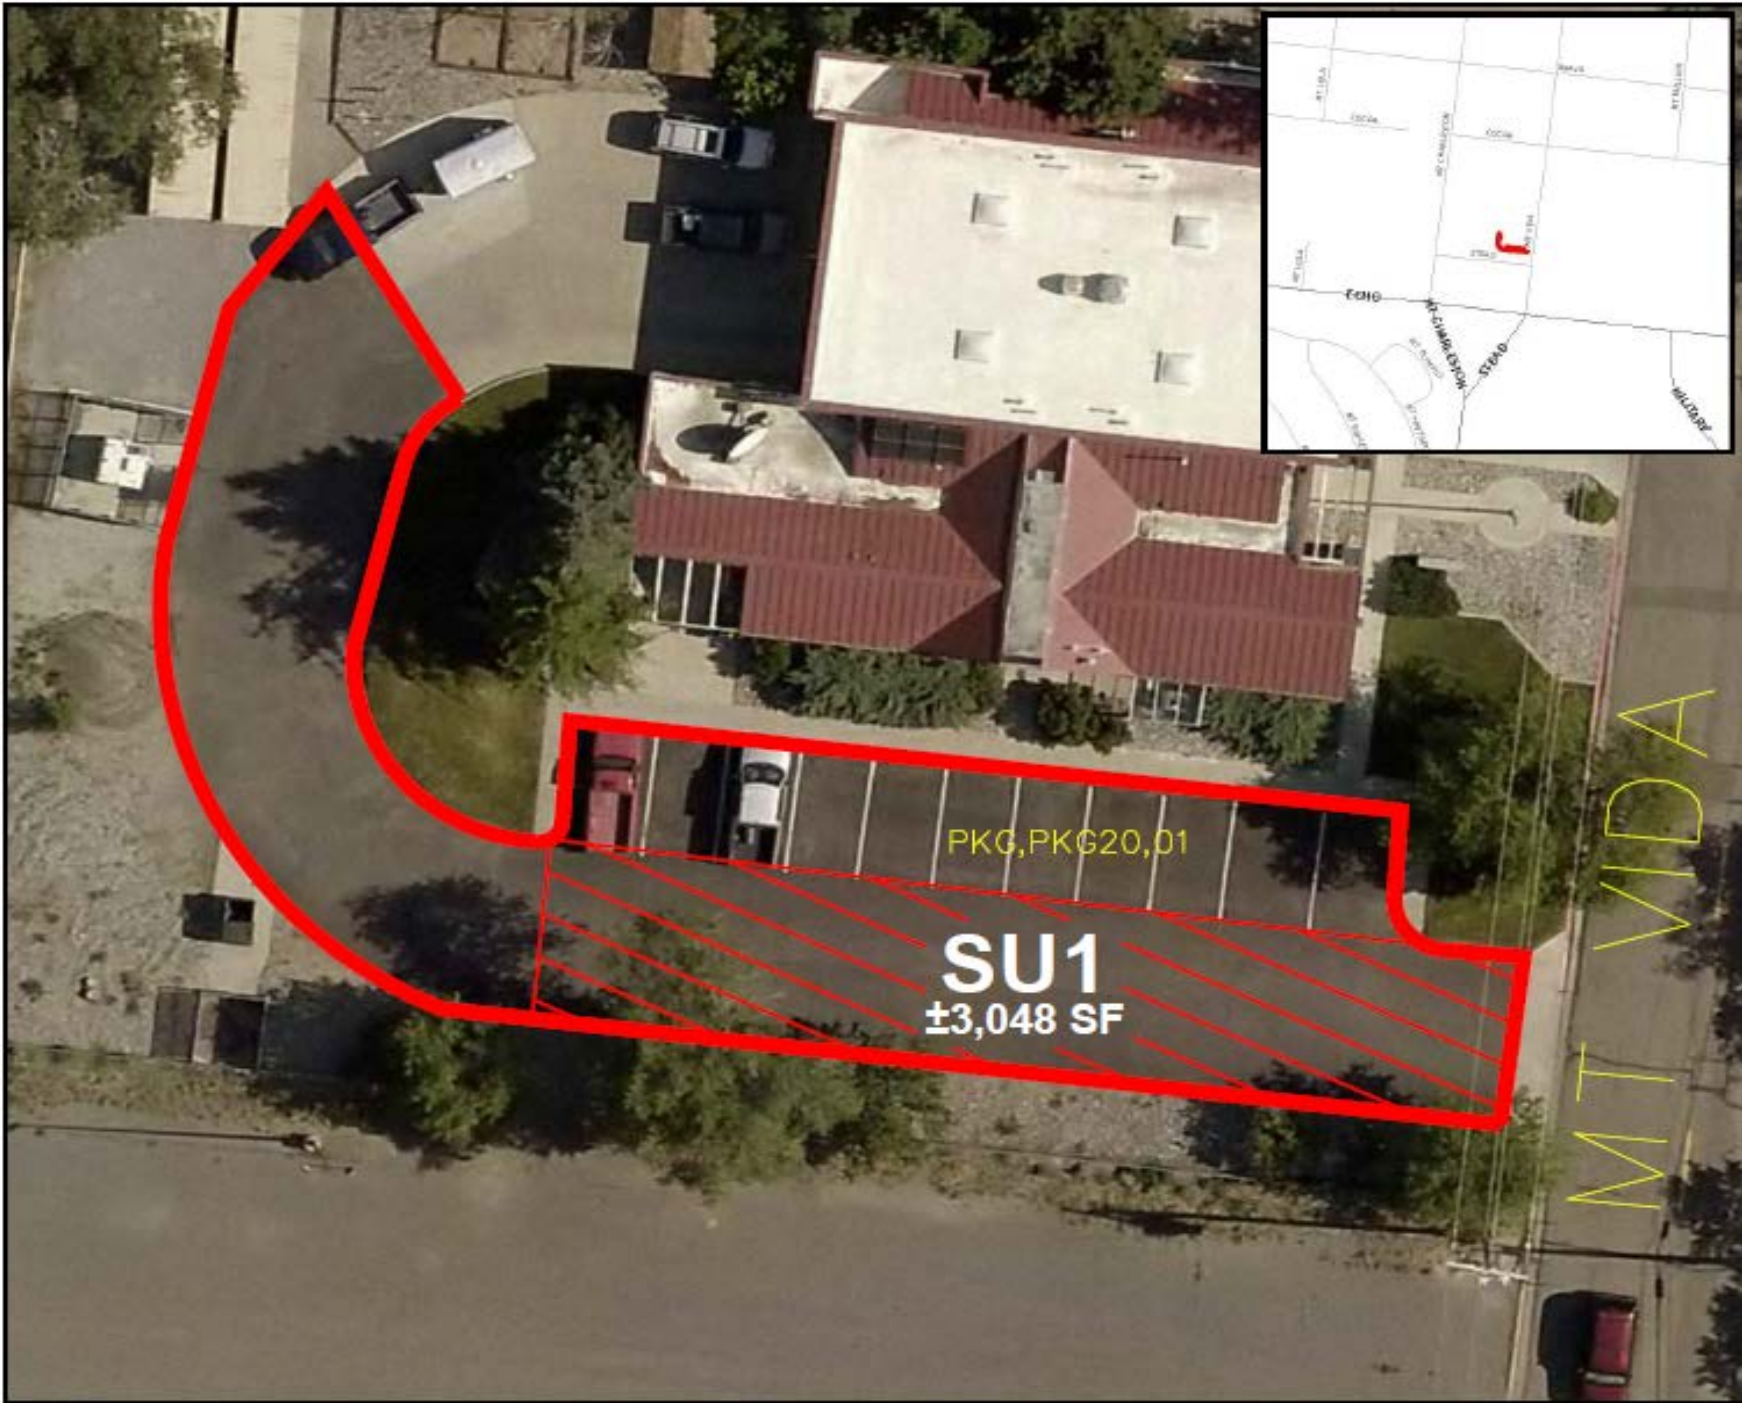
FIRE STATION #9 - MT VIDA, PKG 20
SECTION 01
JANUARY 2018

PARKING LOT INVENTORY :PKG #		20	PAVEMENT TYPE		AC
ORIGINAL CONSTRUCTION DATE		9/2/1987	LAST WORK DATE		7/7/2018
LAST INSPECTION DATE		3/22/2021	LAST INSPECTED PCI		55
			PREDICTED PCI (2022)		53
	UNIT	QUANTITY	COMMENTS	UNIT COST	TOTAL
PAVEMENT AREA	SF	7851	Section 1	\$ 15.00	\$ 117,765.00
CURB	FEET	78		\$ 24.00	\$ 1,872.00
CURB AND GUTTER	FEET				
VALLEY GUTTER	SF				
SIDEWALK	SF	660		\$ 16.00	\$ 10,560.00
PED RAMP	EACH				
LIGHT POLE SINGLE	EACH				
LIGHT POLE DOUBLE	EACH				
LIGHT POLE PIER	EACH				
CATCH BASIN	EACH				
MANHOLE	EACH				
VALVE, GAS	EACH				
VALVE, WATER	EACH				
SIGN	EACH				
SPEED BUMP	EACH				
VAULT	EACH				
WHEEL STOP	EACH				
ROOT MITIGATION	EACH				
SPACES, HANDICAP	EACH				
SPACES, REGULAR	EACH	12		\$ 9.00	\$ 108.00
PCC TRASH APRON	SF	200		\$ 13.00	\$ 2,600.00
AC WOOD 2X RETAINER	FT	64		\$ 3.00	\$ 192.00
			TOTAL		\$ 133,097.00
