FLOOD PLAIN INFORMATION

SOUTHWEST FOOTHILL STREAMS

RENO, NEVADA

DEPARTMENT OF THE ARMY,
SACRAMENTO DISTRICT,
CORPS OF ENGINEERS,
SACRAMENTO, CALIFORNIA

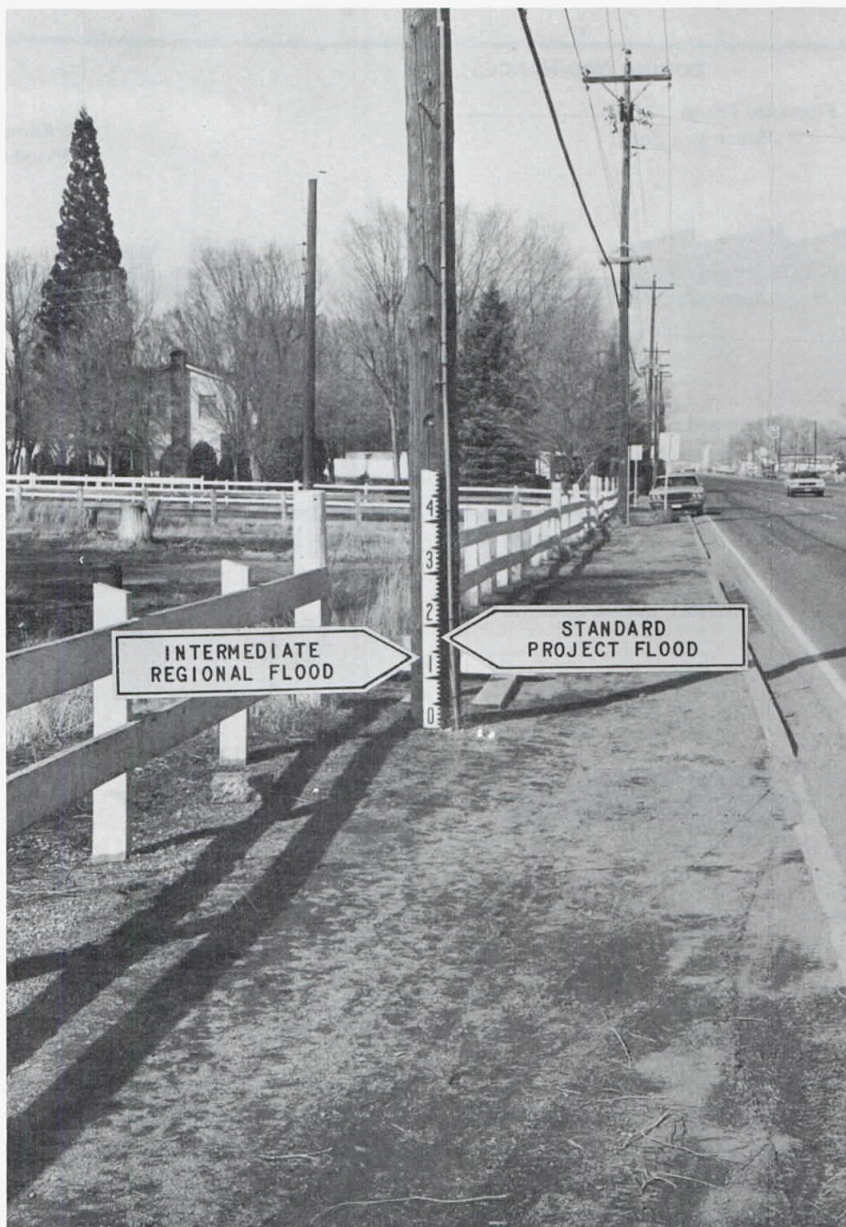
Future flood heights along Evans Creek at U.S. 395.

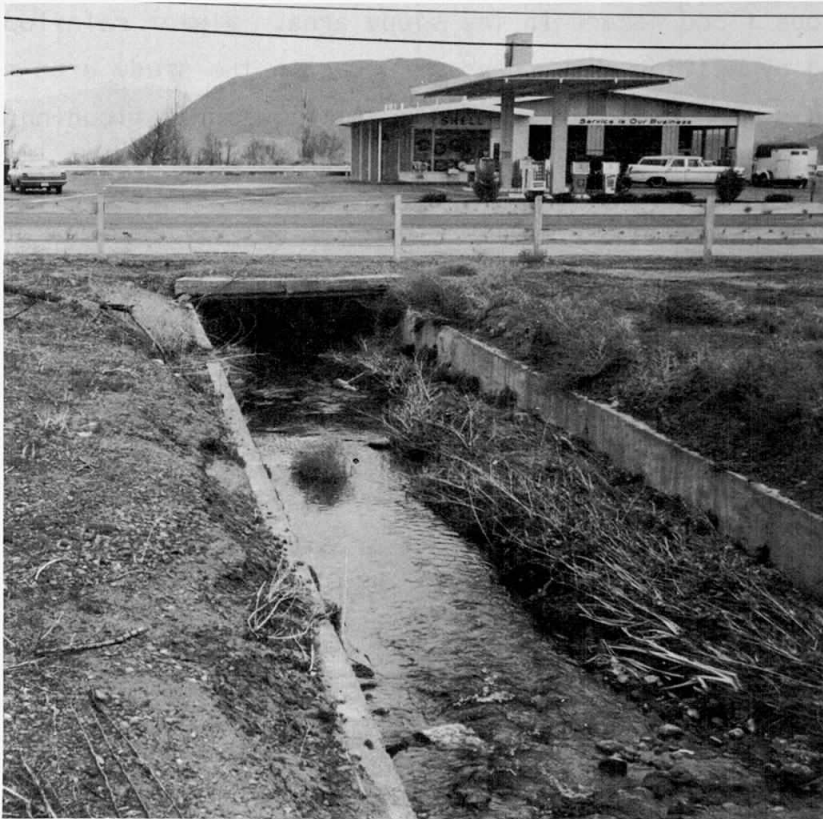
Figure 1 - Culvert on Evans Creek at Highway 395.

In general, obstructions restrict floodflows and cause overbank flows, unpredictable areas of flooding, destruction of or damage to stream crossings, and increased velocity of flow immediately downstream. Representative obstructions in the study area are shown in Figures 1-6. Pertinent data on obstructions to floodflow are shown in Table 5, page 30.

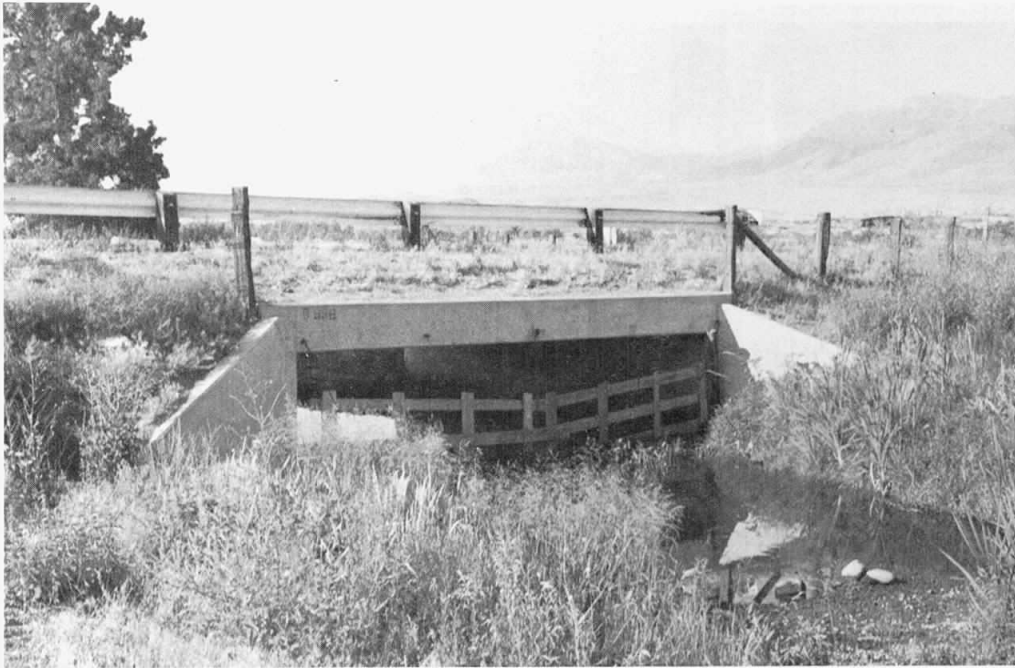
Figure 2 - Culvert on Dry Creek at Huffaker Lane.

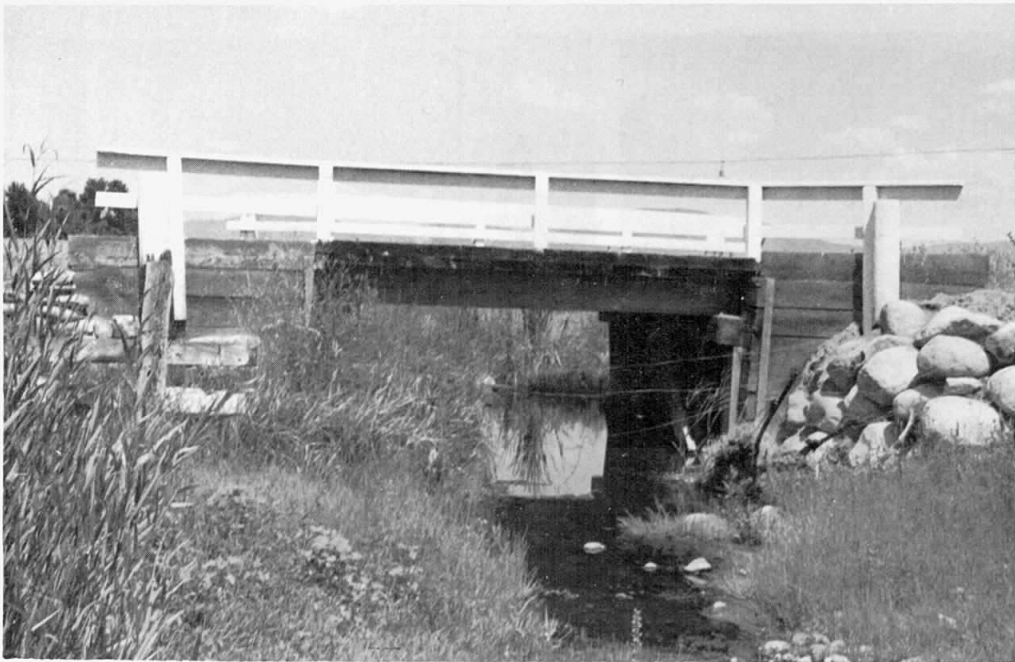
Figure 3 - Bridge over Dry Creek at Timothy Lane.

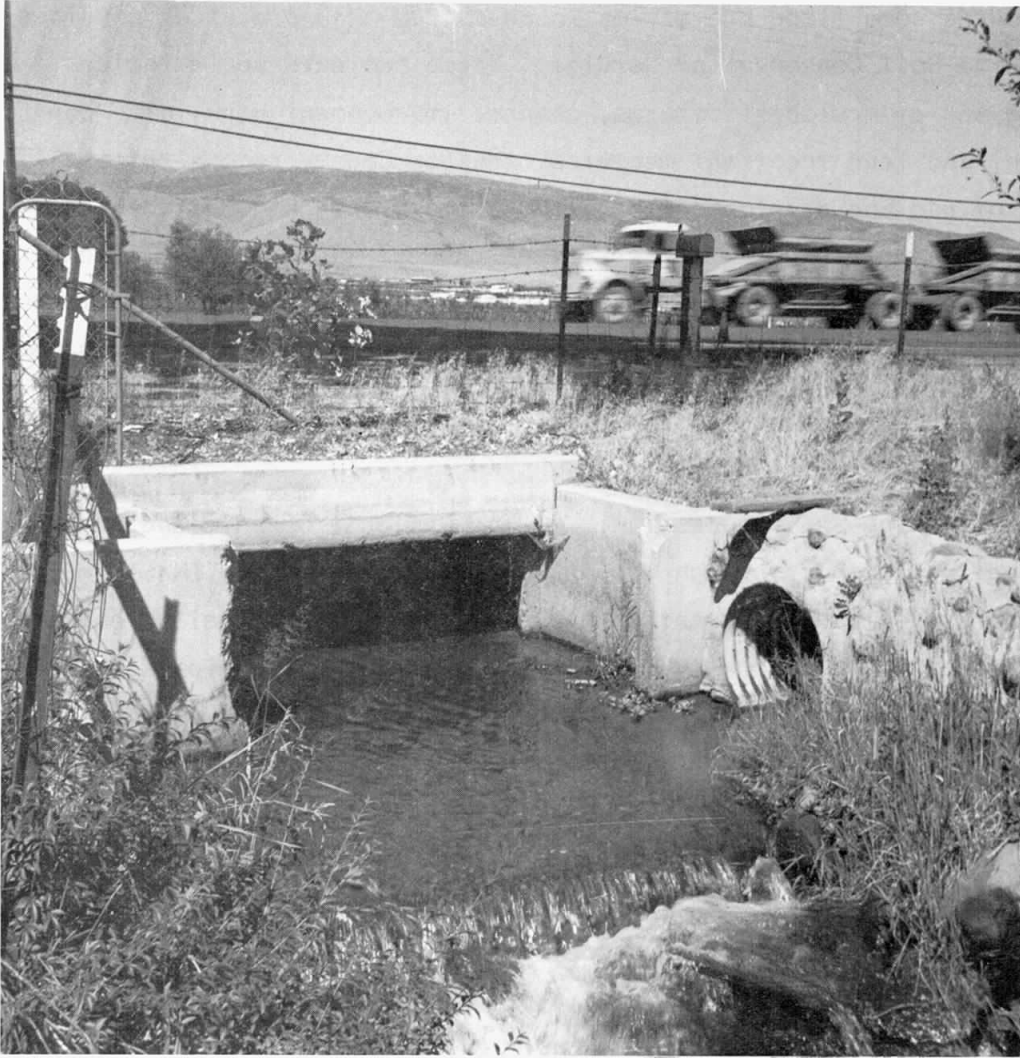
Figure 6 - Culvert on Whites Creek at Highway 395.

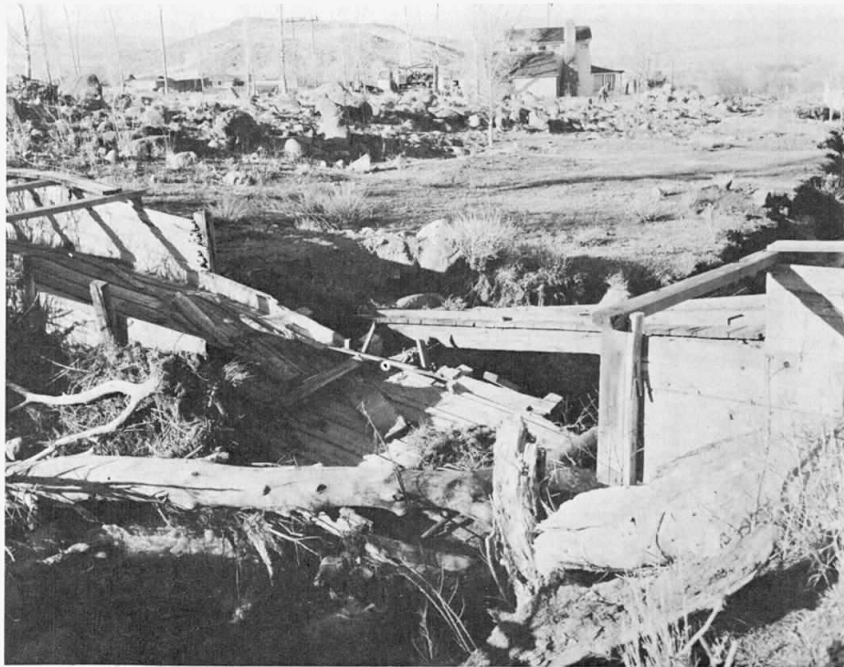
Figure 7 - Remains of Steamboat Ditch Flume crossing of Thomas Creek following the January-February 1963 floods. Rock debris from earlier cloudburst floods appears in the background (Soil Conservation Service photo).

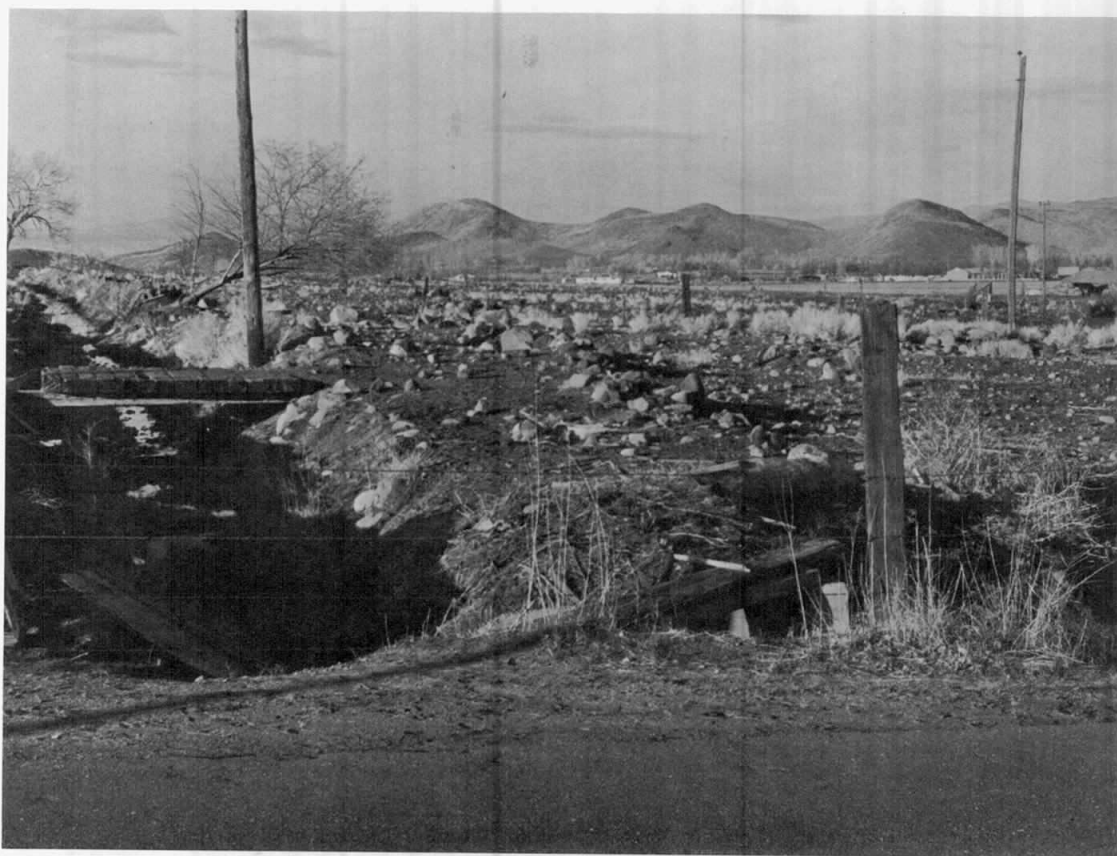
Figure 8 - Typical cloudburst flood debris deposited near the Zolezzi Lane crossing of Whites Creek.

Flood borne debris. - Trees and brush washed out by floods, deadwood lying along stream channels, and sand, silt, rocks, and boulders carried by floodflows aggravate the flood hazard in the study area by plugging culverts and collecting on or filling under bridges. This is particularly true in the higher portions of the study area where stream gradients are very steep. Debris can block small channels on the outwash fan, thus diverting floodflows into other distributaries and requiring extensive channel maintenance to avoid a permanent change in the stream course.

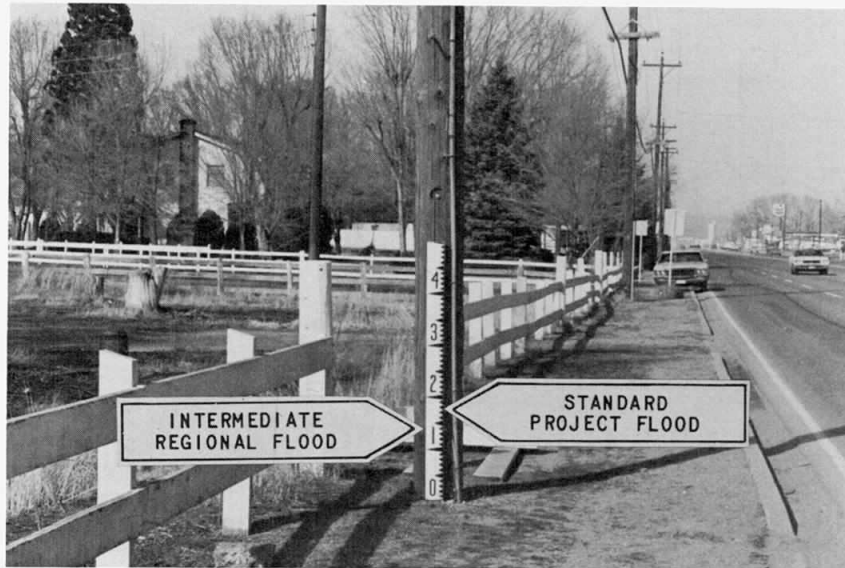
Figure 9 - Future flood heights, Evans Creek at Highway 395.

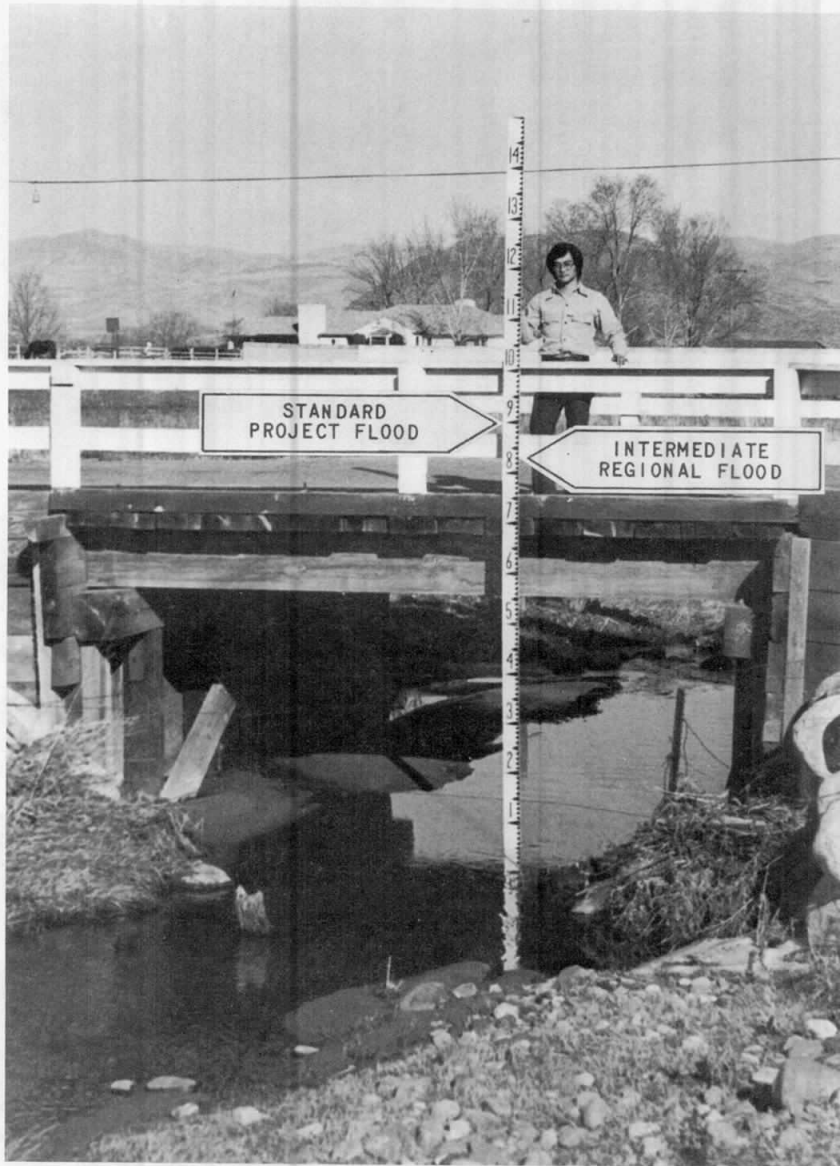
Figure 11 - Future flood heights, Dry Creek at Timothy Lane.

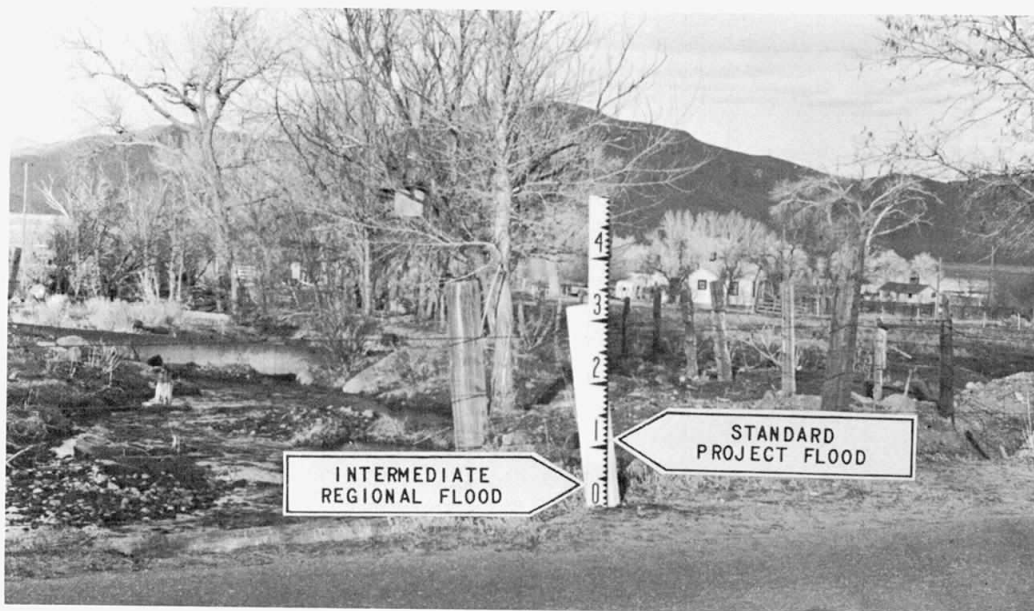
Figure 13 - Future flood heights, Whites Creek at Zolezzi Lane.
