FLOOD PLAIN INFORMATION

TRUCKEE RIVER

RENO-SPARKS-TRUCKEE MEADOWS, NEVADA

DEPARTMENT OF THE ARMY
SACRAMENTO DISTRICT, CORPS OF ENGINEERS
SACRAMENTO, CALIFORNIA
OCTOBER 1970

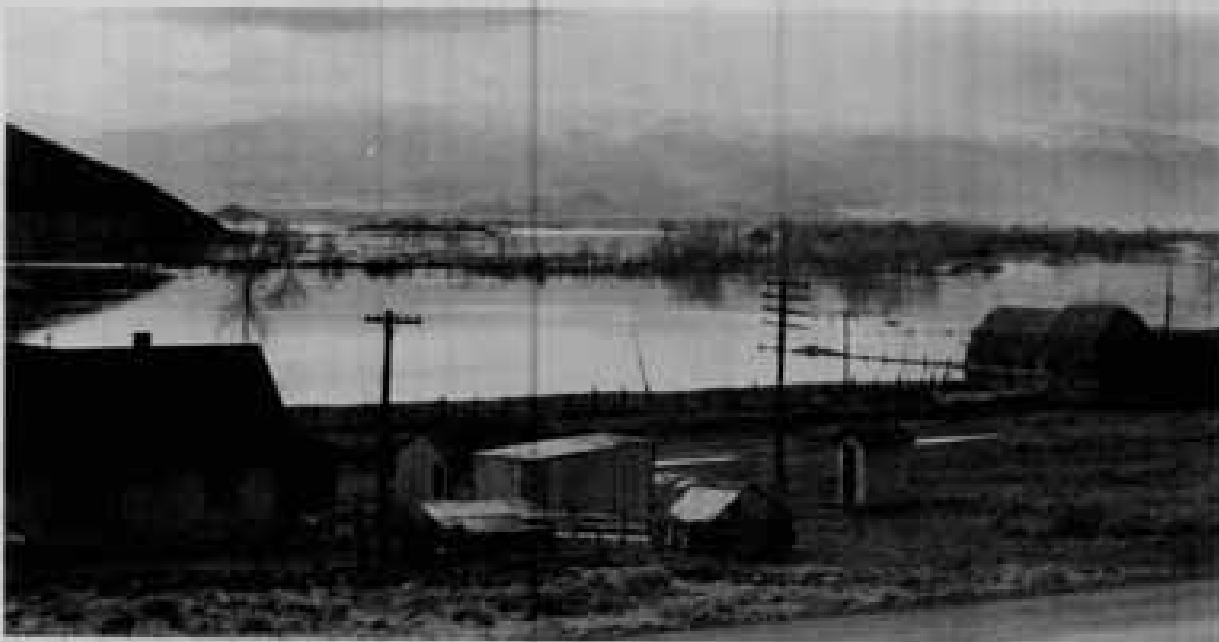
Figure 4. Flooding in Truckee Meadows near Vista, December 1937.
(Reno Evening Gazette photo)

Although not as large as the 1907 flood, the December 1937 flood created moderately heavy damage in Reno. During the flood, main highways and county roads were impassable, a portion of the central section of Reno was flooded, and the Chestnut Street (now Arlington Avenue) bridge was damaged to such an extent that it had to be replaced. Log jams and debris deposits on the upstream side of bridges had to be broken up by blasting. Trees were uprooted and shrubbery and lawns were damaged in Wingfield and other city parks. In general, ranching areas in the Glendale District were hardest hit by the floodwaters, which inundated many ranch homes; caused the loss of cattle, hogs, and sheep; ruined winter pasture; and submerged many haystacks. The feeding corrals were flooded and damaged.

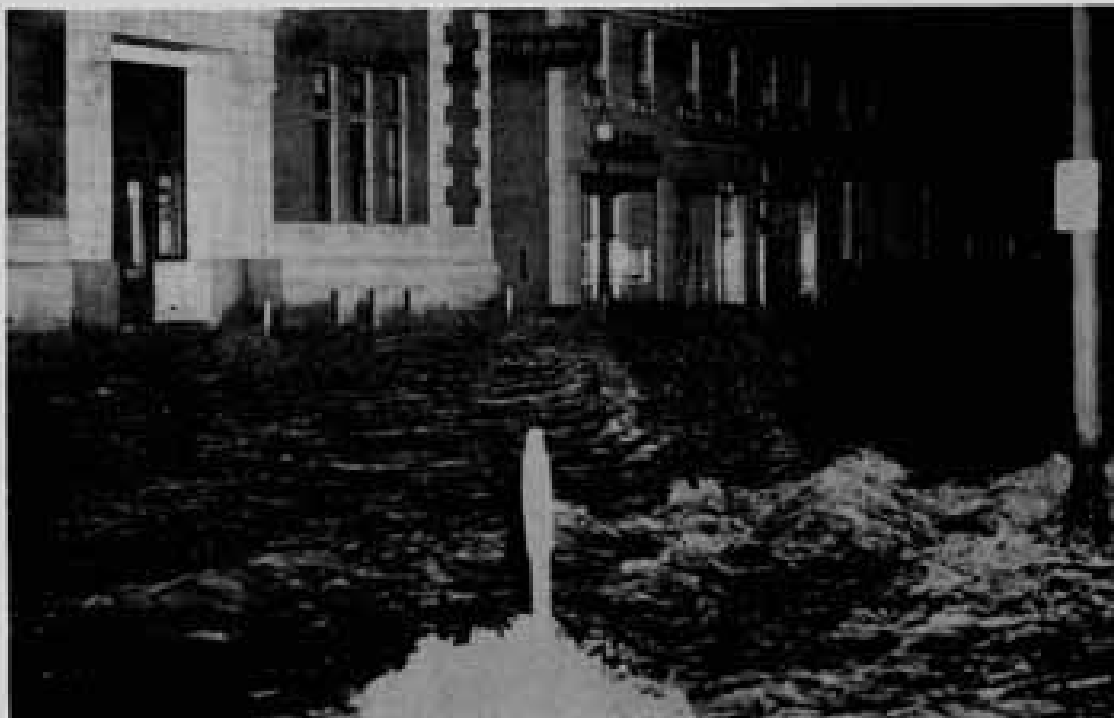
Figure 8. Floodwater on First Street, November 1950. (Mulcahy photo*)

The November 1950 flood, the greatest recorded since streamflow records were begun in 1900, resulted from a succession of warm rainstorms that produced more than 5 inches of precipitation in one day at some stations in the Truckee River basin. In Reno, floodwaters extended from West Second Street on the north to Mill Street on the south. All bridges across the river were closed; the Rock Street Bridge was destroyed; and damage to residential, commercial, and other properties totalled about \$2,000,000. Floodwater in the central business district was more than 4 feet deep. In Truckee Meadows, about 3,800 acres of agricultural lands were flooded. Livestock was drowned, crops destroyed or damaged, land washed away, farm and ranch homes and their furnishings damaged, and irrigation facilities washed out. Power and other utility lines were extensively damaged.

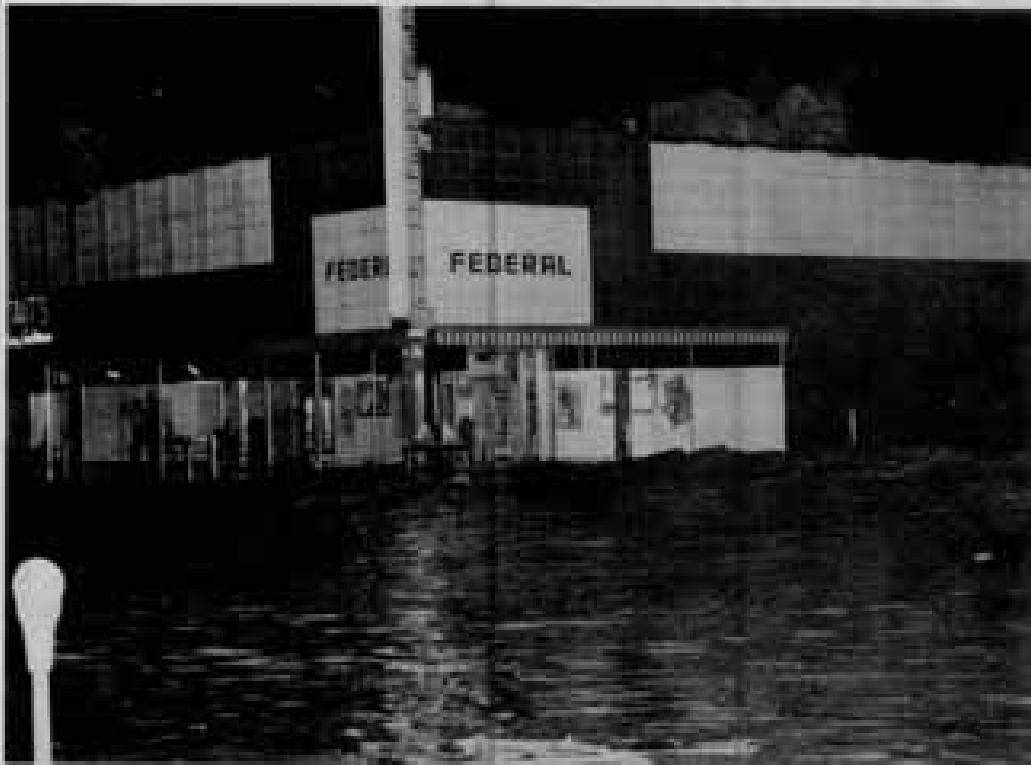
Figure 9. Surging floodwaters at First and Sierra Streets, November 1950. (Mulcahy Photo*)

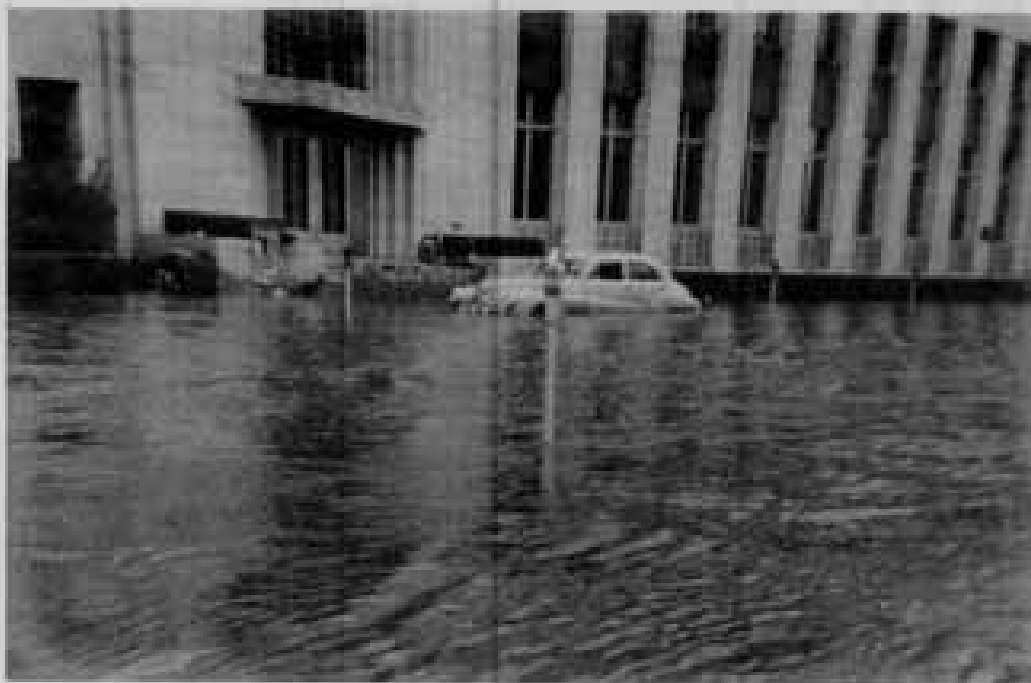
Figure 10. Mill Street and Post Office Building, November 1950. (Hughes Photo*)

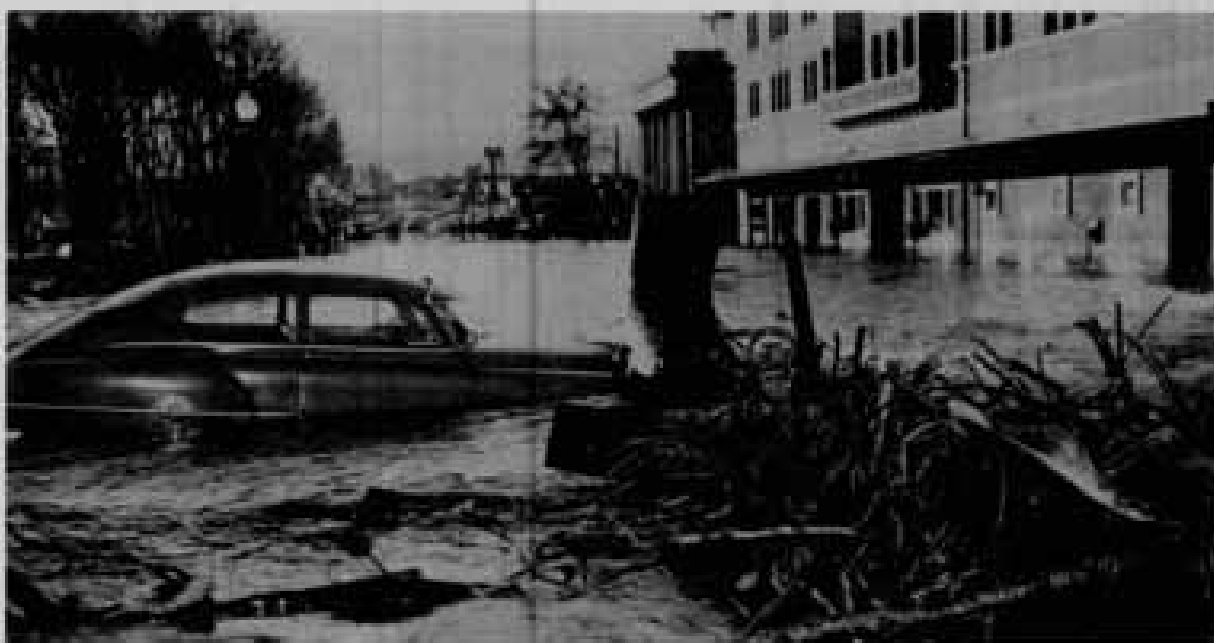
Figure 12. Partially submerged automobile and debris deposited on South Virginia Street, November 1950.
(Gene Christensen photo*)

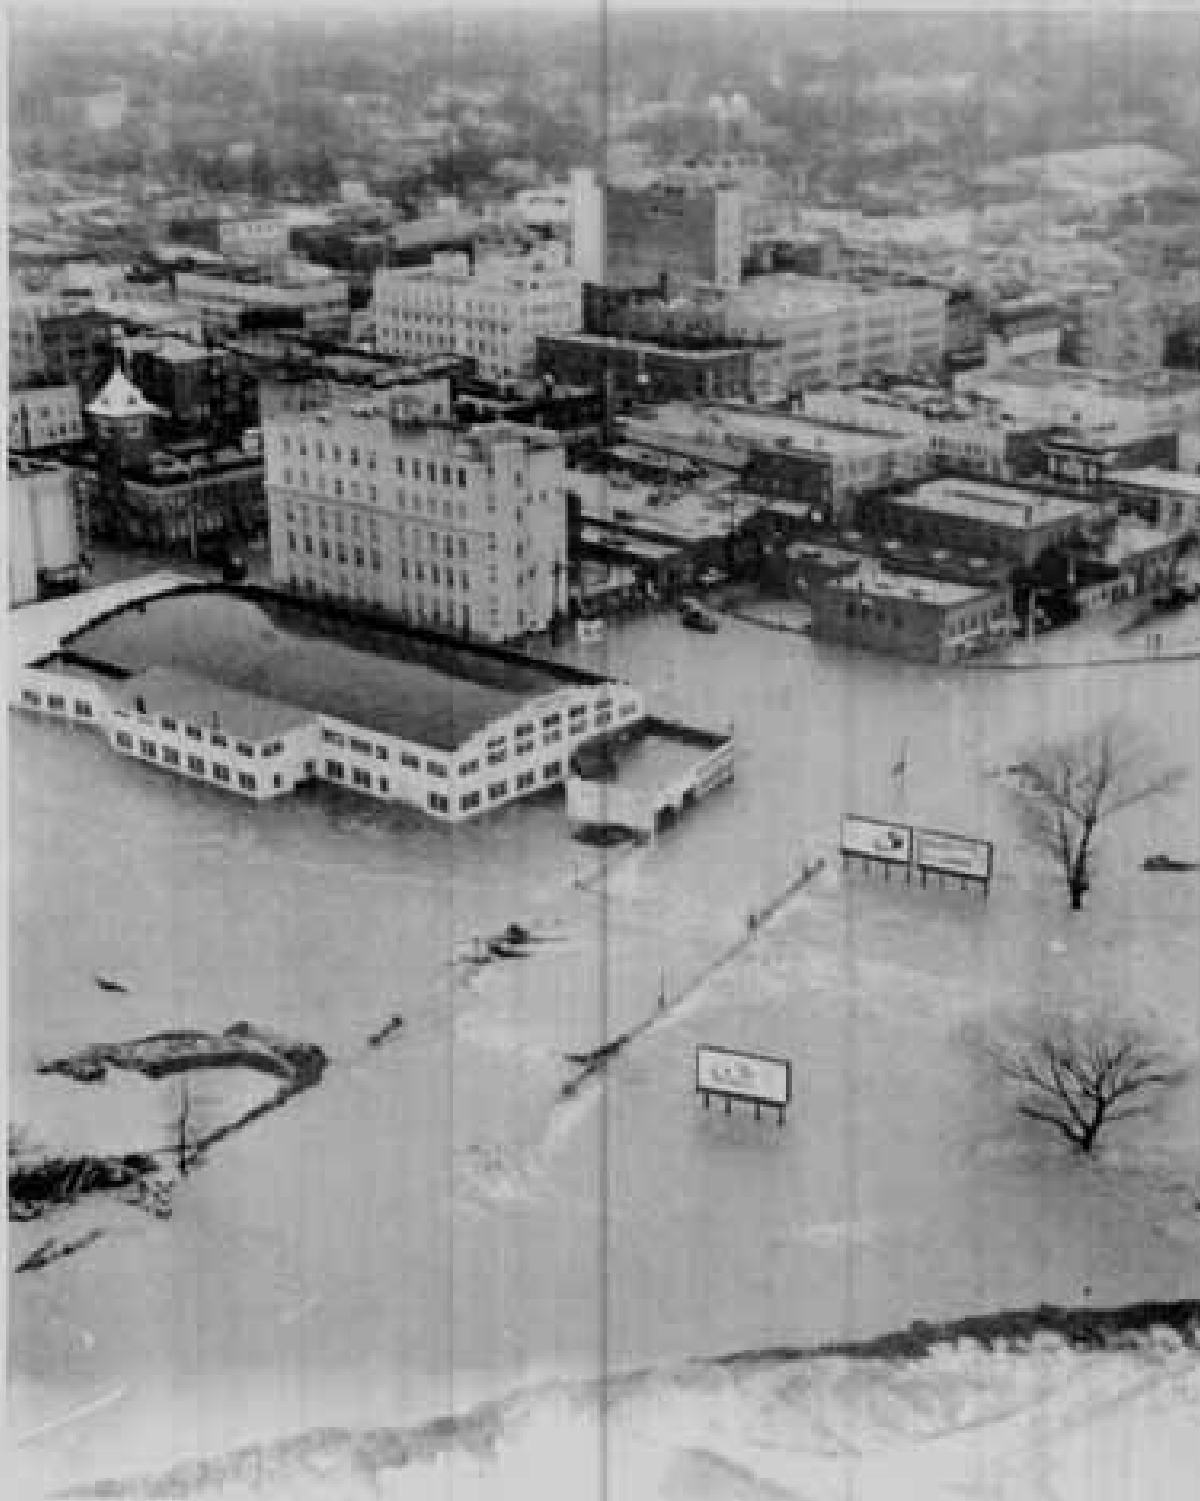
Figure 13. Flooding in the vicinity of the Lake Street Bridge, December 1955.
(Photo courtesy of the Silver State Press)

Fed by 15 inches of melted snow and more than 13 inches of rain in a 3-day period, the December 1955 flood was the largest experienced in the Reno-Sparks-Truckee Meadows area. In Reno, floodwaters 3 to 5 feet deep covered a strip one to two blocks wide on each side of the river from Idlewild Park to the eastern city limits. However, advance preparations and a well-coordinated flood fighting program limited flood damage. Water entered some basements and some unprotected buildings in the central commercial district were flooded, and streets, lawns, and shrubbery were

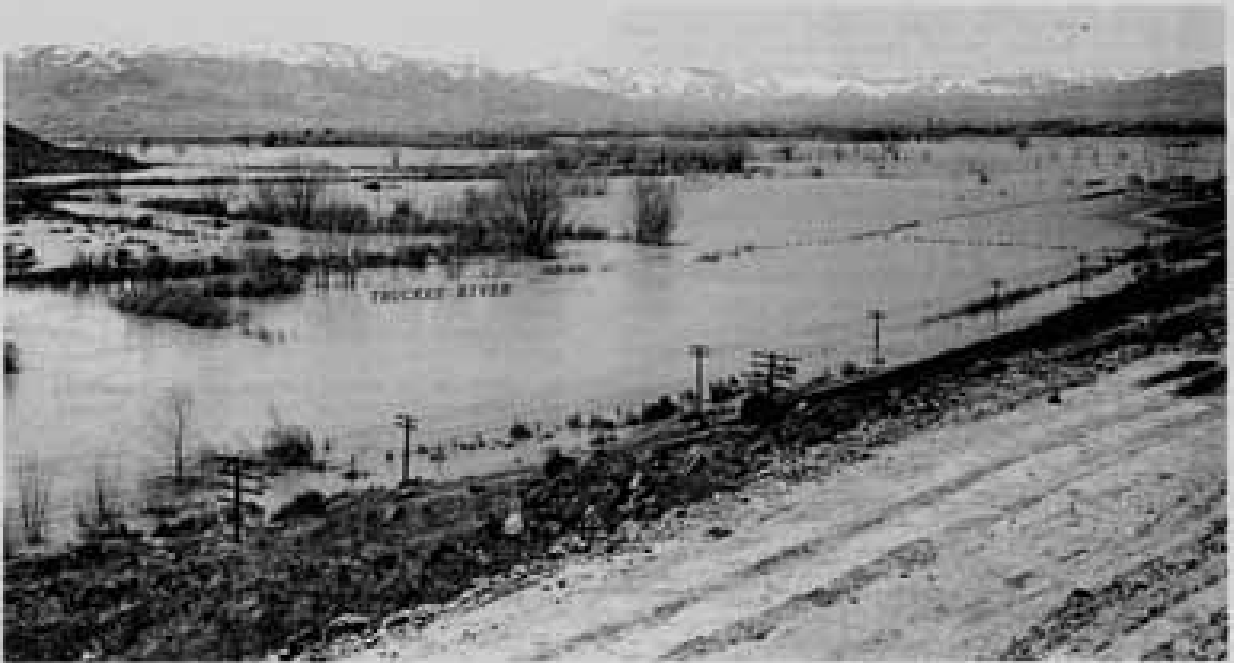
Figure 14. Flooding in Truckee Meadows, December 1955.
(Photo courtesy of Albert Katona)

In Truckee Meadows, more than 6,000 acres of agricultural lands were inundated for 6 to 10 days by floodwaters up to 6 feet deep. Extensive flooding occurred in the Steamboat Creek area where destruction of irrigation headgates let floodwaters into the canals and onto the adjoining lands. Reno Municipal Airport was inundated and air traffic completely curtailed for several days, and the University of Nevada Experimental Farm was damaged. Throughout the flooded areas, stream-banks were eroded, fences destroyed, baled hay and haystacks ruined, and deep deposits of sand, silt, and debris were left on the land.

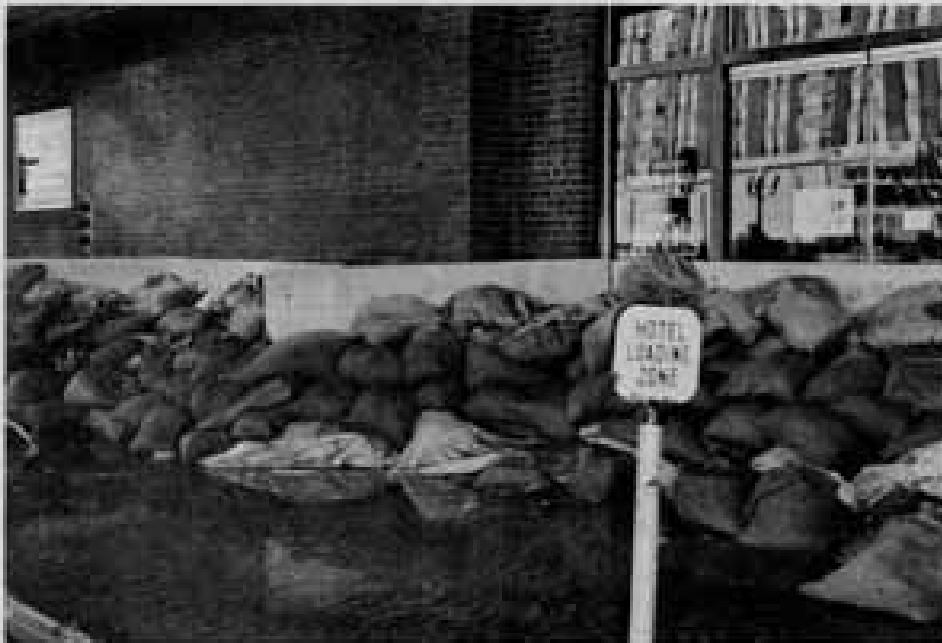
Figure 15. Sandbag barrier emplaced to protect the Riverside Hotel during the February 1963 flood. (Reno Evening Gazette photo)

The flood of February 1963 inundated essentially the same areas flooded during the 1950 and 1955 floods; that is, a strip one to two blocks wide along each side of the river from Idlewild Park on the west to Coney Island Drive on the east. As in 1955, potential flood damage was greatly reduced by advance preparation and effective flood fighting. In 1963, Sparks escaped flooding, but about 4,000 acres of agricultural lands in Truckee Meadows, and Reno Municipal Airport, were flooded. Damage in Reno and Truckee Meadows was about \$600,000.

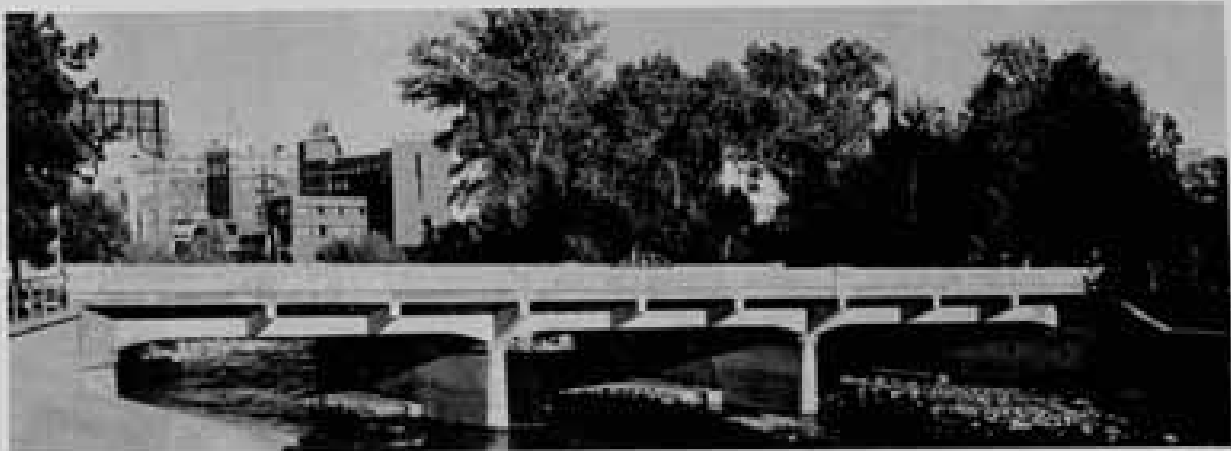
Figure 19. Arlington Avenue Bridge.

There are 15 street bridges and 2 railroad bridges across the Truckee River between Vista and Lawton. Ten would obstruct flows from an Intermediate Regional Flood and 13 would obstruct flows from a Standard Project Flood. The city of Reno has improved the flow characteristics through the bridges in downtown Reno through rigid channel maintenance and clearance of debris. Removable handrails have been installed on the Lake Street Bridge. During floods, the handrails are removed to prevent collection of debris and damage to the bridge. The obstructive effect of the Arlington Avenue and Sierra, Virginia, Center, and Lake Street bridges is to divert water into the downtown area, particularly along First Street. The obstructive effect of eight irrigation diversion structures located in the study area aggravates the flood situation. Representative bridges across the Truckee River

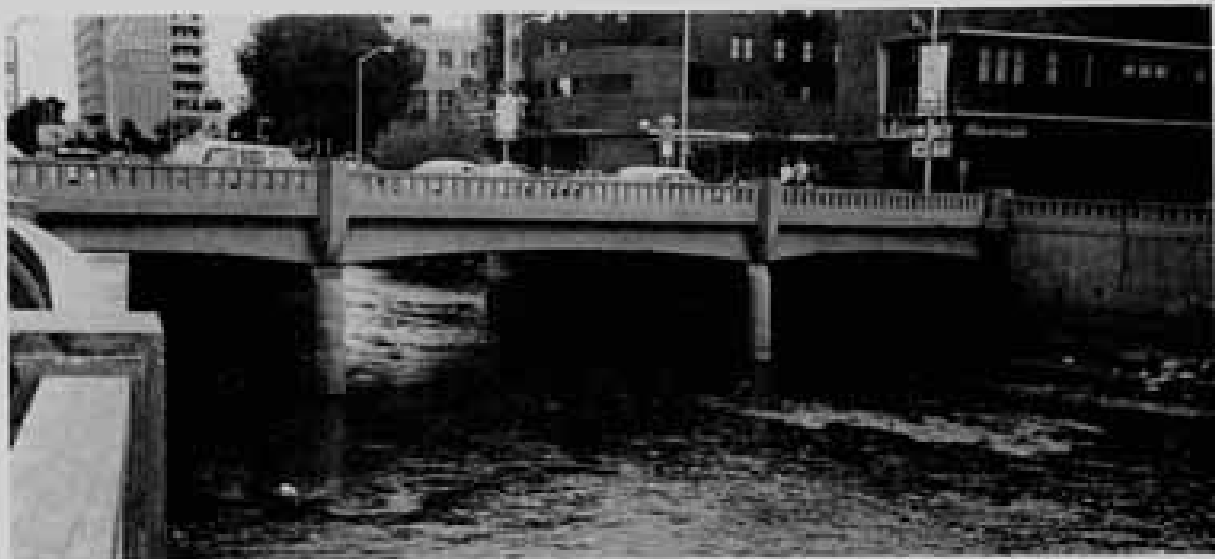
Figure 20. Sierra Street Bridge.

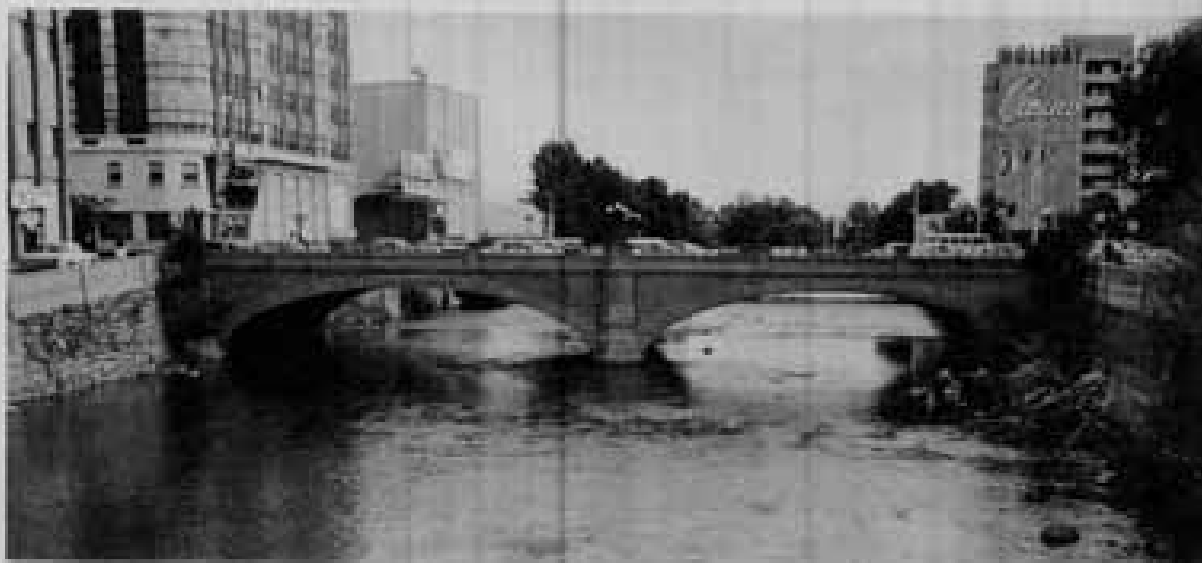
Figure 21. Virginia Street Bridge.

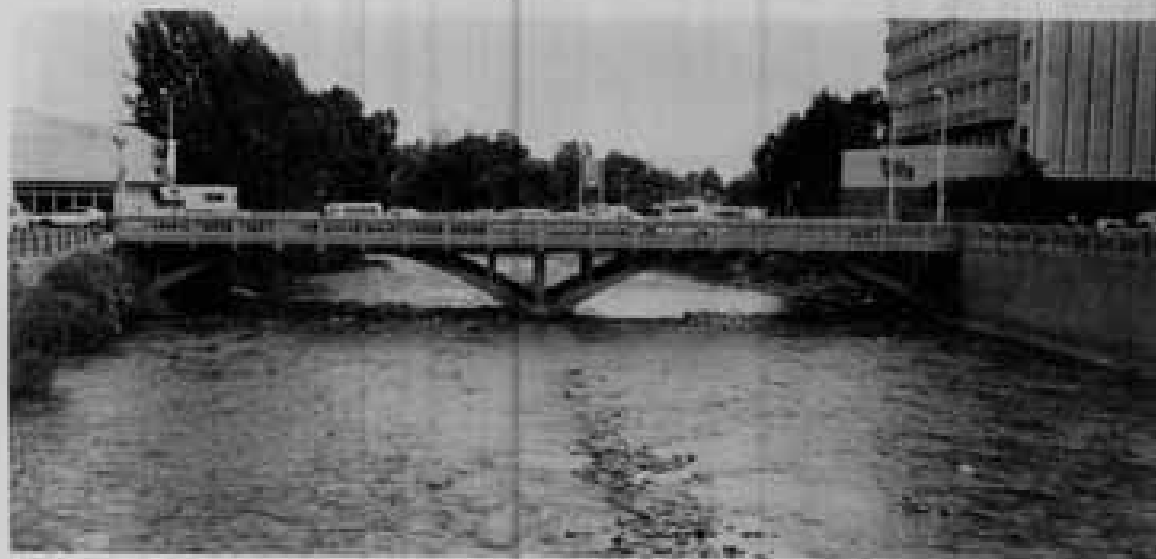
Figure 22. Center Street Bridge.

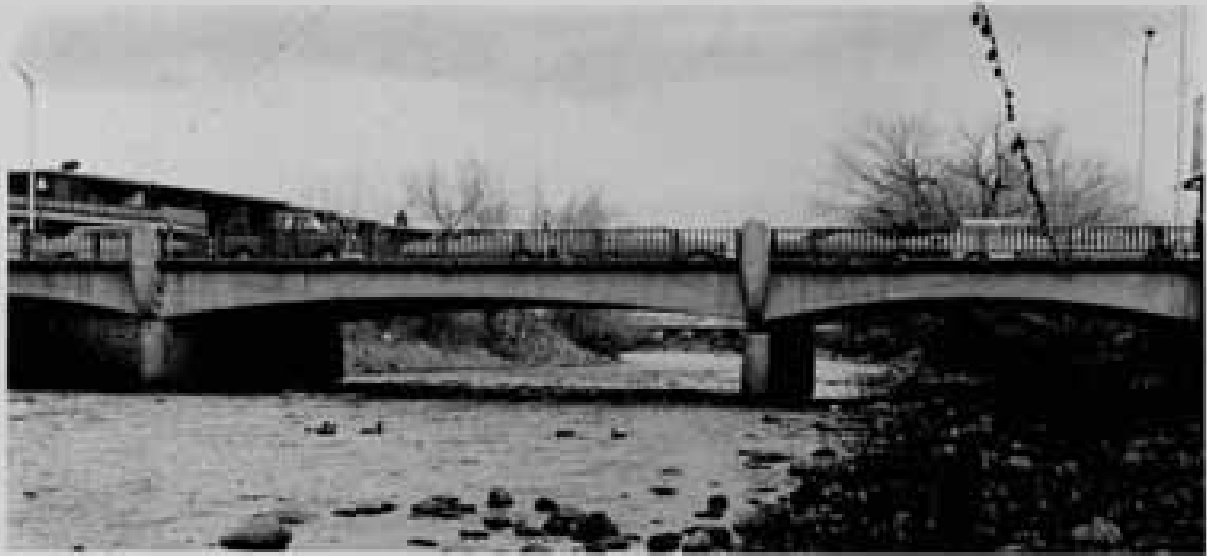
Figure 23. Lake Street Bridge showing removable handrails.

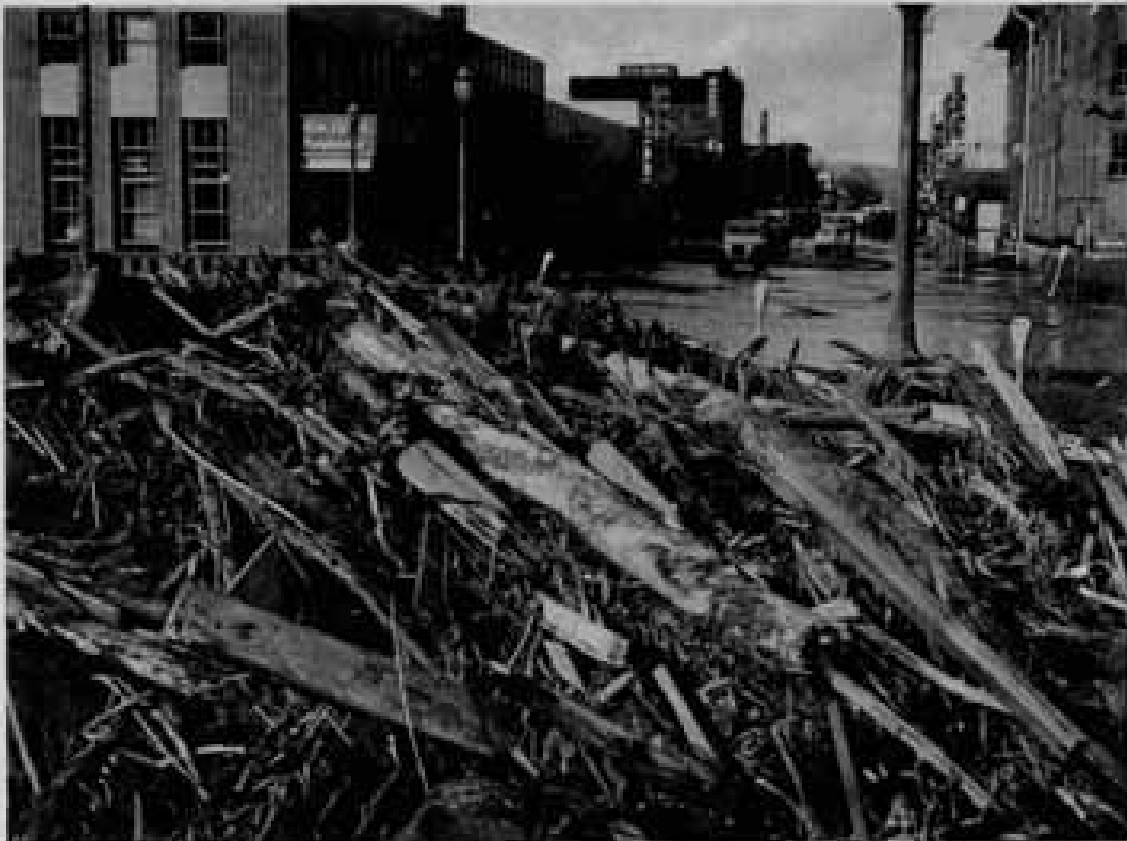
Figure 24. Debris jam at the Sierra Street Bridge, November 1950 flood.
(Gene Christensen Photo*)

In Reno and collections of flood-carried debris behind bridges are shown in the following photographs. Pertinent data on railroad and street bridges are contained in Table 6.

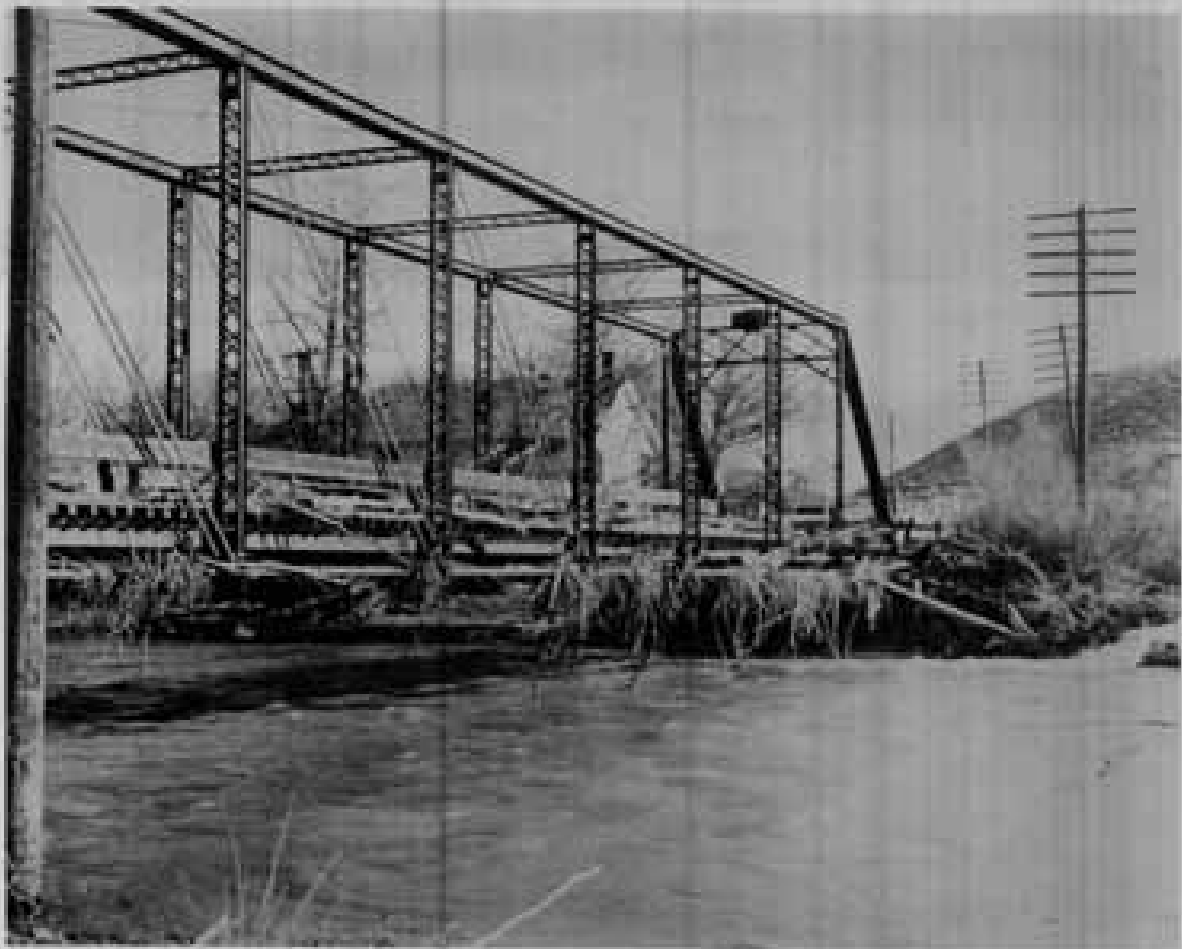
Figure 25. Debris on Mayberry Drive Bridge after the December 1955 flood.
(Photo courtesy of the Washoe County Engineer's Office)

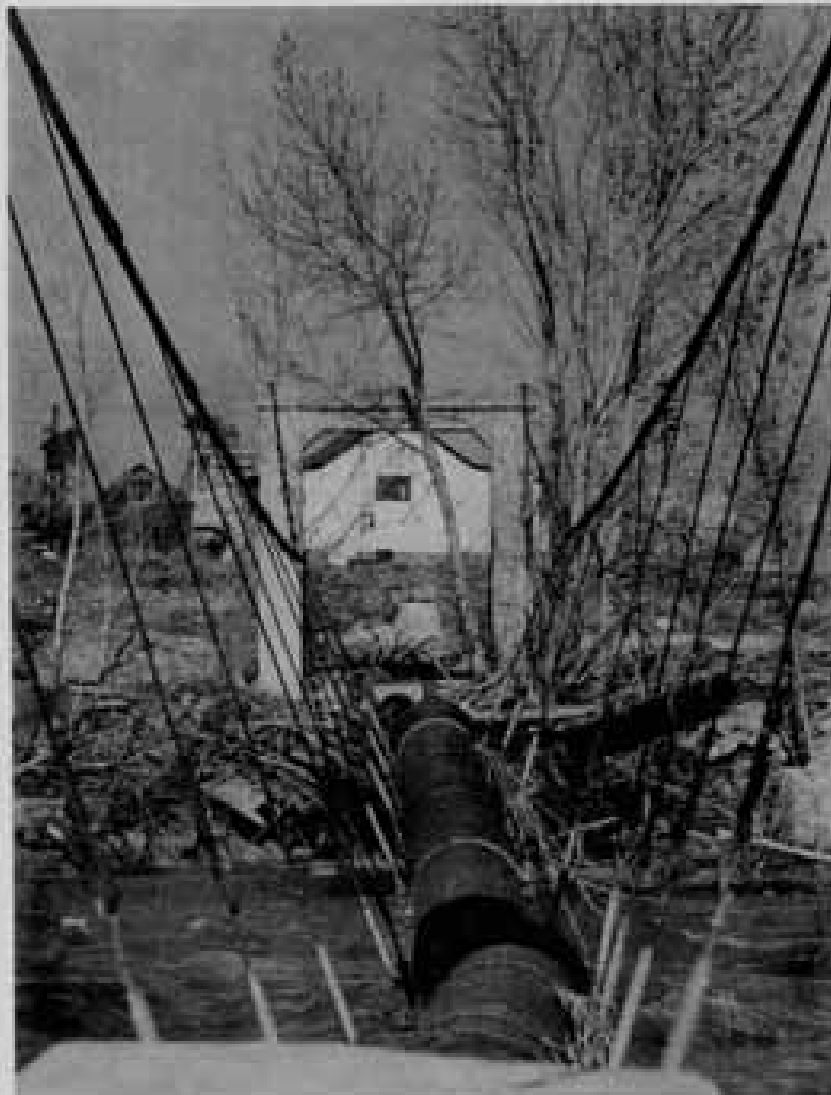
Figure 26. Flood-carried debris seriously damaged the main sewerage pipeline bridge east of Wells Avenue, November 1950
(Gene Christensen Photo*)

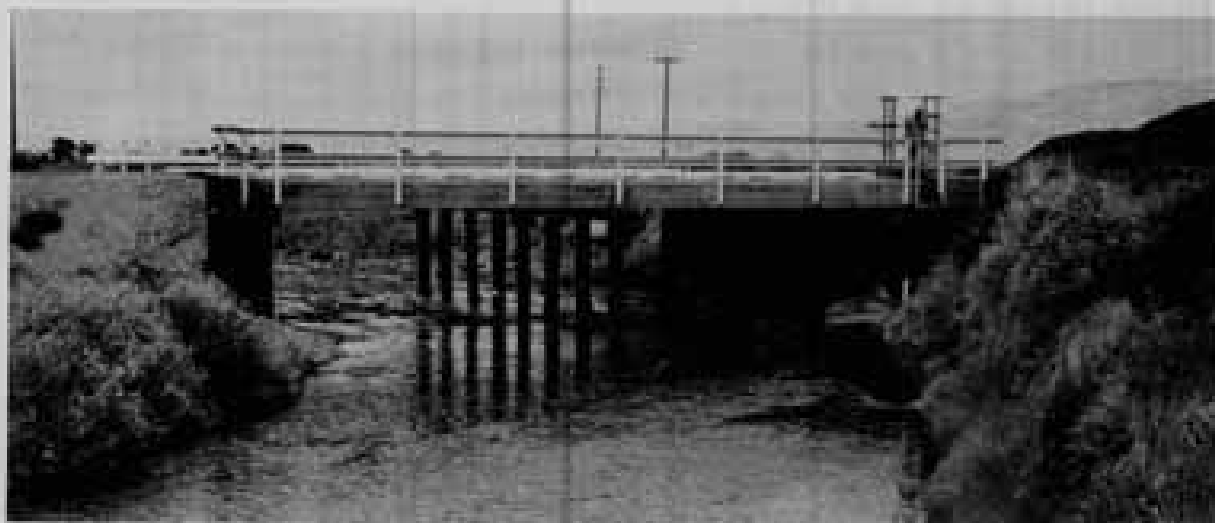
Figure 27. Pembroke Drive Bridge over Steamboat Creek.

exceptions, all are inadequate to pass flows of the Intermediate Regional and Standard Project Floods. During moderate flows, the culverts and bridges often become blocked with debris, which causes localized flooding in the vicinity of the obstruction. A series of pictures showing bridges and culverts and other obstructions on the tributary streams follow. Pertinent data on bridges and culverts are contained in Table 7.

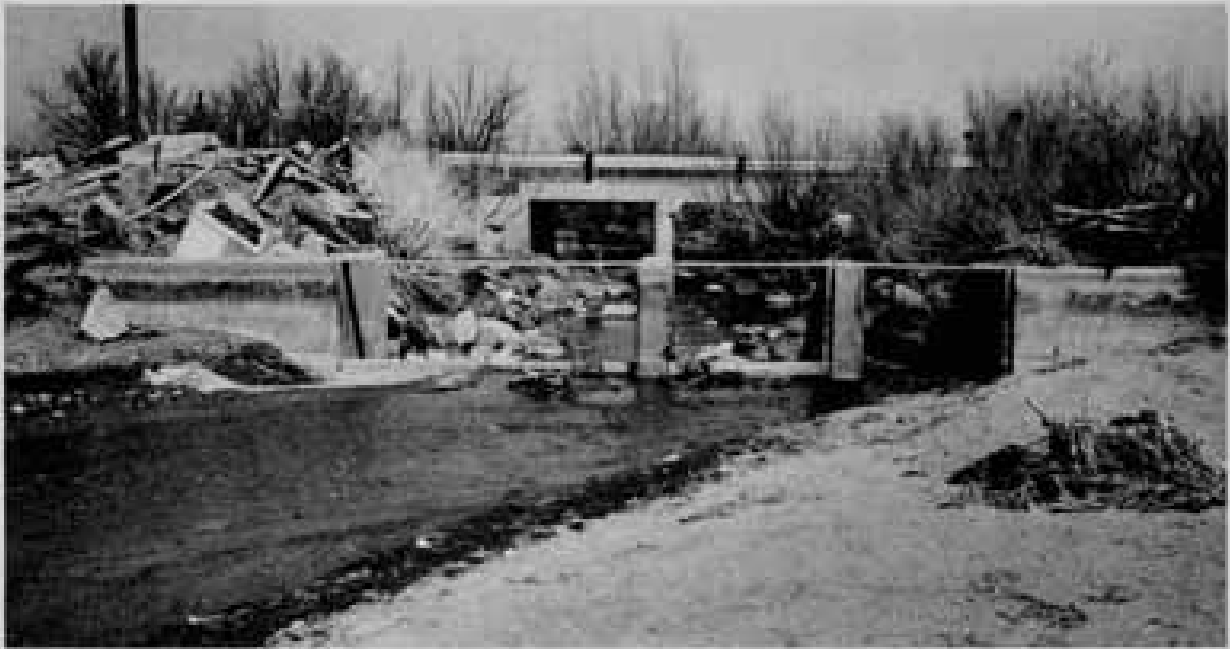
Figure 28. Obstructive irrigation structure on Dry Creek.
Bridge at East Peckham Lane in background.

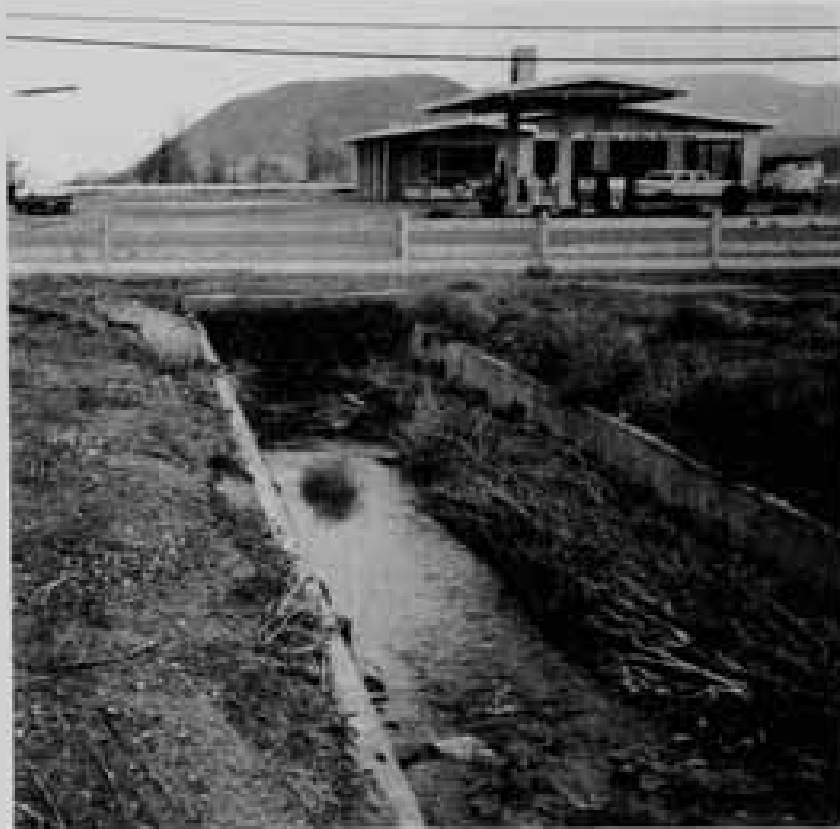
Figure 29. Culvert on Evans Creek at South Virginia Street.

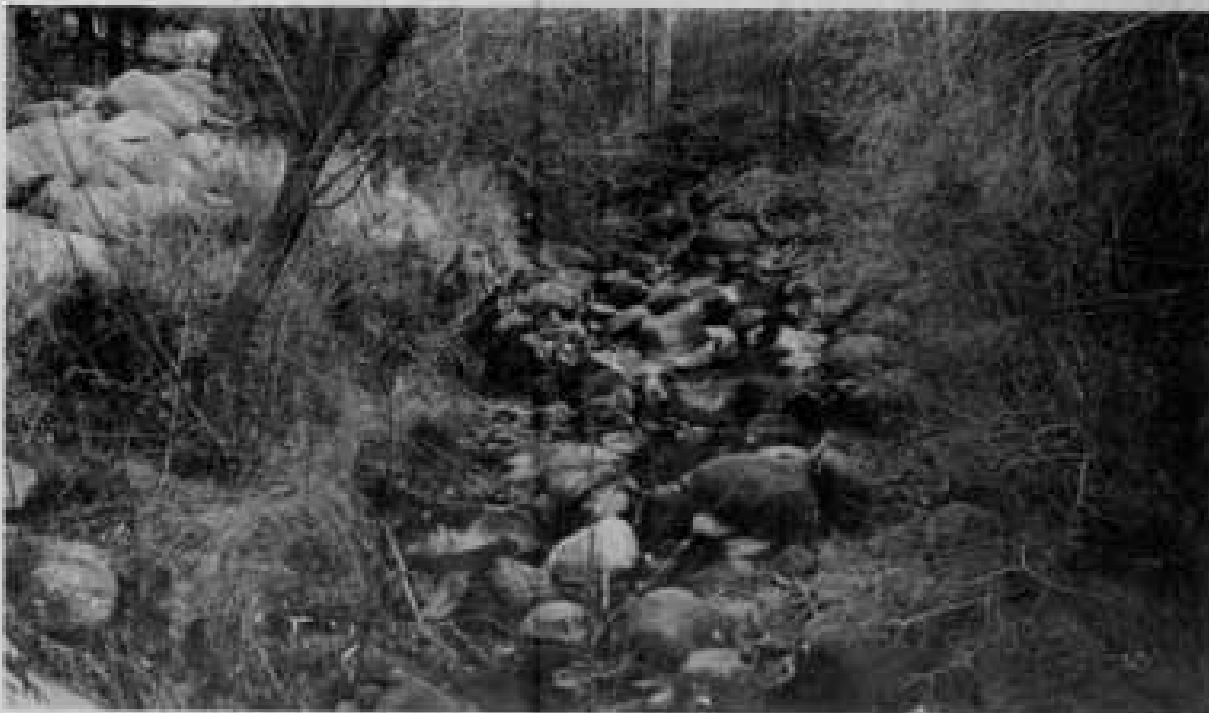
Figure 30. Natural obstructions in and along the channel of Hunter Creek.

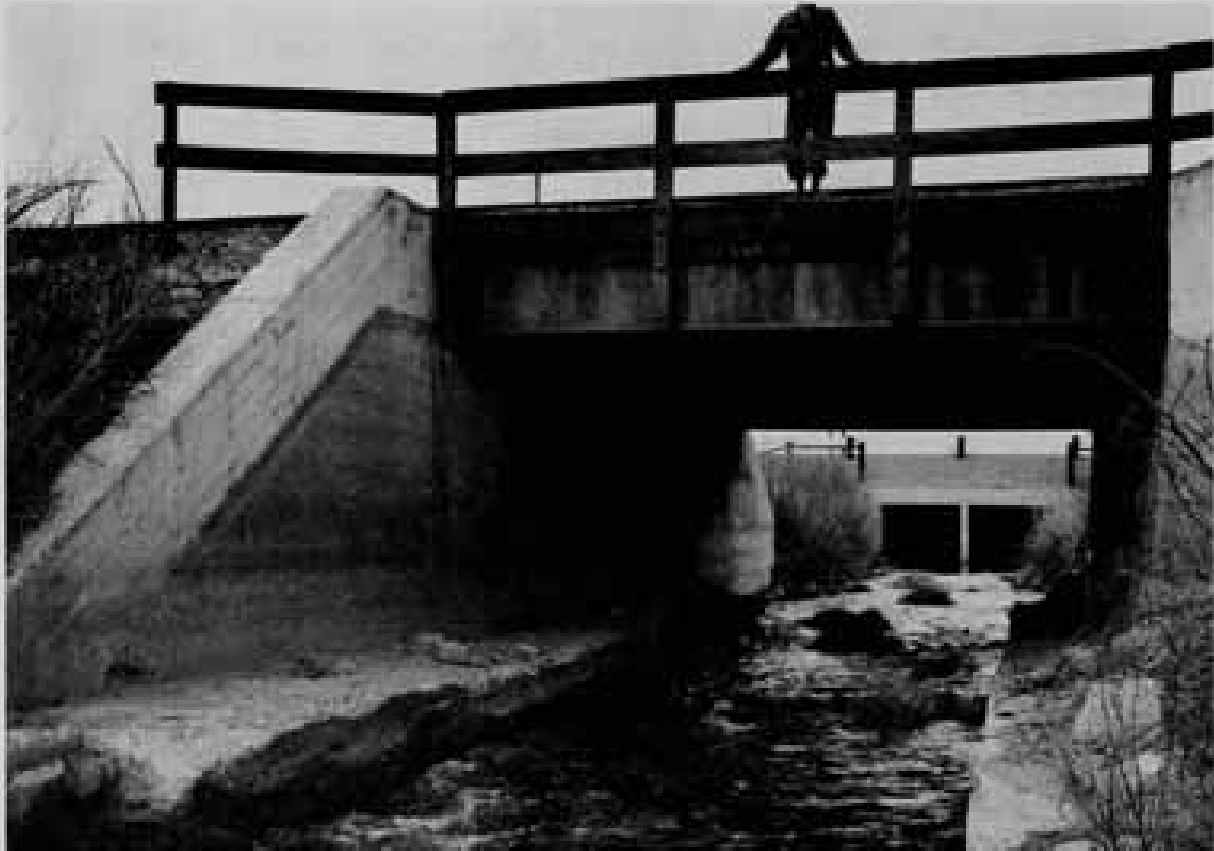
Figure 32. Southern Pacific railroad bridge crossing of North Truckee Drain. Box culvert at Interstate 80 in background.

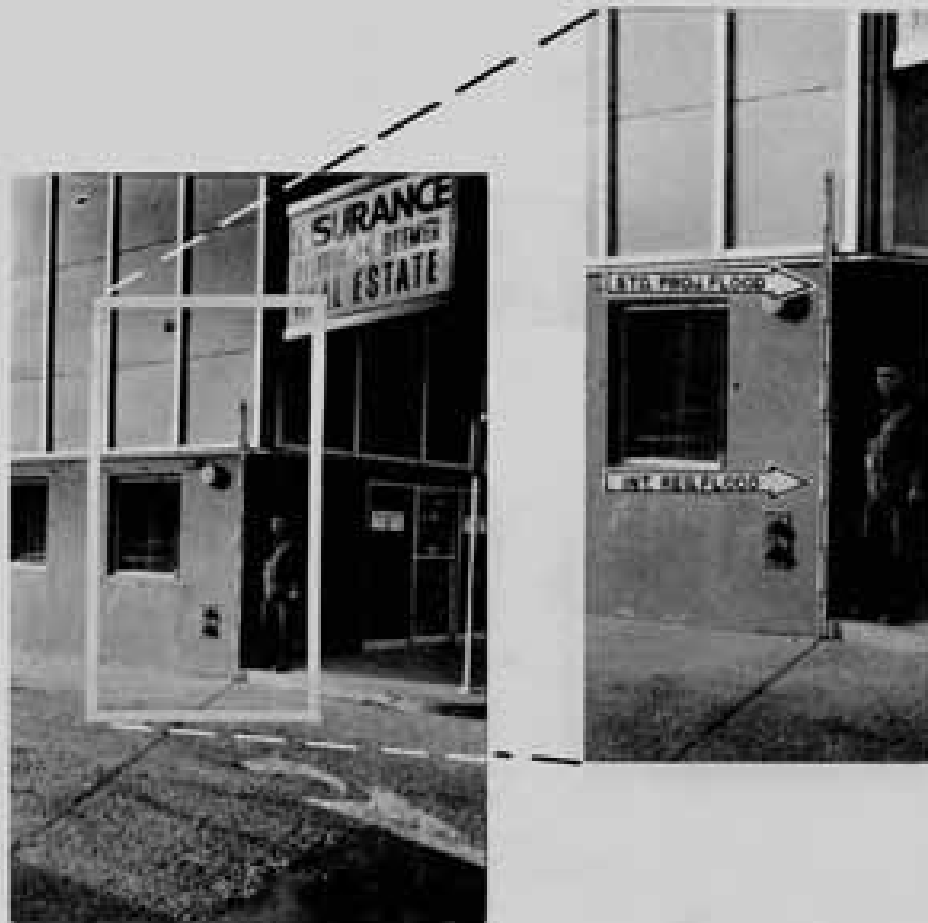
Figure 33 - Future flood heights at the northwest corner of Sierra Street and Truckee Lane in downtown Reno.

The water surface elevation of the Standard Project Flood along the Truckee River in downtown Reno would be, in general, about 5-6 feet higher than the Intermediate Regional Flood. Following is a series of photographs illustrating the elevations that the Intermediate Regional and Standard Project Floods are expected to reach at various key locations in the study area.
