FLOOD PLAIN INFORMATION

TRUCKEE RIVER

RENO-SPARKS-TRUCKEE MEADOWS, NEVADA

DEPARTMENT OF THE ARMY
SACRAMENTO DISTRICT, CORPS OF ENGINEERS
SACRAMENTO, CALIFORNIA
OCTOBER 1970

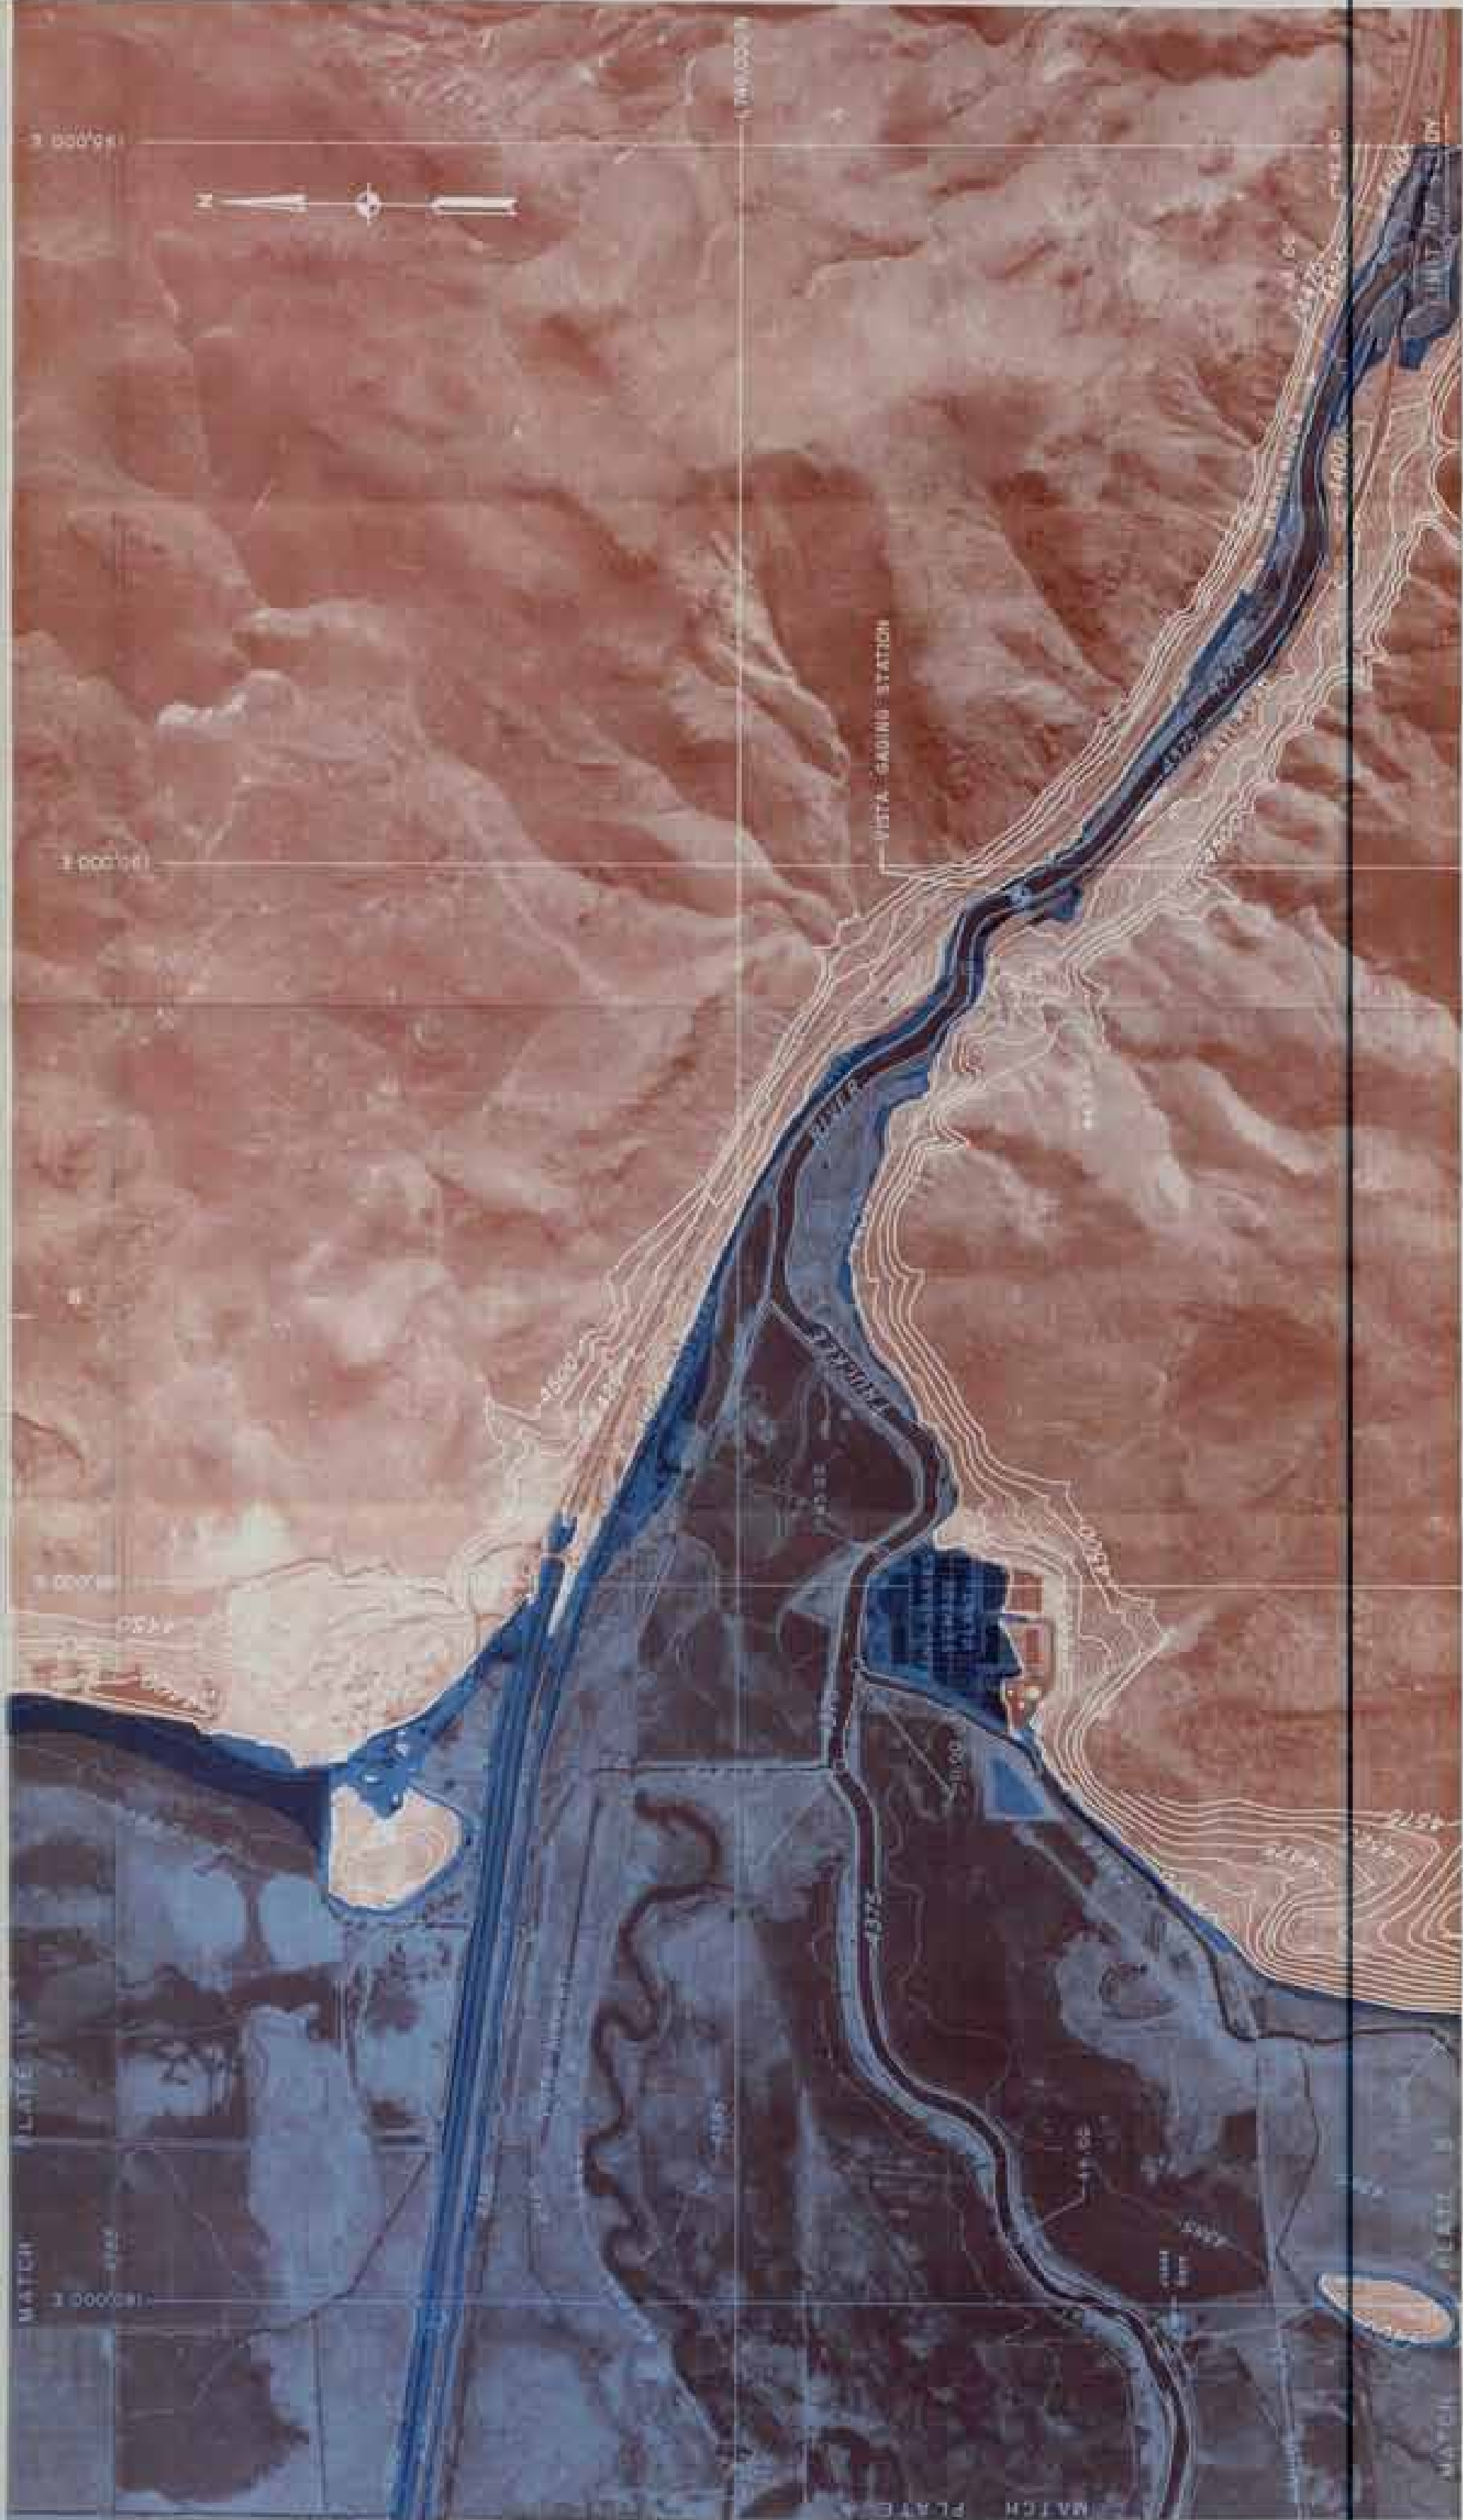
FLOODED AREAS
TRUCKEE RIVER, STEAMBOAT CREEK
NORTH TRUCKEE DRAIN
OCTOBER 1970 PLATE 3

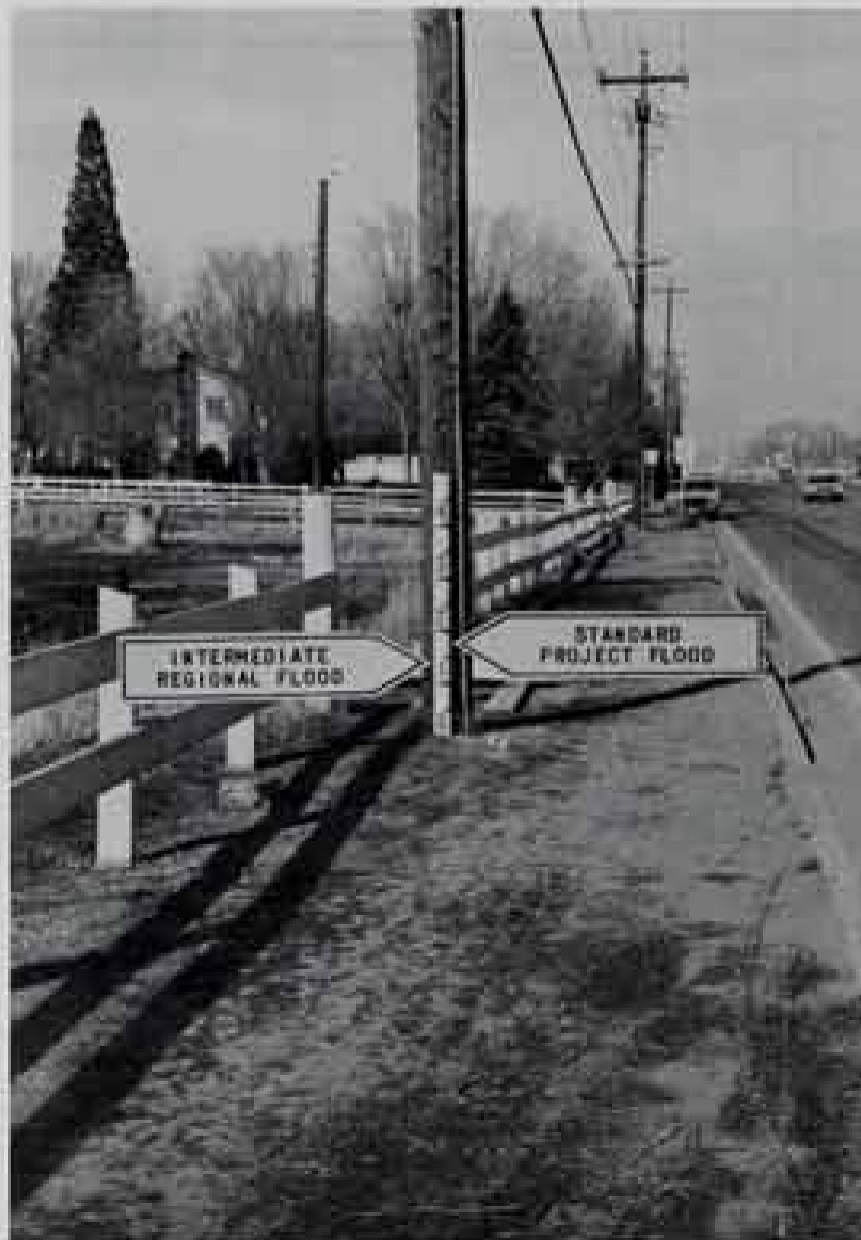
Future flood heights along Evans Creek at U.S. 395.
