# HYBRID MEETING NOTICE

## Truckee Meadows Stormwater Permit Coordinating Committee

This technical memorandum presents mapped field data, field observations, and preliminary recommendations for restoration and improvement projects along Chalk Creek within the project reach between Lancer Street and Mae Anne Avenue (**Appendix A, Figure 1**). The project reach was selected based on a review of the *2020 Watershed Management and Protection Plan for Tributaries to the Truckee River* (2020 Plan) (NCE, 2020) Tributary Project list; this project list was developed in coordination with the Truckee Meadows Stormwater Permit Coordinating Committee as potential projects that may be submitted for 319(h) funding (**Appendix B, Project Count #2**). In addition, Chalk Creek has been assessed under previous watershed assessments for tributaries of the Truckee River.

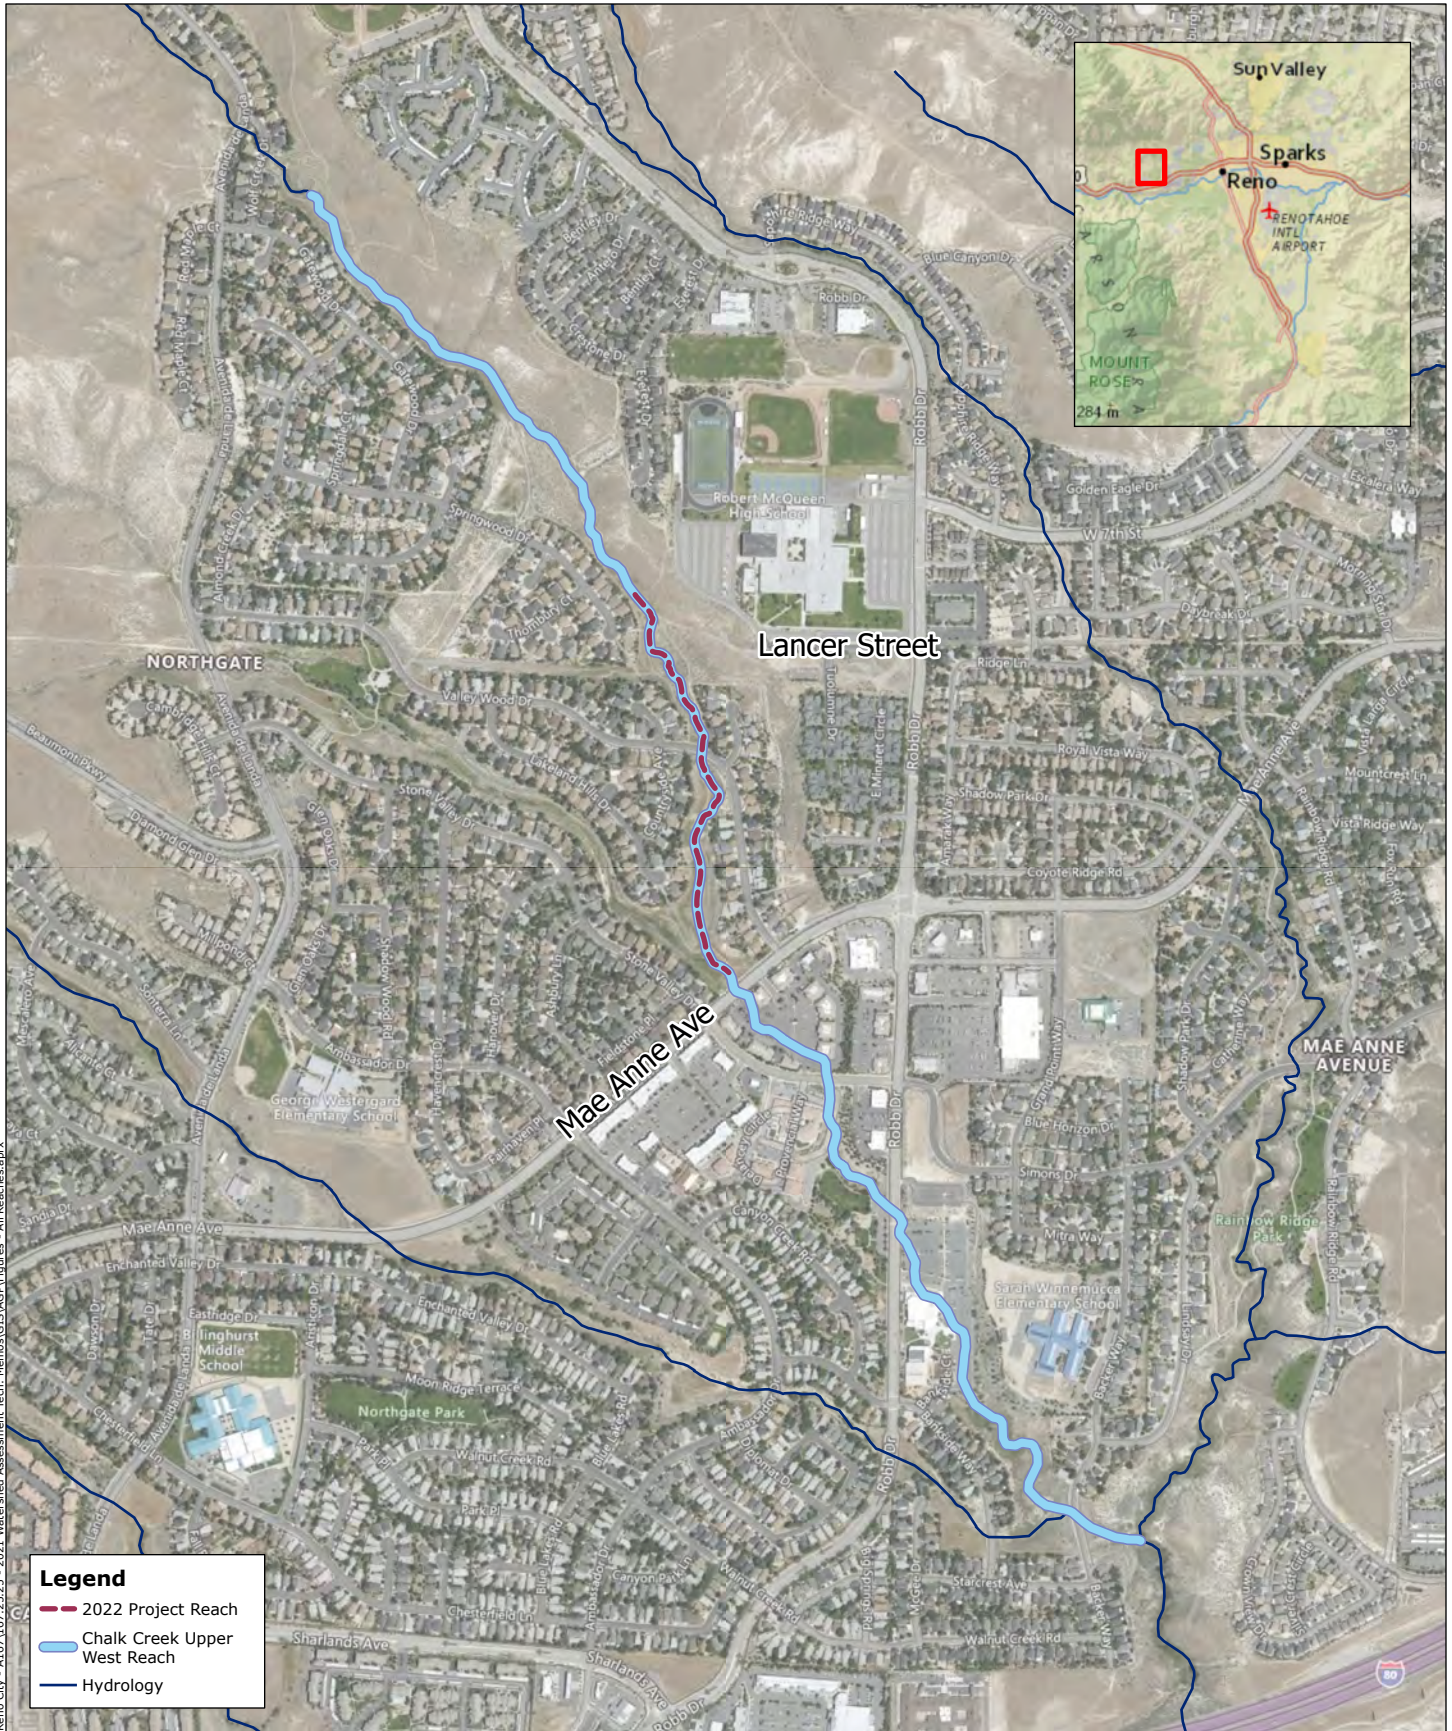
**FIGURE 5: IMPROVEMENT CONCEPTS**

Based on the field work accomplished during the 2022 project reach assessment, below are preliminary recommendations to stabilize this portion of Chalk Creek. Specifically, these preliminary recommendations have the potential to reduce the erosion, headcutting, and channel incision, and increase vegetation complexity through noxious weed control and native plantings. These preliminary recommendations are also depicted on **Appendix A, Figure 5**.

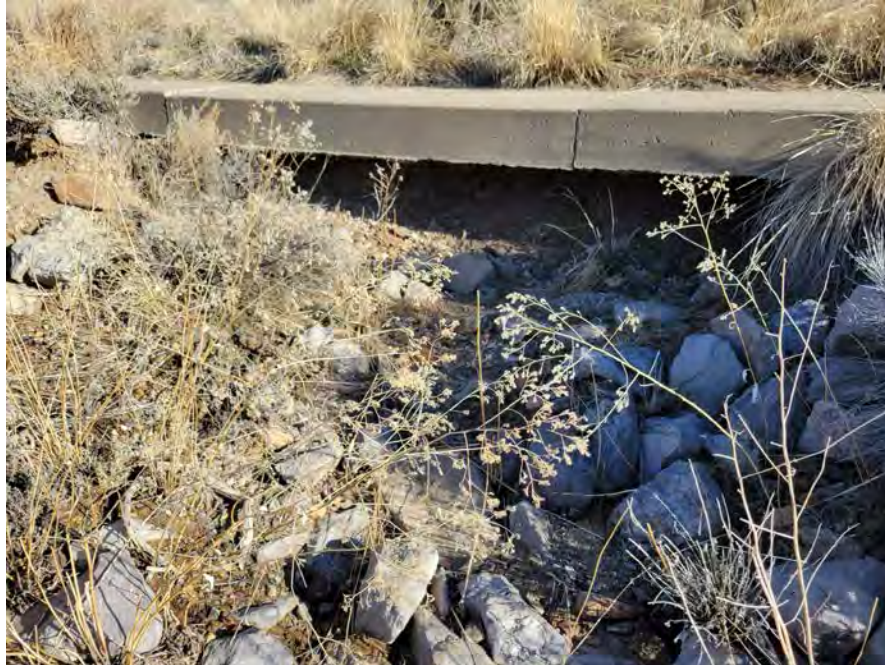
Photo 1. Standing downstream and looking upstream at concrete grade control structure. The historic channel crossed the existing structure at this location until the formation of western channel (Photo 2). Flow from Chalk Creek has undercut the existing concrete.

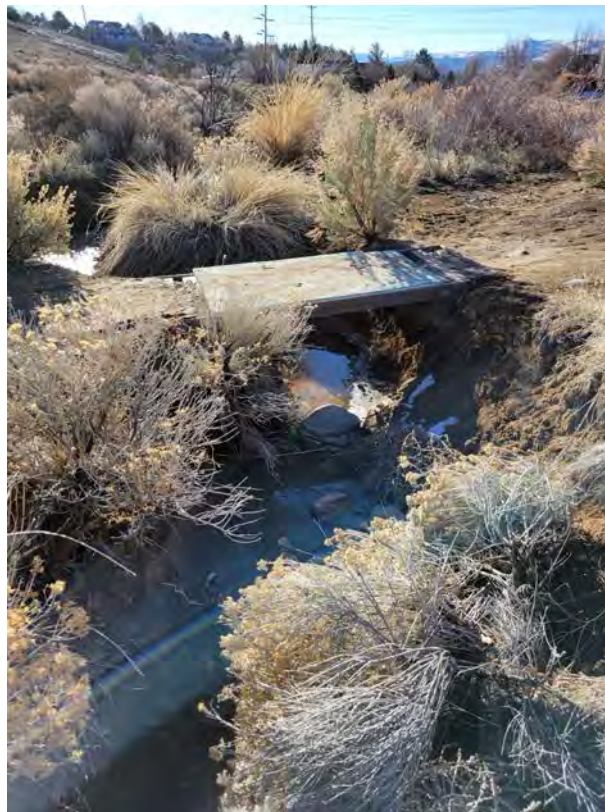
Photo 2. Western channel bypassing concrete grade control (Photo 1).

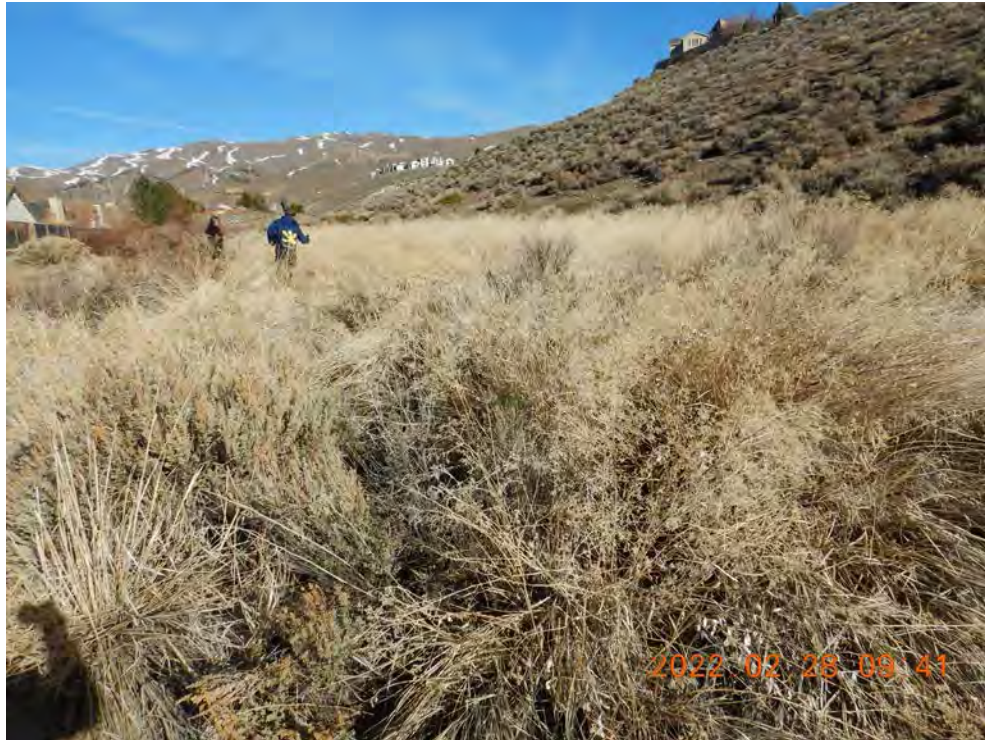
Photo 3. Previously unmapped tall whitetop (*Lepidium latifolium*) upstream of concrete grade control structure (Photo 1).

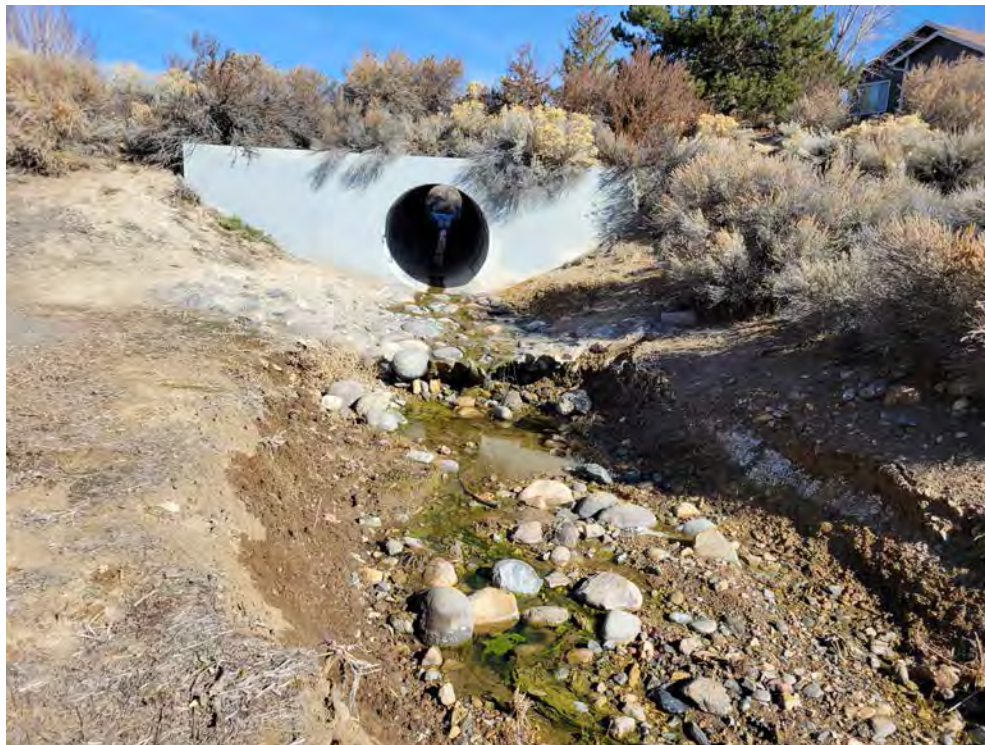
Photo 4. Valley Wood Drive culvert with 18-inch headcut downstream of the grouted riprap apron.

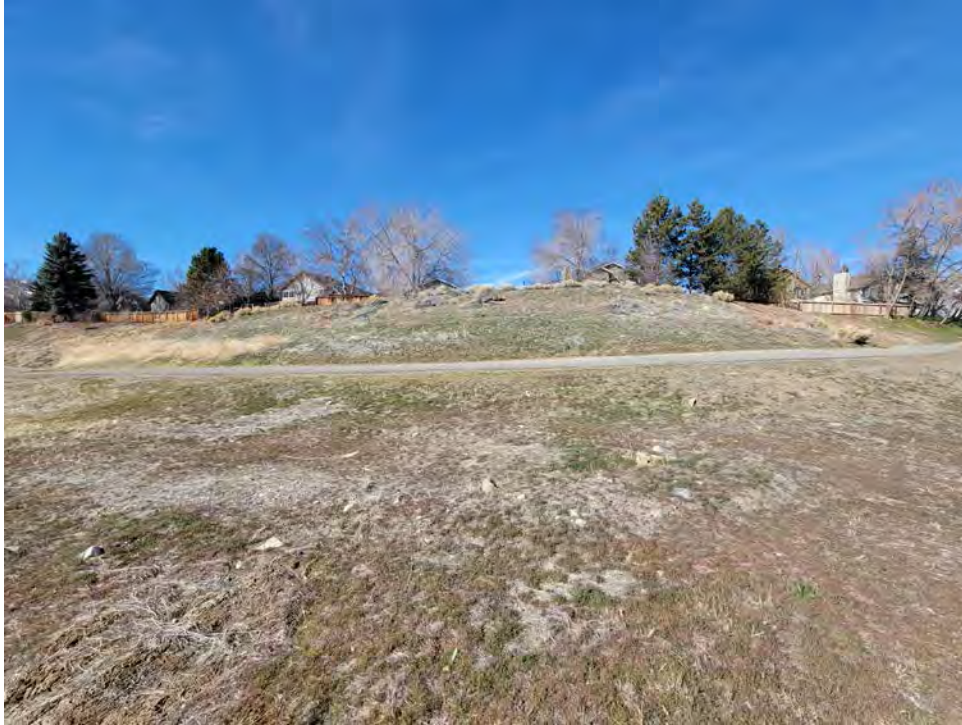
Photo 5. Floodplain and upland slope west of channel between Mae Anne Avenue and Valley Wood Drive lack vegetation.

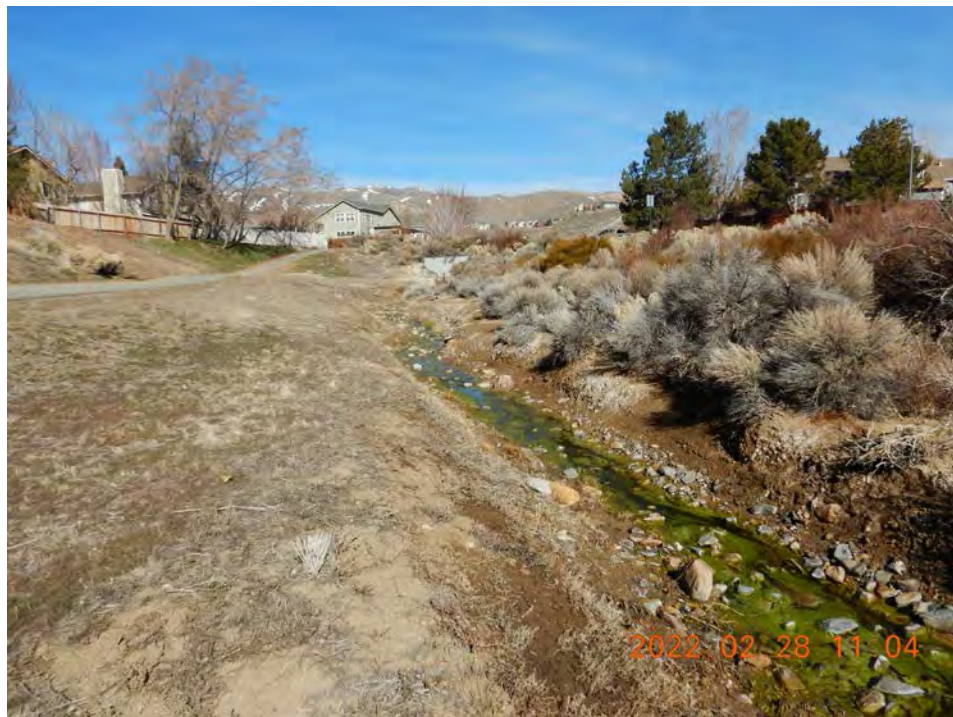
Photo 6. Chalk Creek looking upstream (north) south of Valley Wood Drive. Eastern bank has healthy upland vegetation. Western side of greenway lacks riparian and upland vegetation (also shown in Photo 5).

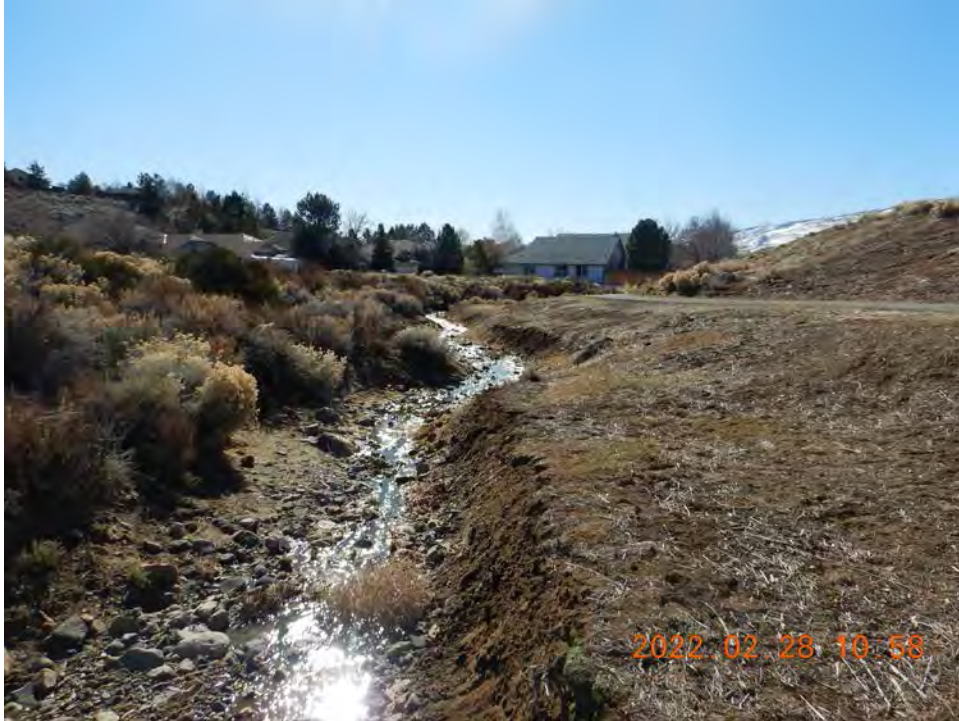
Photo 7. Chalk Creek looking downstream near Valley Wood Drive. Eastern bank has healthy upland vegetation. Western side of greenway lacks riparian and upland vegetation. Channel appears incised and disconnected from floodplain.

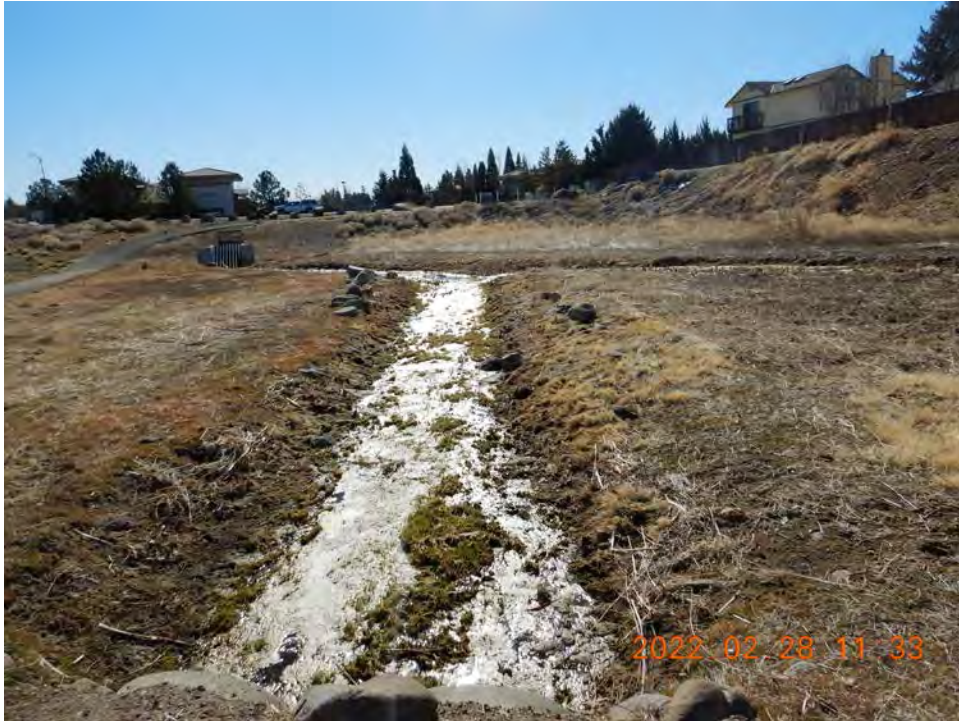
Photo 8. Chalk Creek looking downstream at Mae Anne Avenue outlet structure.

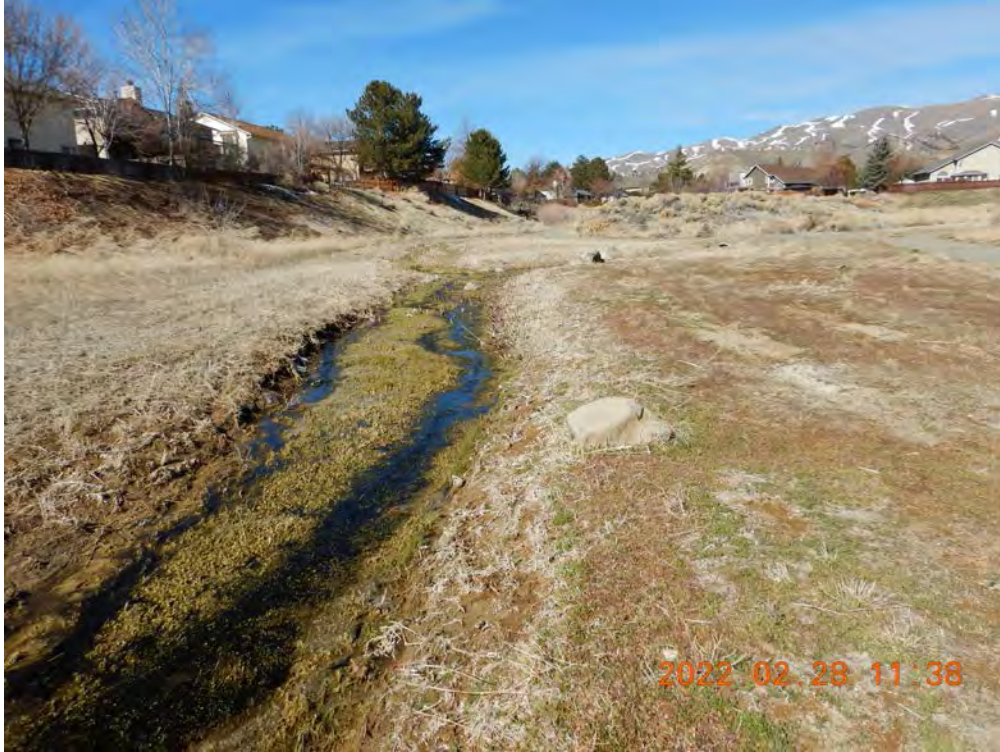
Photo 9. Chalk Creek looking upstream from outlet structure north of Mae Anne Avenue.

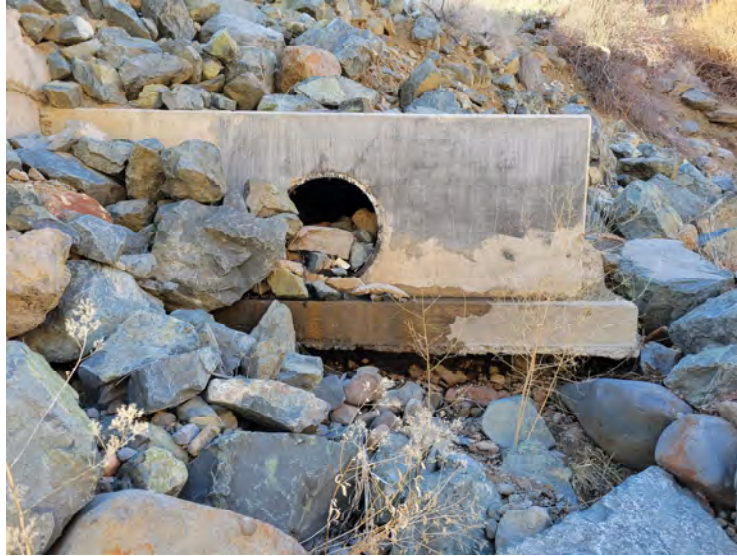
Photo 1. An upstream storm drain outfall is blocked with debris and rocks. The outfall footing is being undermined.

- Repair/stabilize undermined section of the engineered channel
- Stabilize slopes and establish vegetation where active bank cutting is occurring
- Repair undermined riprap outfall and clear debris and rocks from storm drain pipe
- Implement noxious weed control

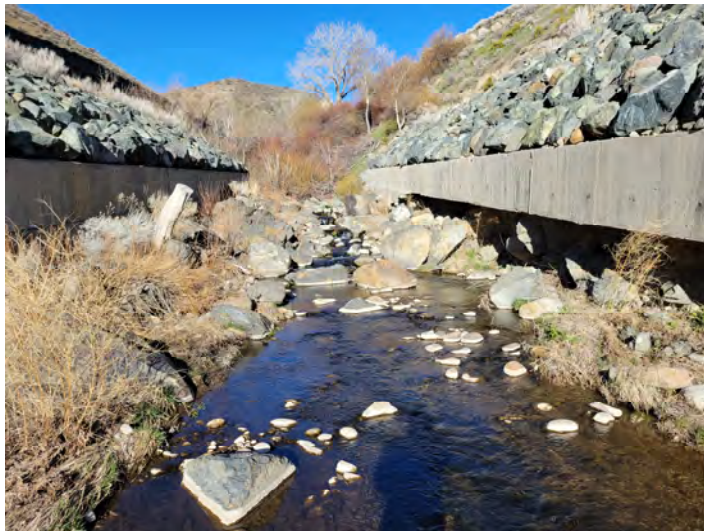
Photo 2. Galena Creek looking upstream in the section of engineered channel under the I-580 bridge. The concrete walls are undermined and stand 4 feet tall. It was estimated that the northern wall (right) has been undermined between 4 and 8 feet from the front face and is suspended up to 6 feet above the existing channel bottom. Access along the way was limited, and observations were made from the southern bank.

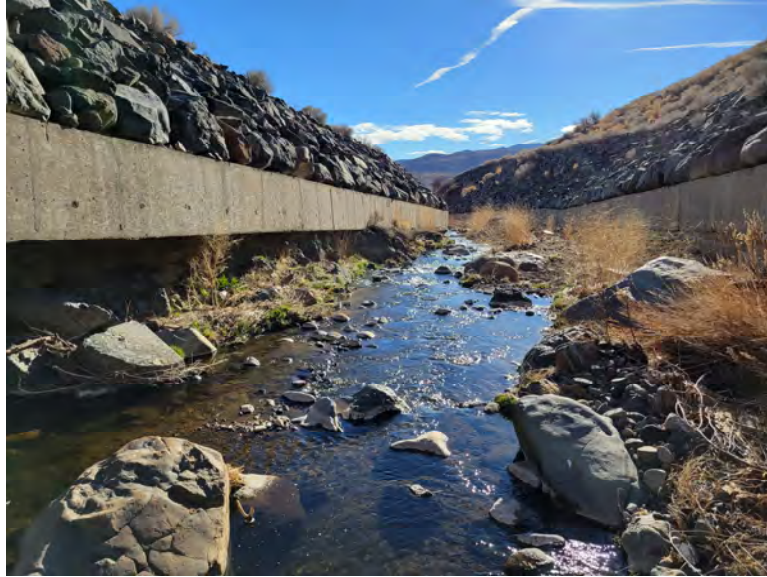
Photo 3. Galena Creek looking downstream in the section of engineered channel under the I-580 bridge. Galena Creek is actively migrating laterally within the section of engineered channel and eroding under the concrete walls on both banks.

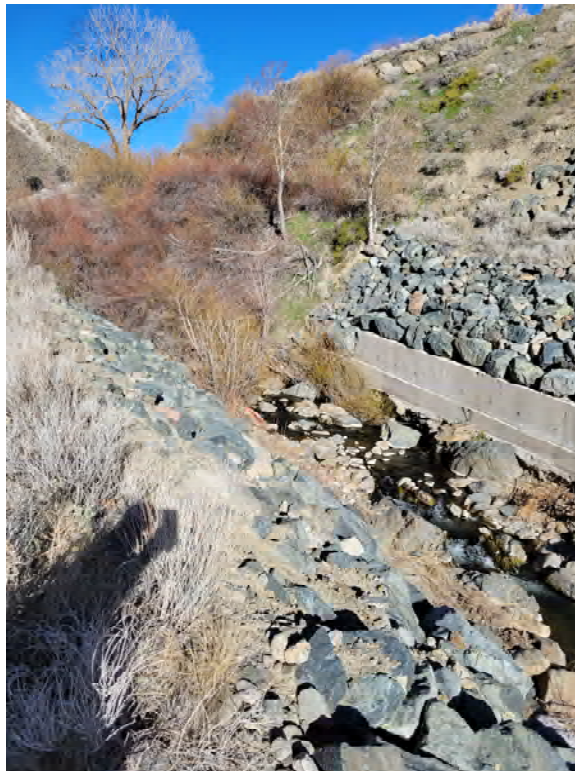
Photo 4. Looking upstream from outside the engineered channel.

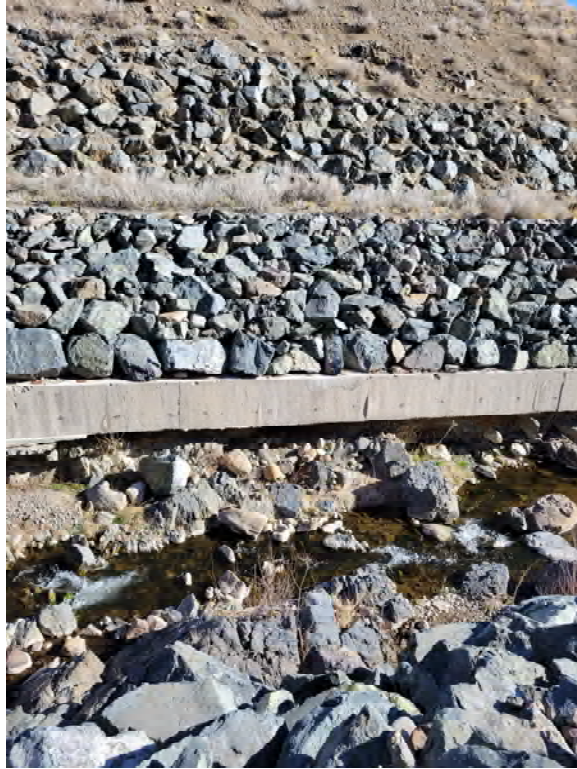
Photo 5. Looking north at the engineered channel.

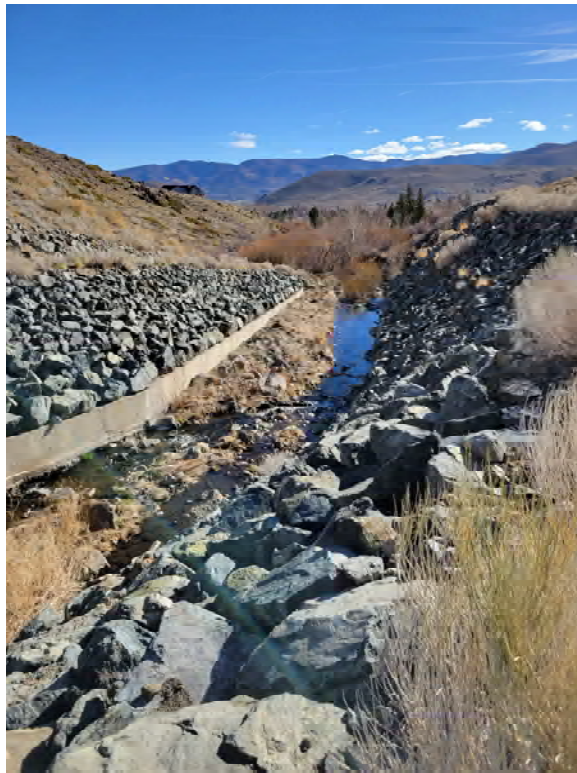
Photo 6. Looking downstream from outside the engineered channel.

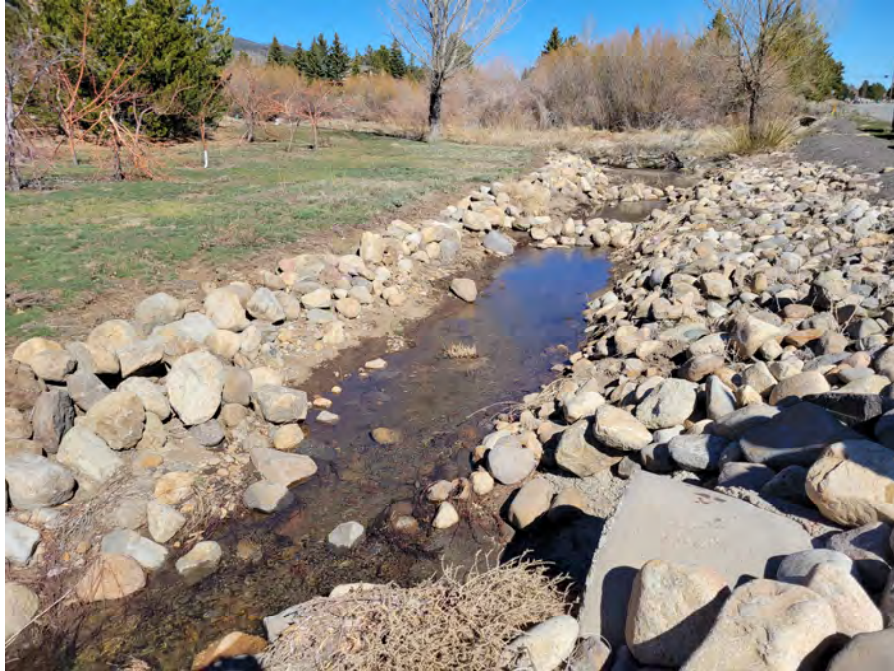
Photo 1. Upstream of Callahan Ranch Road, Jones Creek runs parallel to the road. The channel is lined with large cobble and check dams are present.

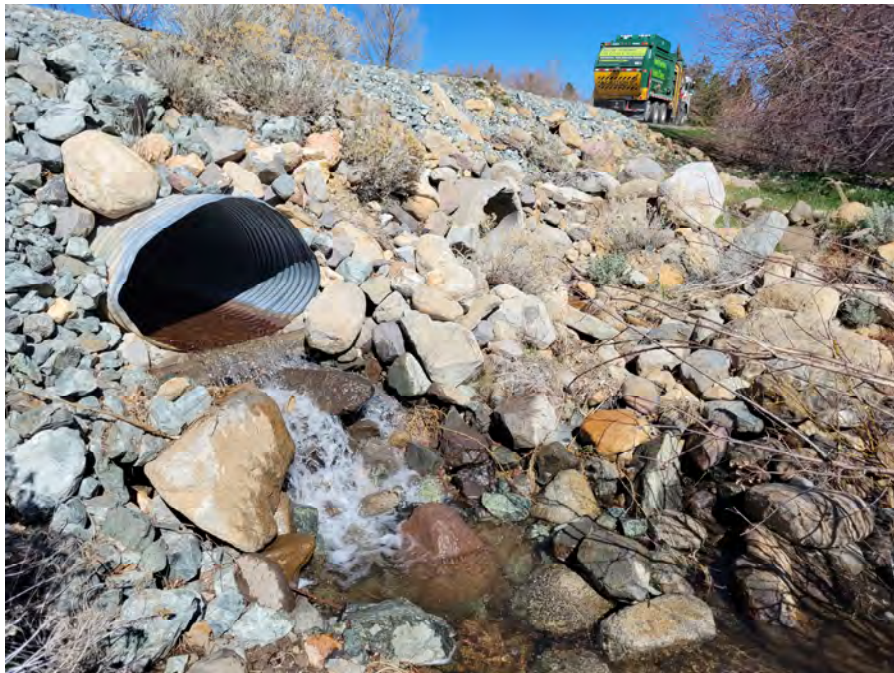
Photo 2. A 38-inch by 54-inch arch corrugated metal pipe (CMP) and 36-inch concrete culvert convey flow under Callahan Ranch Road. The CMP culvert inverts are set below the concrete culvert and convey low flows.

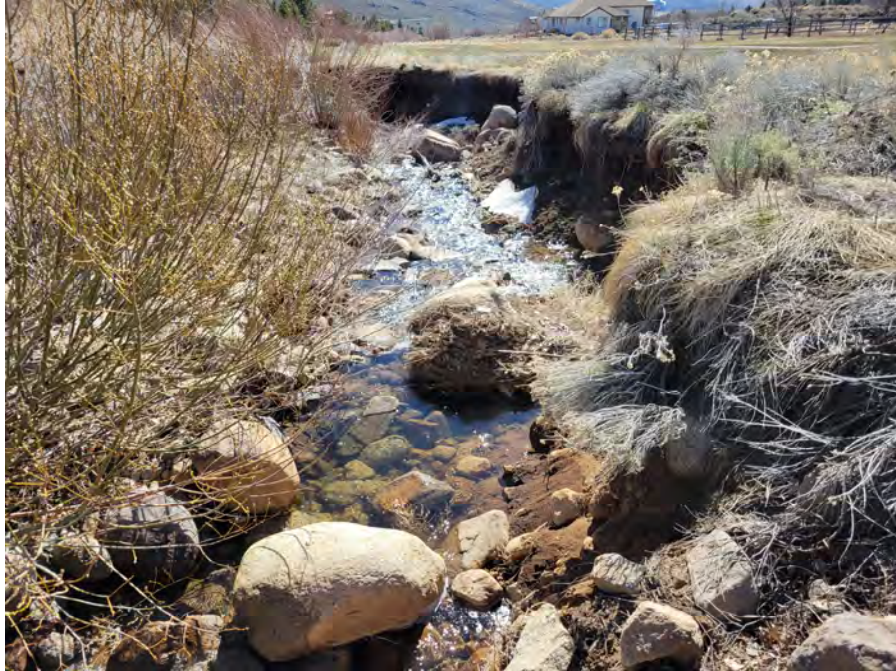
Photo 3. Looking downstream from Callahan Ranch Road. Willows are present on the left bank. The right bank is eroding and is approximately 5-feet tall.

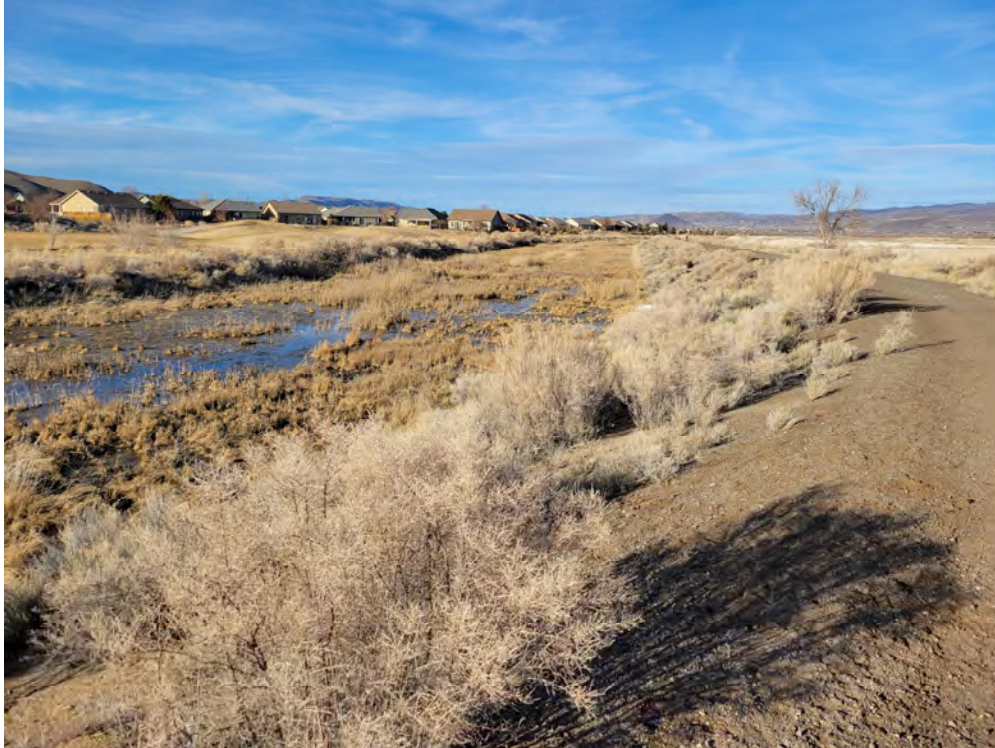
Photo 1. North Truckee Drain looking upstream at POI NTDA06.

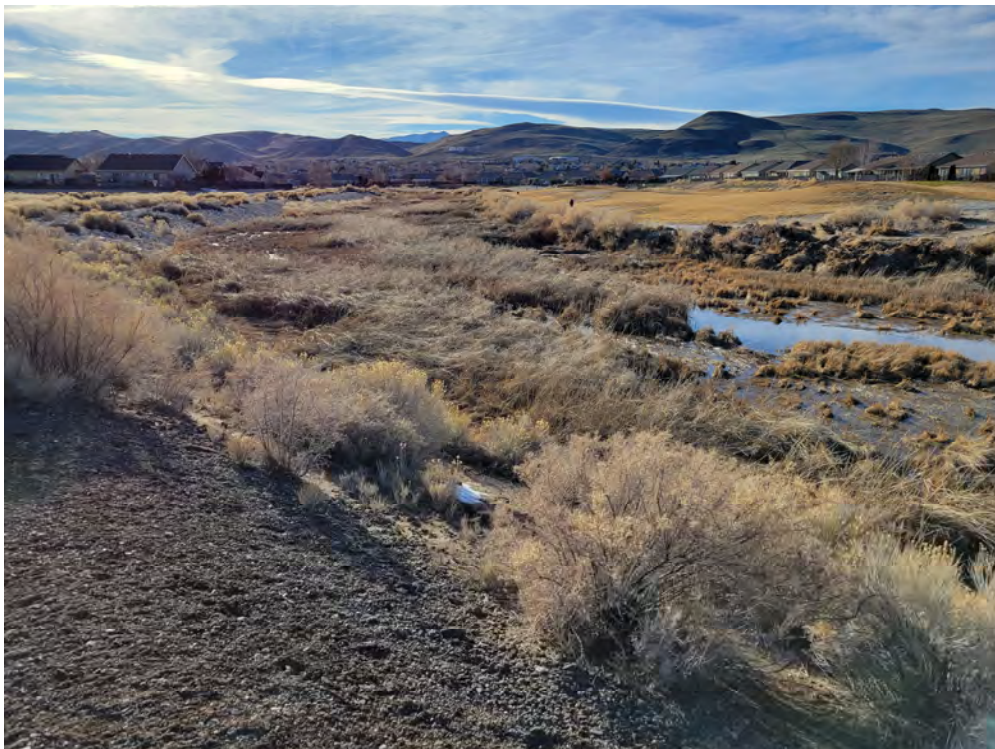
Photo 2. North Truckee Drain looking downstream at POI NTDA06. Tall whitetop (*Lepidium latifolium*) dominates the floodplain adjacent to the low flow channel.

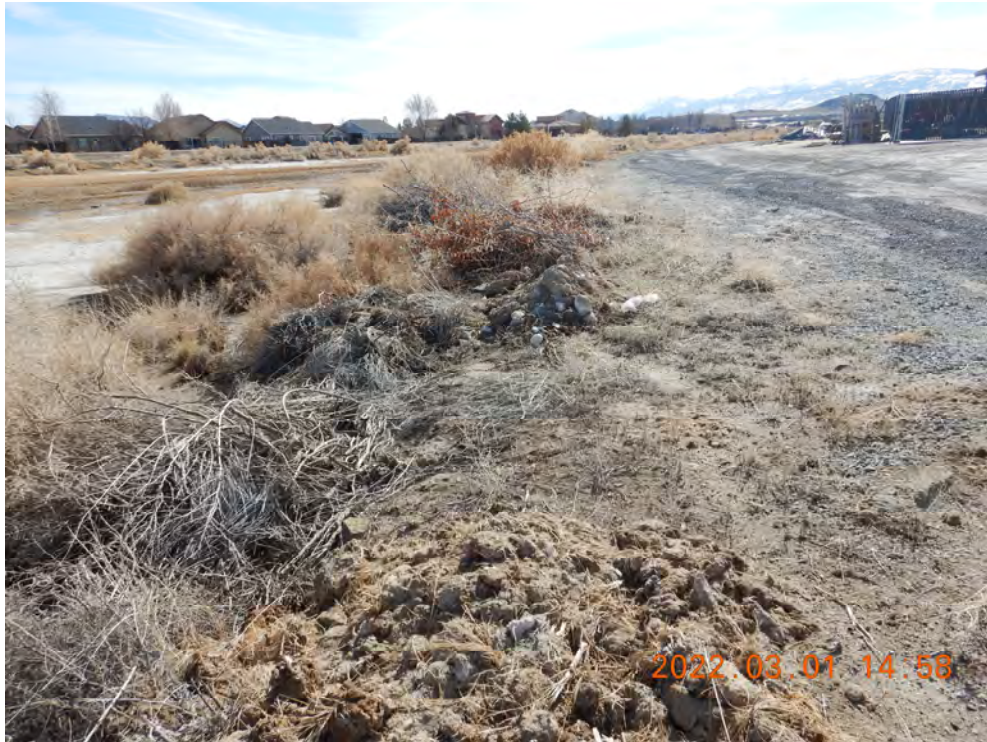
Photo 3. Soil and landscaping debris stockpiles along the west bank of the North Truckee Drain.

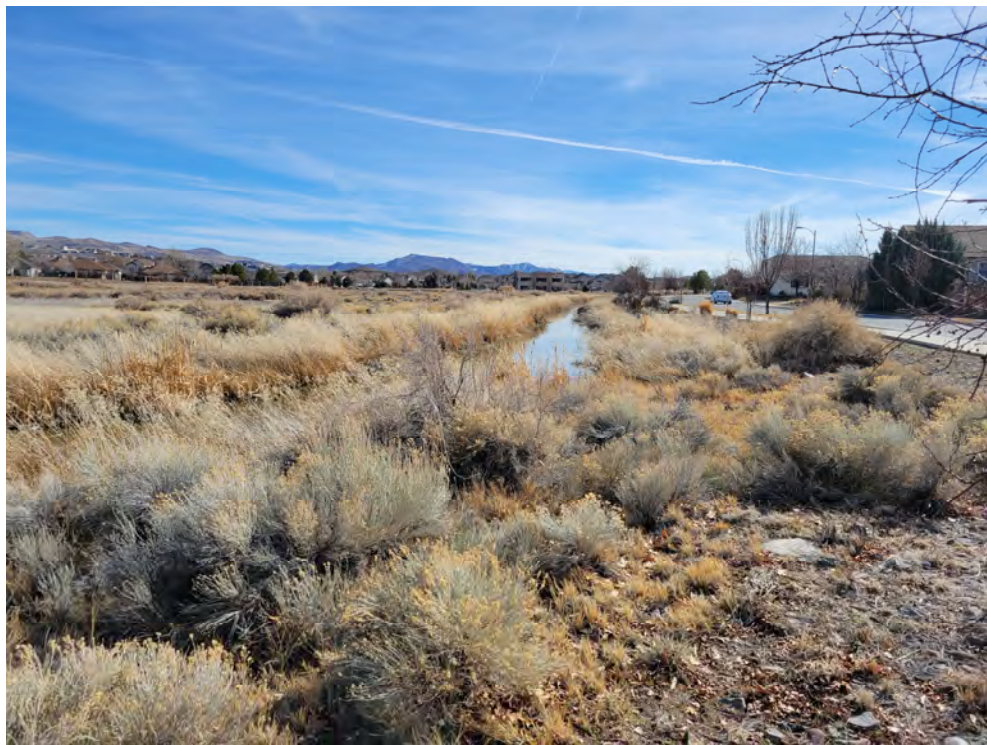
Photo 4. Looking south along a storm drain channel west of the North Truckee Drain. Tall whitetop (*Lepidium latifolium*) dominates the banks of the storm drain channel.

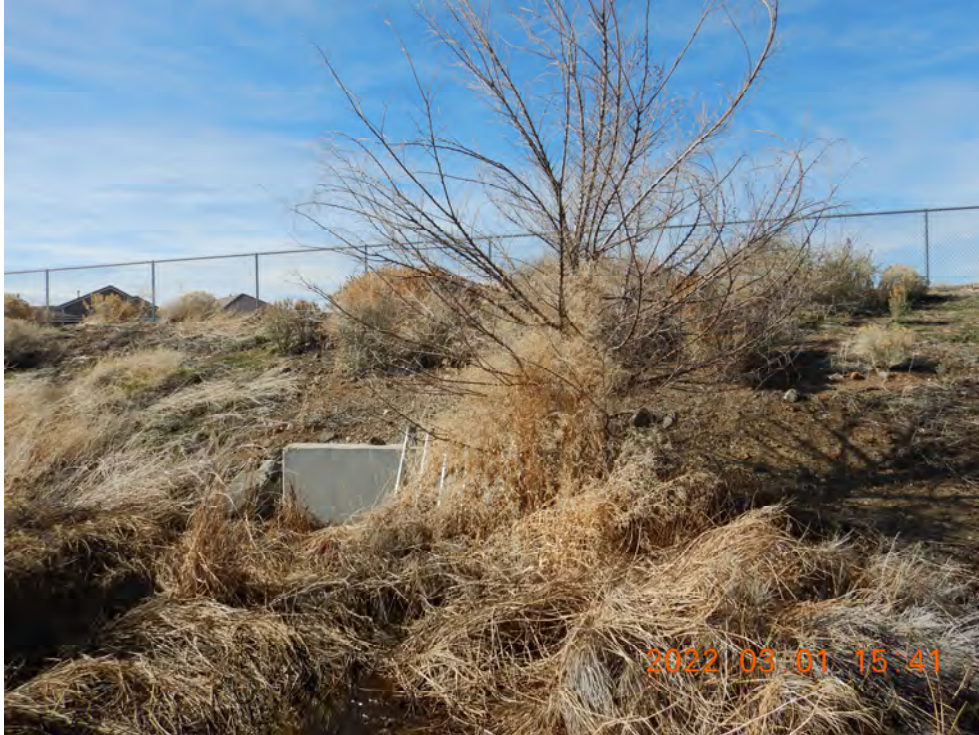
Photo 5. Overgrown storm drain outfall near Miguel Sepulveda Elementary School.

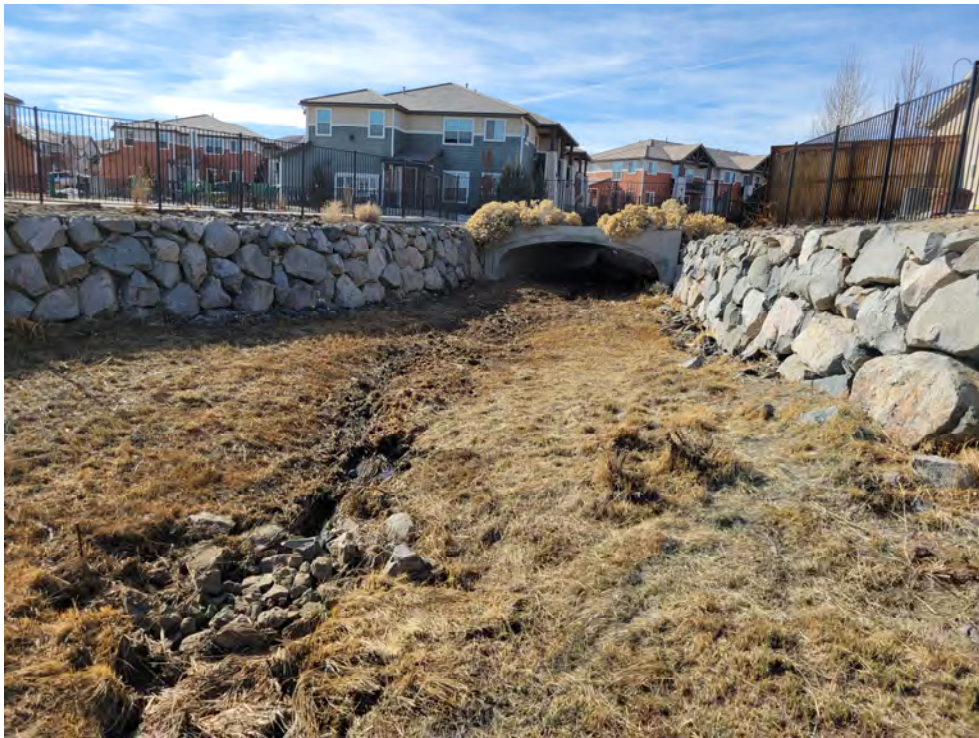
Photo 6. Drainage channel to the west of the North Truckee Drain was recently cleared. The area was documented to have purple loosestrife (*Lythrum salicaria*) and tall whitetop (*Lepidium latifolium*) in 2015.

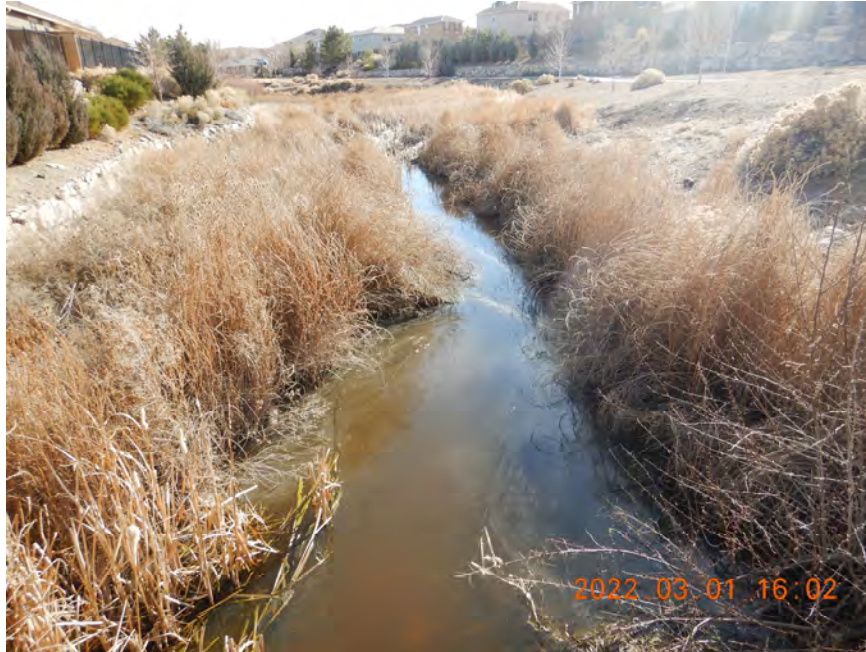
Photo 7. Looking downstream from Tree Swallow Lane. Purple loosestrife (*Lythrum salicaria*) dominate both the left and right banks.

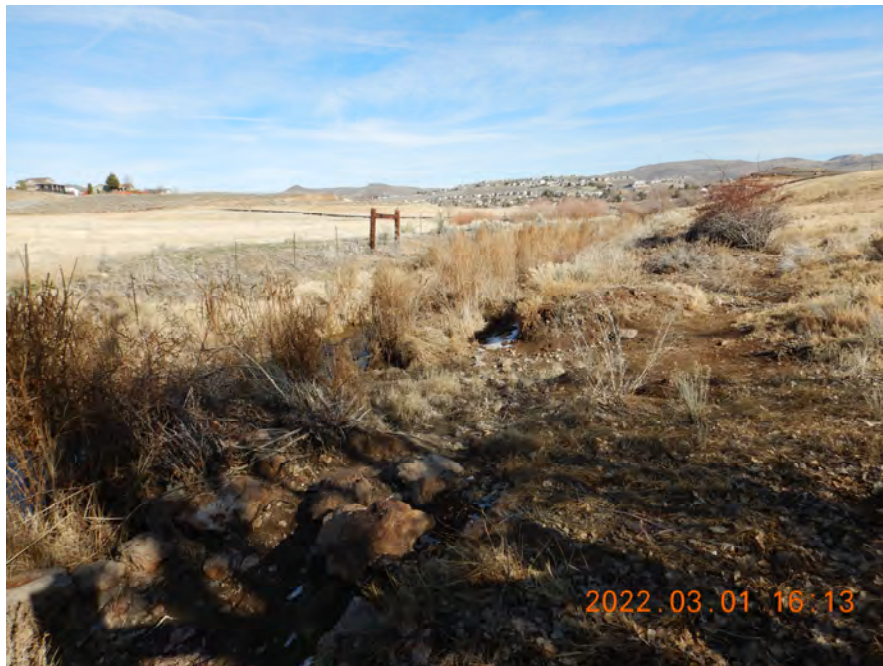
Photo 8. North Truckee Drain looking downstream at the pasture at the end of the project reach limits. Purple loosestrife (*Lythrum salicaria*) dominates the bank as observed from the property line.

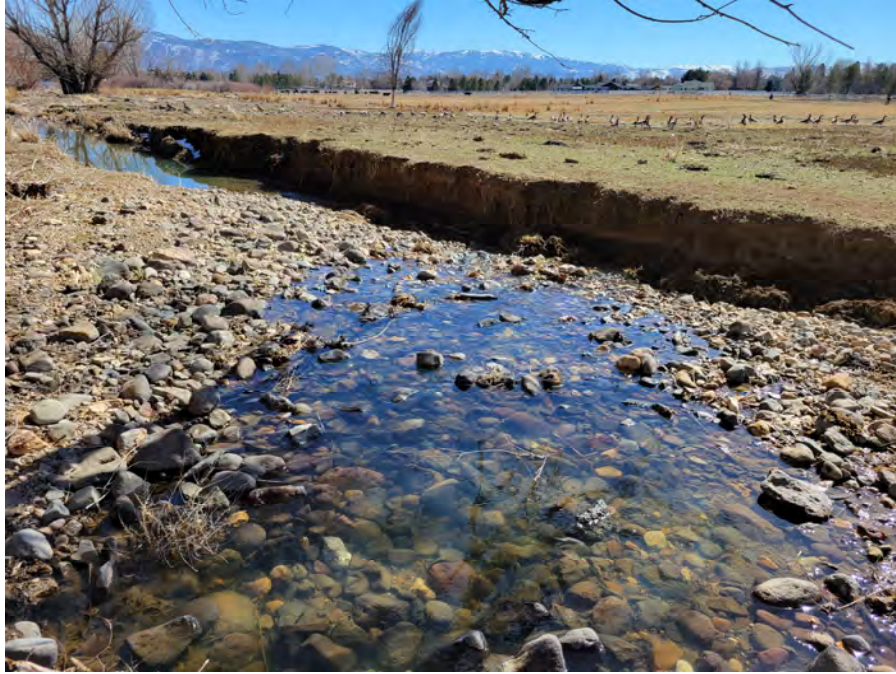
Photo 1. Looking southeast at the vertical bank of South Evans Creek. The channel is disconnected from the existing floodplain and pasture in the background.

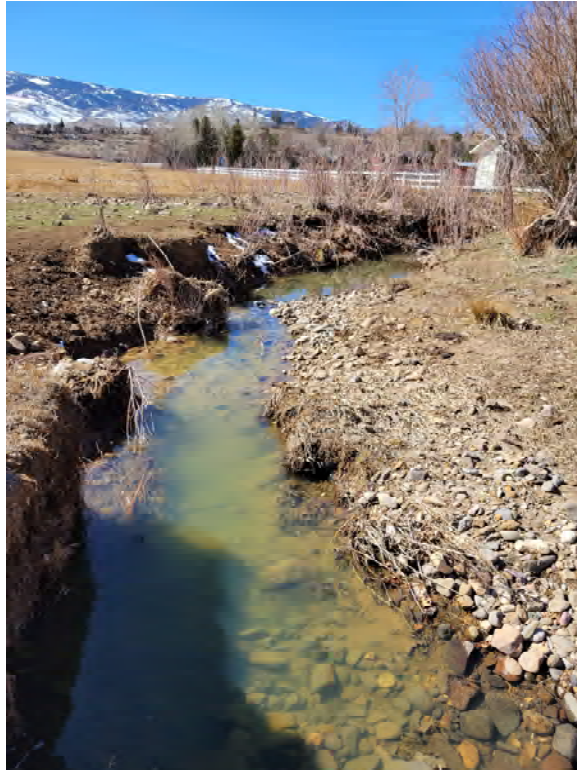
Photo 2. Looking east standing at the top of the southern bank. The southern bank is actively being eroded and soil is slumping into South Evans Creek.

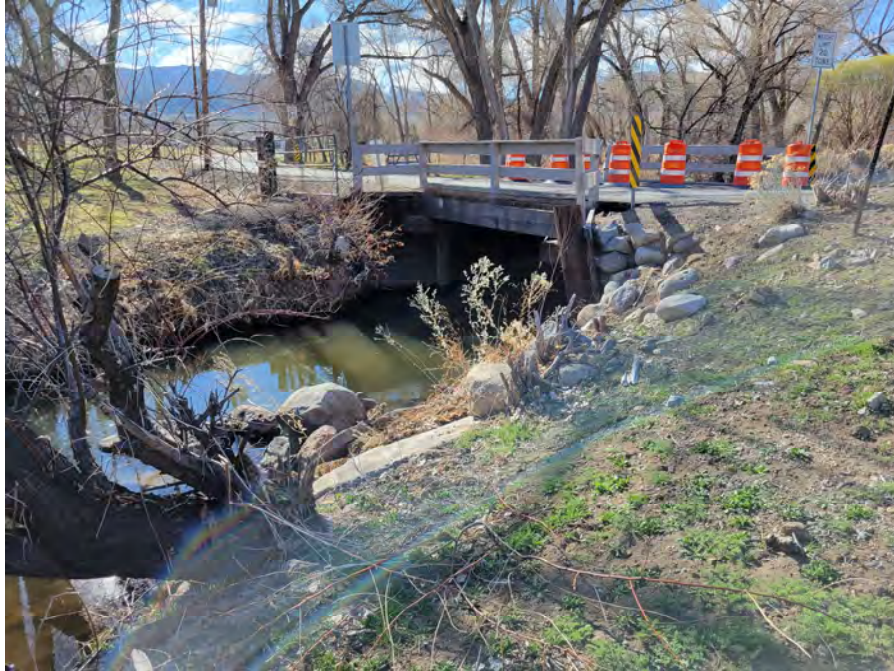
Photo 1. Rhodes Road crossing. There is active erosion near the footing of the wooden structure. Washoe County is currently working through the design phase to replace the existing structure.

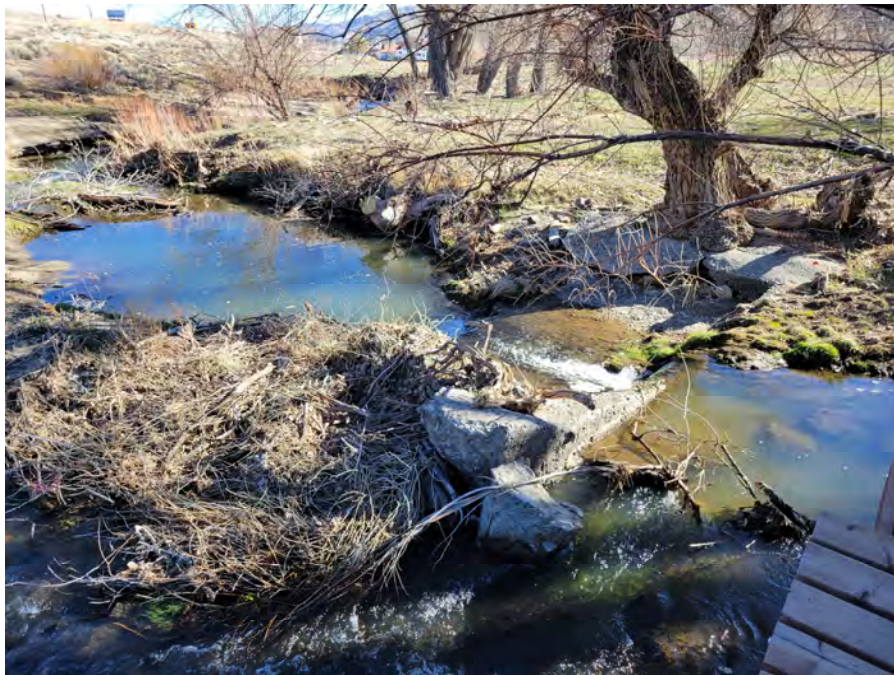
Photo 2. Existing weir downstream of the USGS gauge station. The majority of flow in Steamboat Creek bypasses the existing weir.

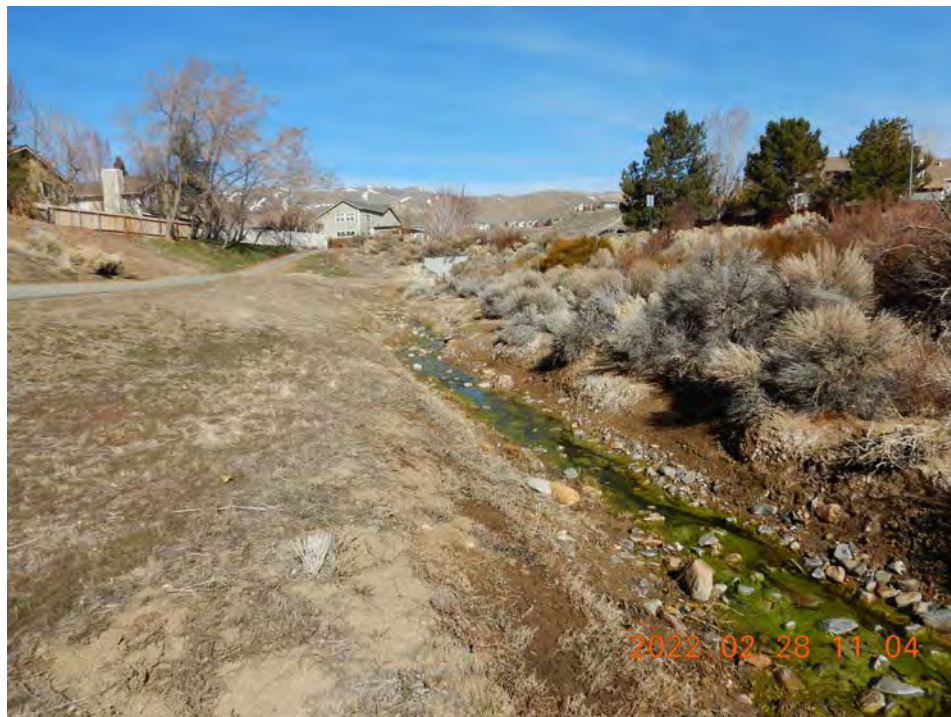
Photo 5. Floodplain and upland slope west of channel between Mae Anne Avenue and Valley Wood Drive lack vegetation.
