# HYBRID MEETING NOTICE

## Truckee Meadows Stormwater Permit Coordinating Committee

This technical memorandum presents mapped field data, field observations, and preliminary recommendations for restoration and improvement projects along Chalk Creek within the project reach between Lancer Street and Mae Anne Avenue (**Appendix A, Figure 1**). The project reach was selected based on a review of the *2020 Watershed Management and Protection Plan for Tributaries to the Truckee River* (2020 Plan) (NCE, 2020) Tributary Project list; this project list was developed in coordination with the Truckee Meadows Stormwater Permit Coordinating Committee as potential projects that may be submitted for 319(h) funding (**Appendix B, Project Count #2**). In addition, Chalk Creek has been assessed under previous watershed assessments for tributaries of the Truckee River.

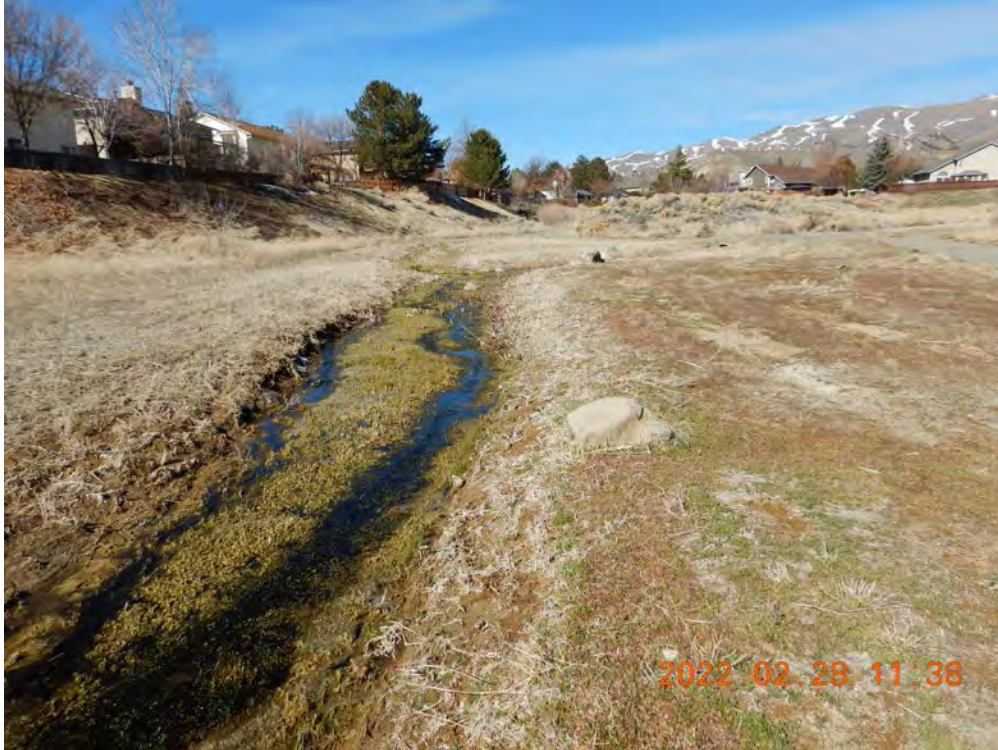
Photo 8. Chalk Creek looking downstream at Mae Anne Avenue outlet structure.

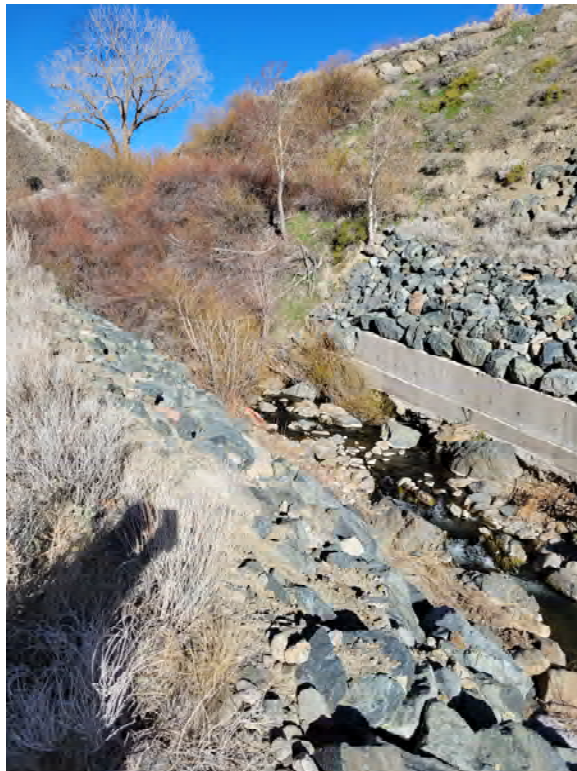
Photo 3. Galena Creek looking downstream in the section of engineered channel under the I-580 bridge. Galena Creek is actively migrating laterally within the section of engineered channel and eroding under the concrete walls on both banks.

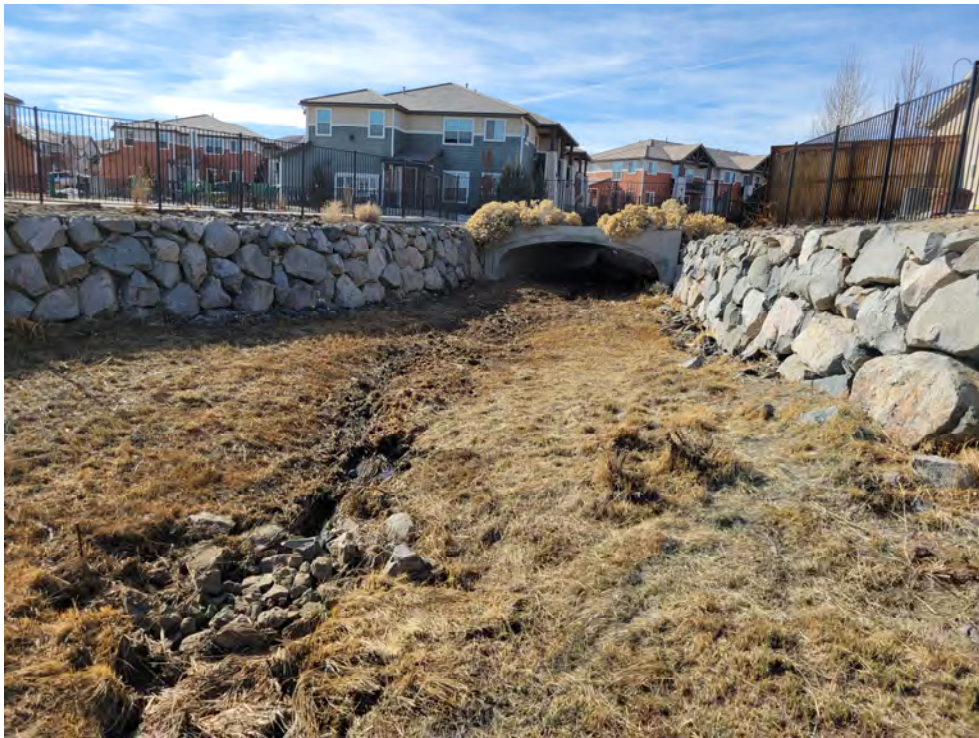
Photo 6. Drainage channel to the west of the North Truckee Drain was recently cleared. The area was documented to have purple loosestrife (*Lythrum salicaria*) and tall whitetop (*Lepidium latifolium*) in 2015.

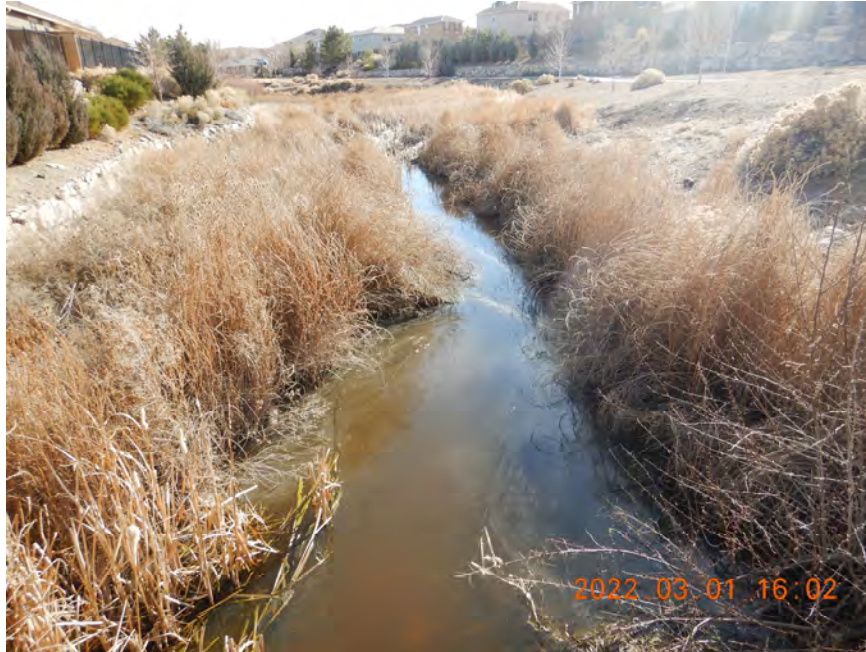
Photo 7. Looking downstream from Tree Swallow Lane. Purple loosestrife (*Lythrum salicaria*) dominate both the left and right banks.

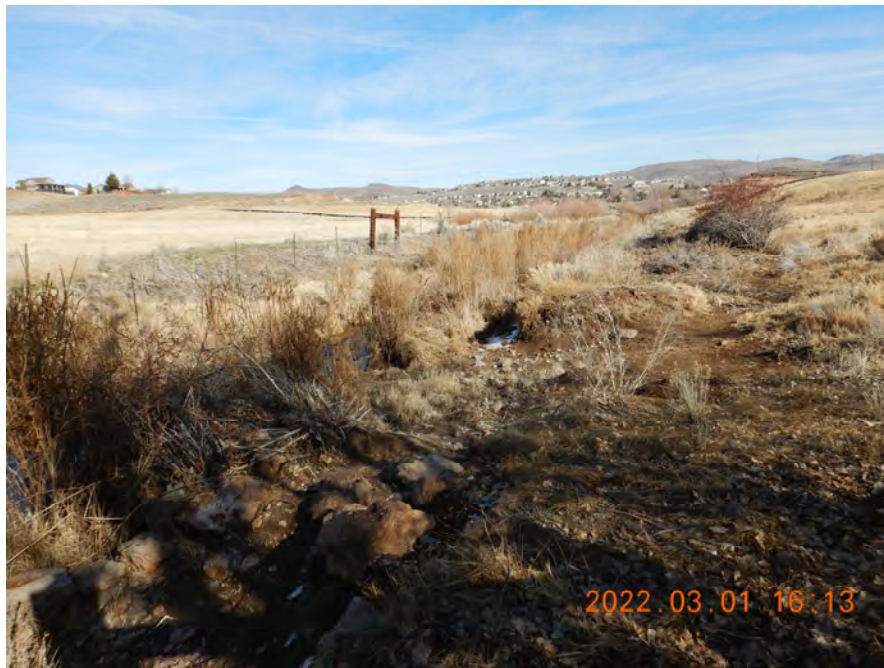
Photo 8. North Truckee Drain looking downstream at the pasture at the end of the project reach limits. Purple loosestrife (*Lythrum salicaria*) dominates the bank as observed from the property line.

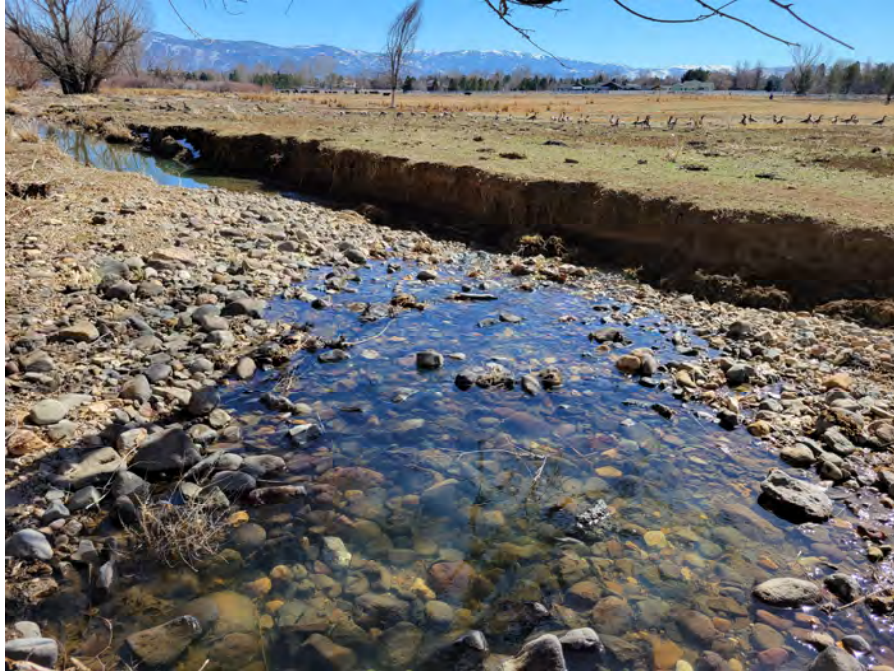
Photo 1. Looking southeast at the vertical bank of South Evans Creek. The channel is disconnected from the existing floodplain and pasture in the background.

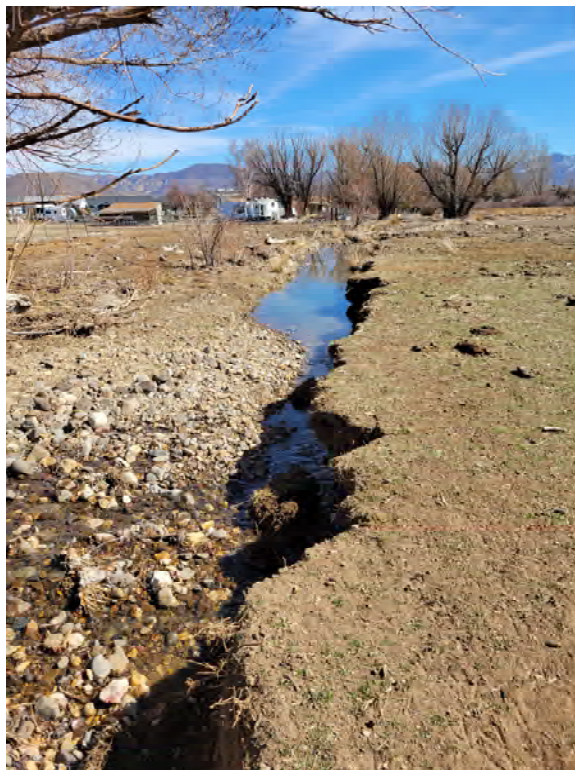
Photo 2. Looking east standing at the top of the southern bank. The southern bank is actively being eroded and soil is slumping into South Evans Creek.

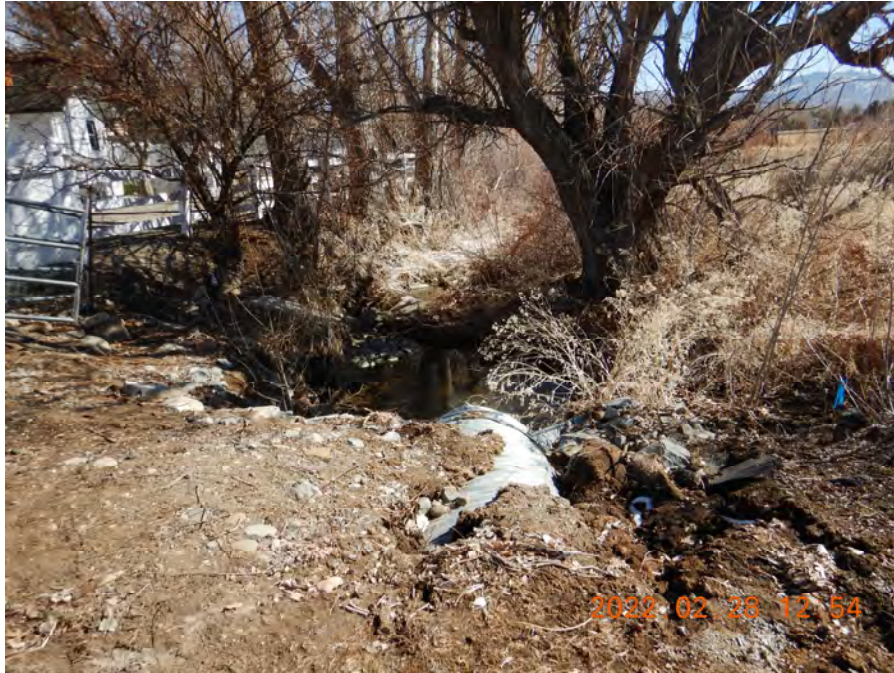
Photo 4. Channel bifurcates at this location. Concrete ready-mix bags and t-post have been used to block flow towards the northeast and limit flow entering the private parcel to the north. Debris has collected on the makeshift improvised diversion structure.

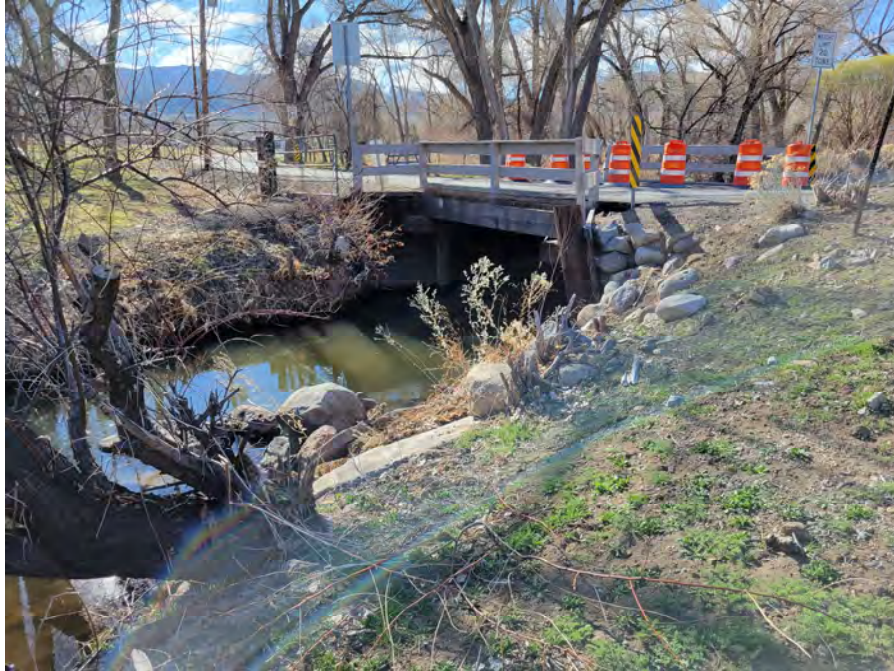
Photo 1. Rhodes Road crossing. There is active erosion near the footing of the wooden structure. Washoe County is currently working through the design phase to replace the existing structure.

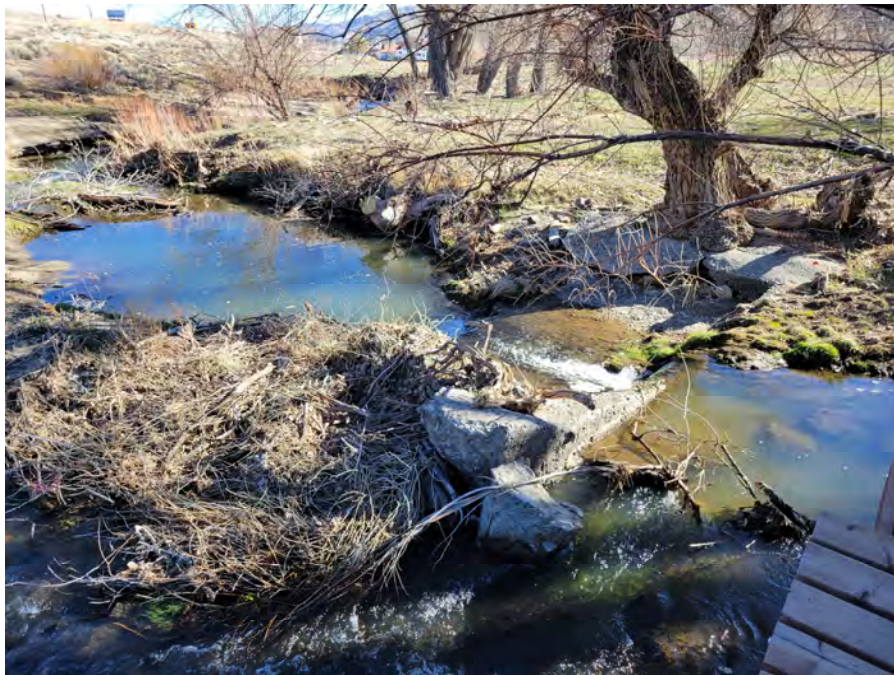
Photo 2. Existing weir downstream of the USGS gauge station. The majority of flow in Steamboat Creek bypasses the existing weir.
