DATE: February 28, 2023
TO: Honorable Mayor and City Council
THROUGH: Doug Thornley, City Manager Approved Electronically
FROM: Trina Magoon, Director of Utility Services
SUBJECT: **January 2023 Storm Event: Status of City Maintained Retention, Detention, and Flood Control Channels in the Swan Lake Watershed**

NORTH VALLEYS FIELD INSPECTION REPORT CONDUCTED JANUARY 11, 2023

CITY OF RENO - UTILITY SERVICES AND MAINTENANCE AND OPERATIONS DEPARTMENTS
Site Inspections Performed / Photos By: Norman Nash and Tim Lovett

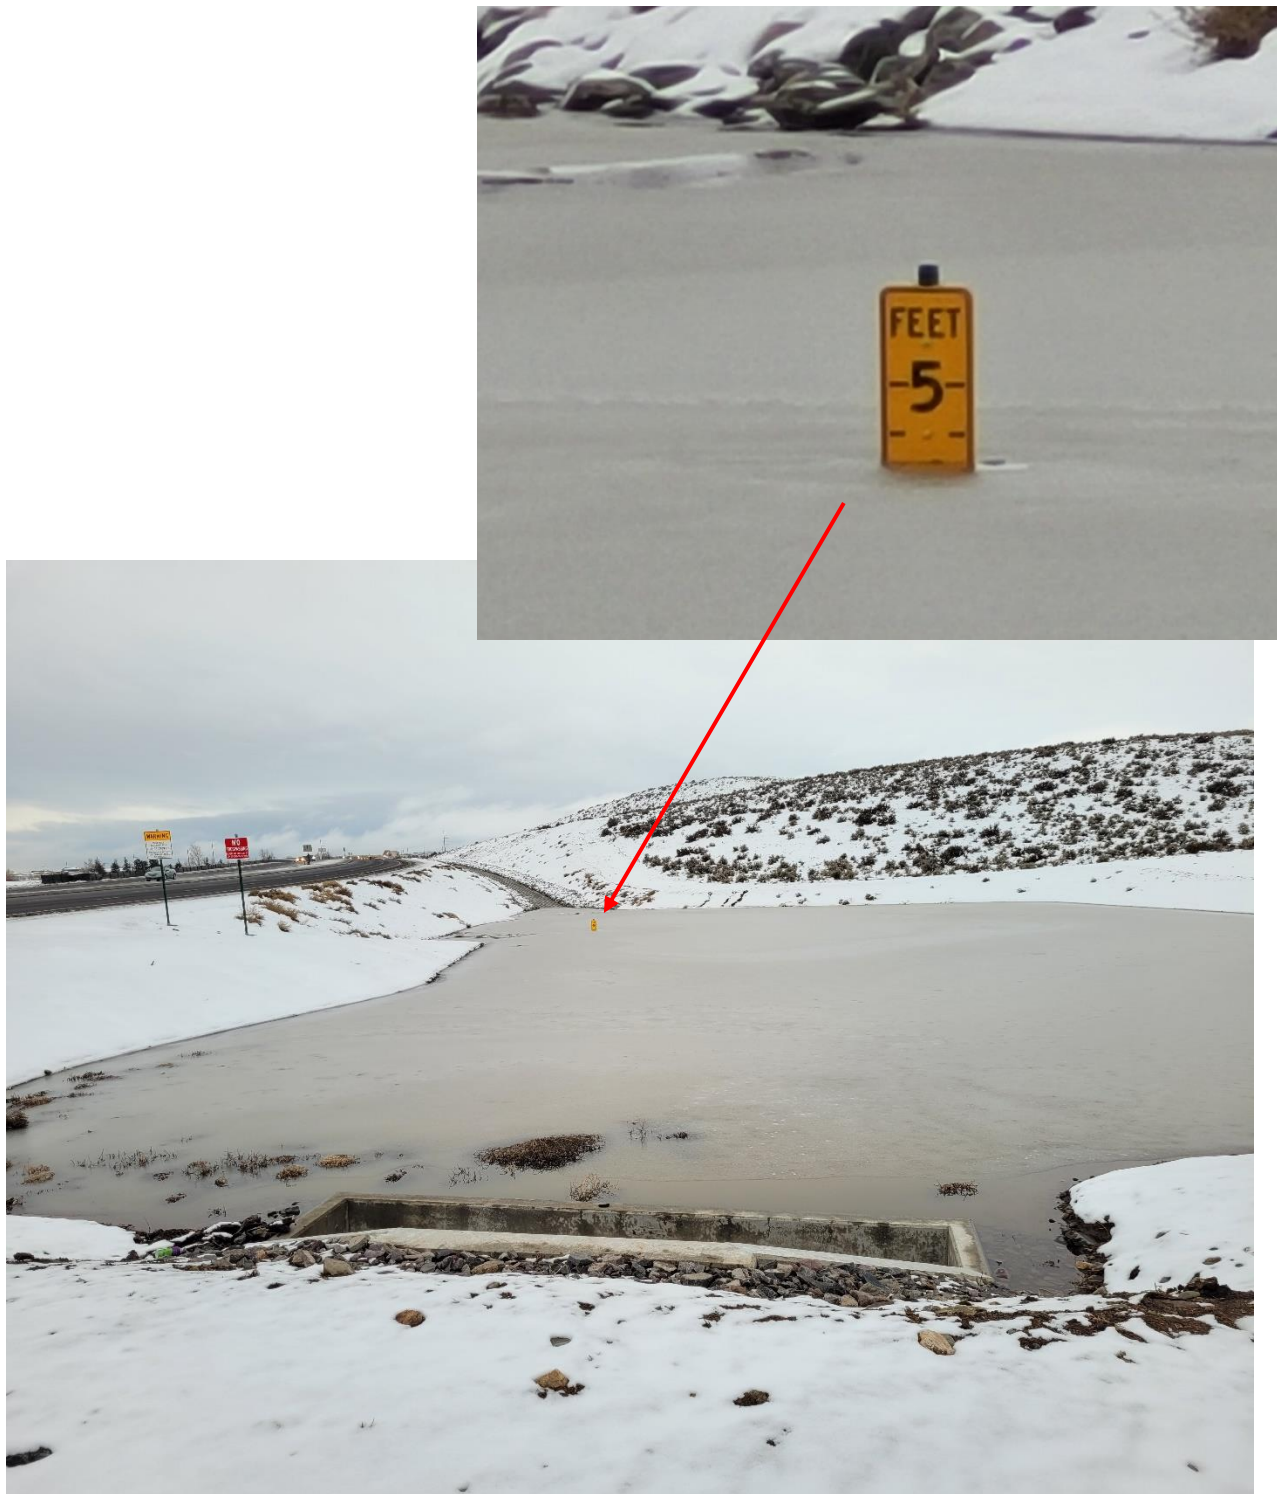
Inspection Site 1) Retention structure south of 8075 Lemmon Dr. The water level inside the basin is below the designed outlet structure and is in no danger of overtopping. (1/11/2023)

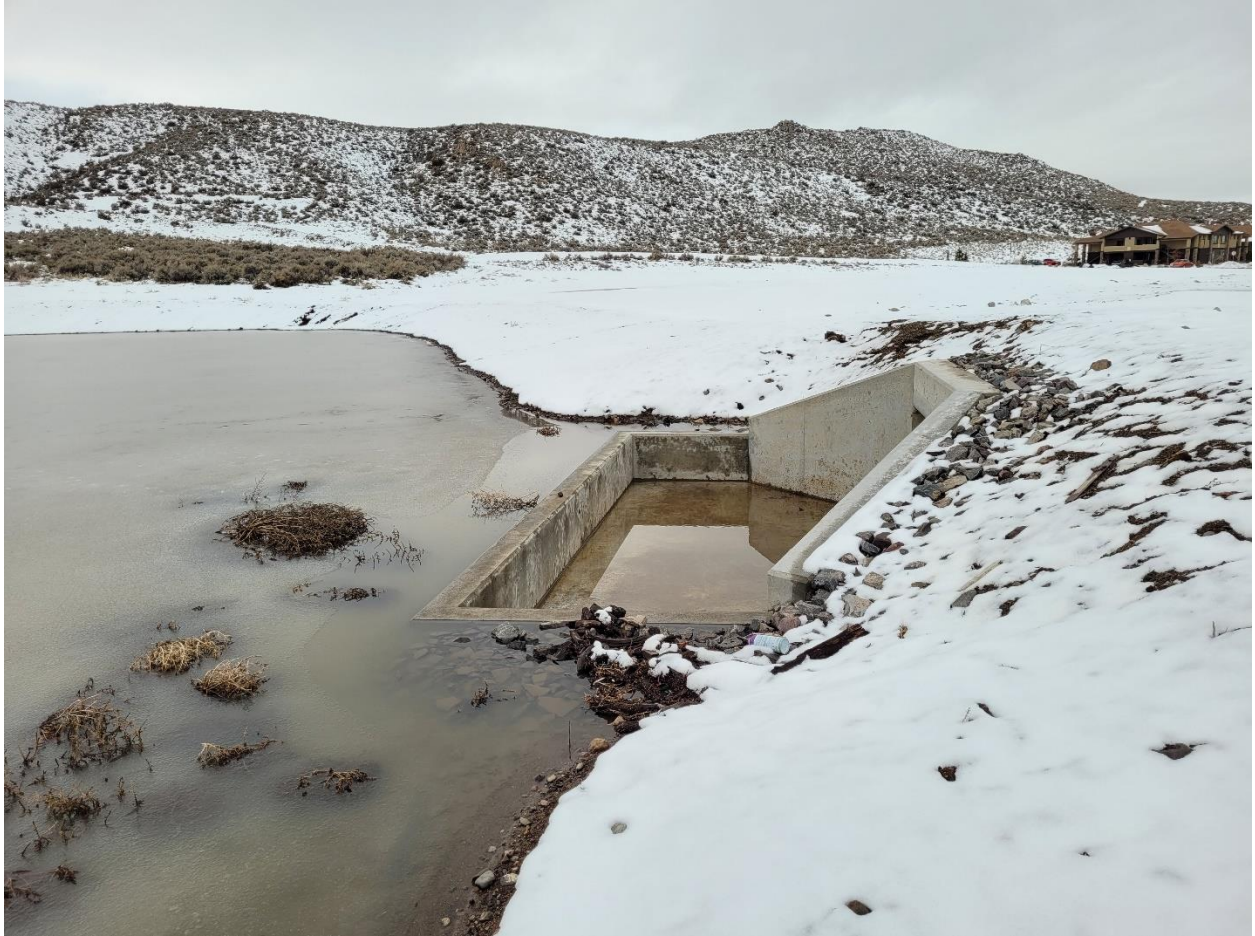
Inspection Site 1) Picture of the outlet structure. It is clean with no obstructions to impede water.
(1/11/2023)

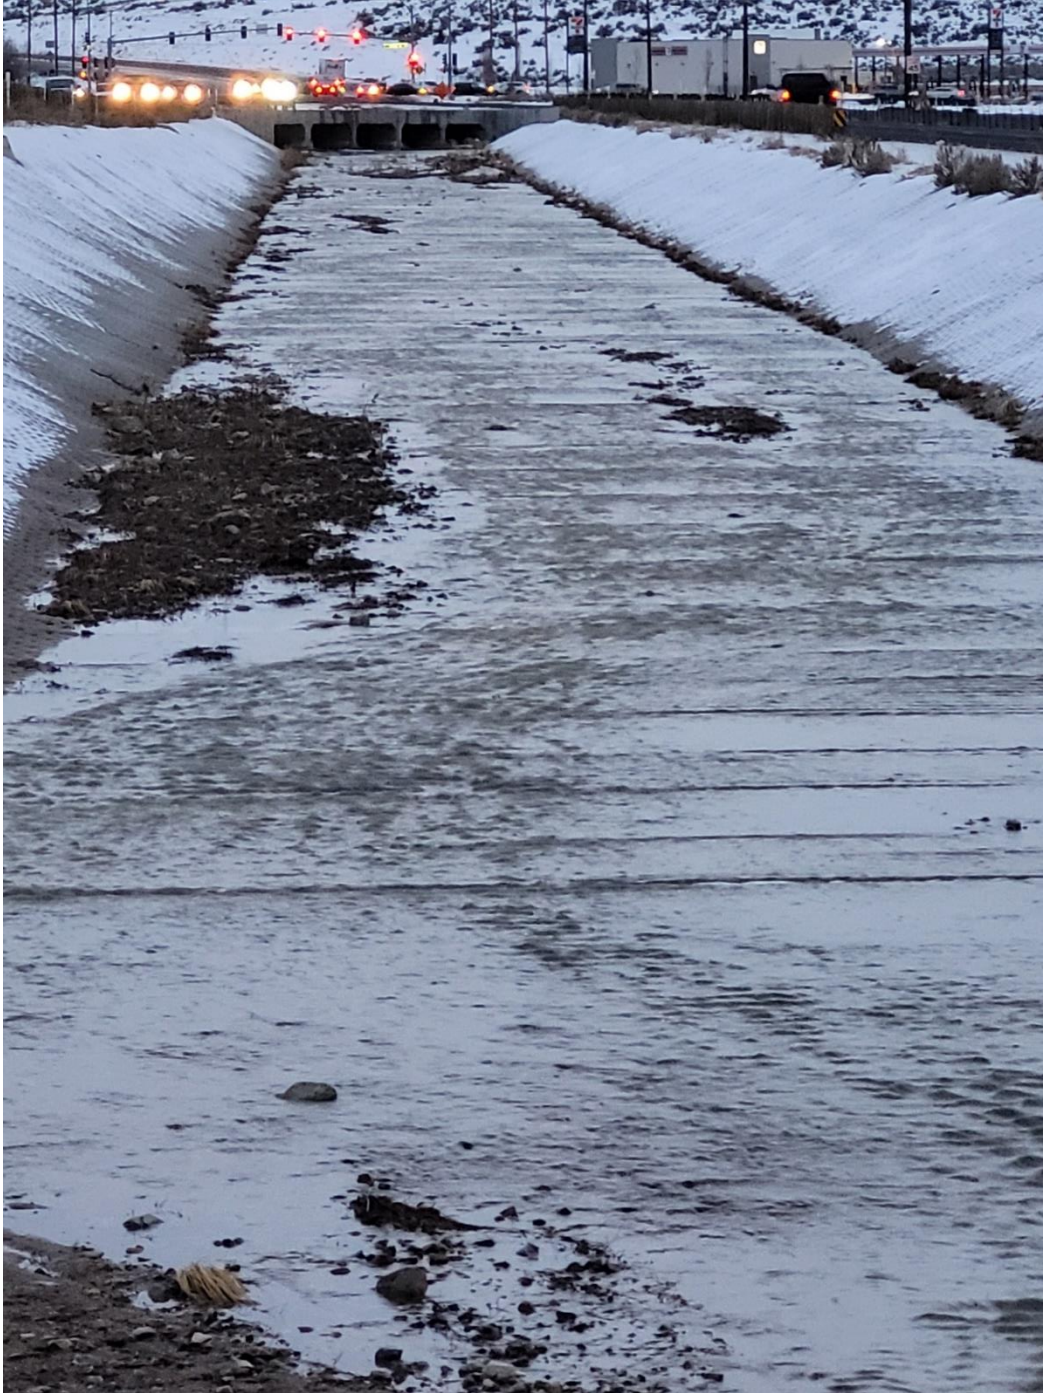
Inspection Site 2) Lemmon Valley drainage - picture of the road crossing under Lemmon Dr. near Lemmon Dr. and Military Rd. The channel is clear with no obstructions to impede water. (1/11/2023)

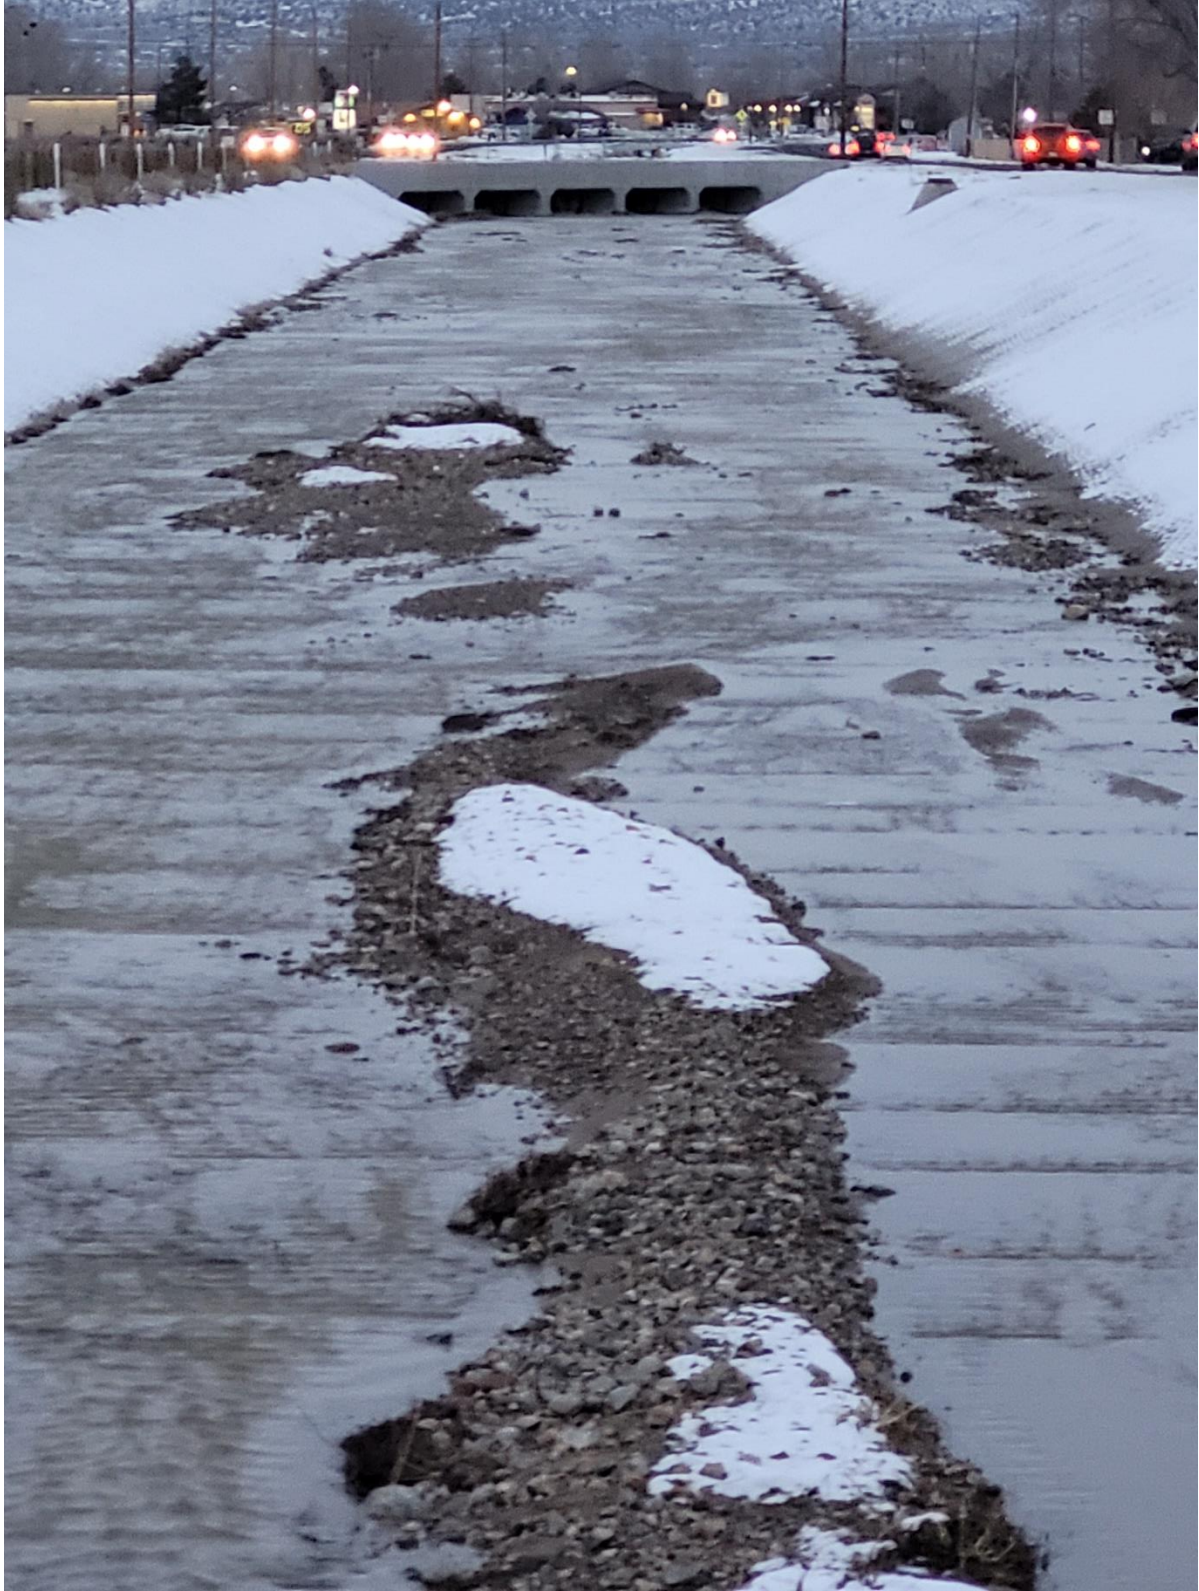
Inspection Site 3) Downstream road crossing under Lemmon Dr. heading north toward Swan Lake. The channel is clear with no obstructions to impede the water. (1/11/2023)

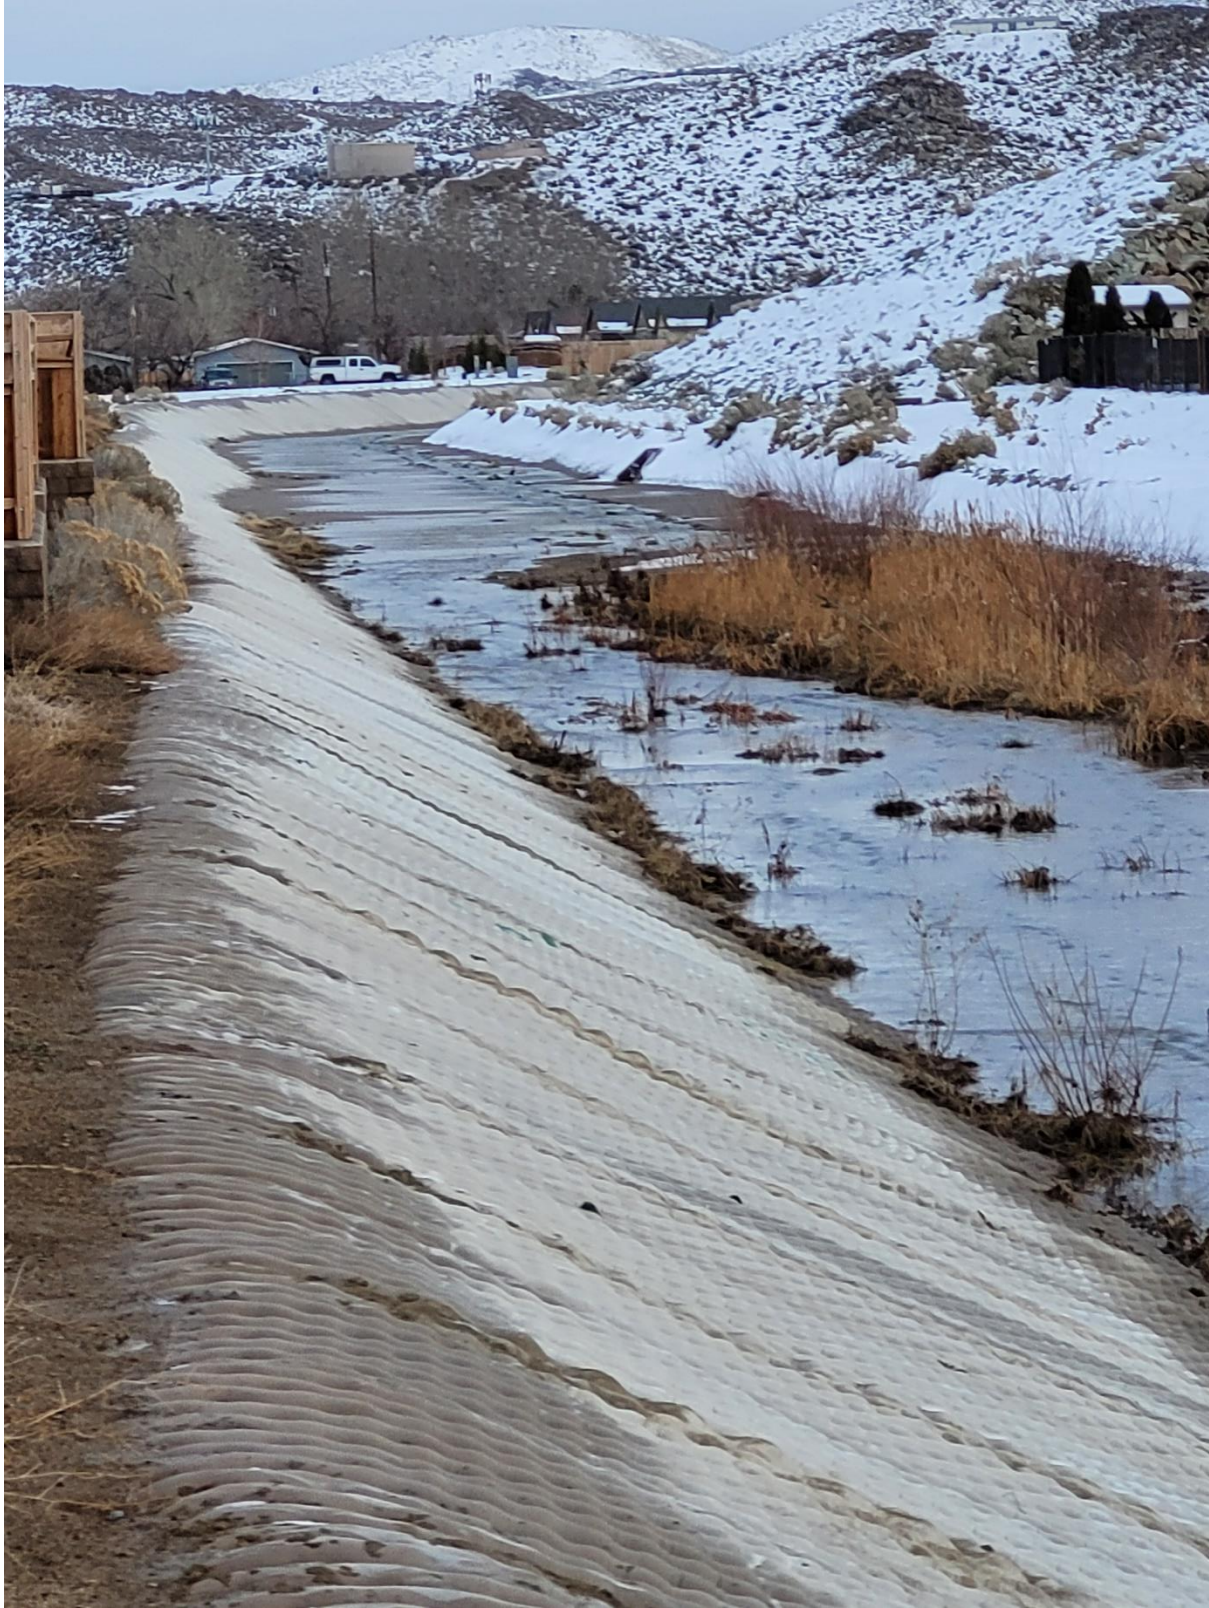
Inspection Site 4) Downstream of Lemmon Dr. road crossing. The channel is in no danger and functioning as designed. (1/11/2023)

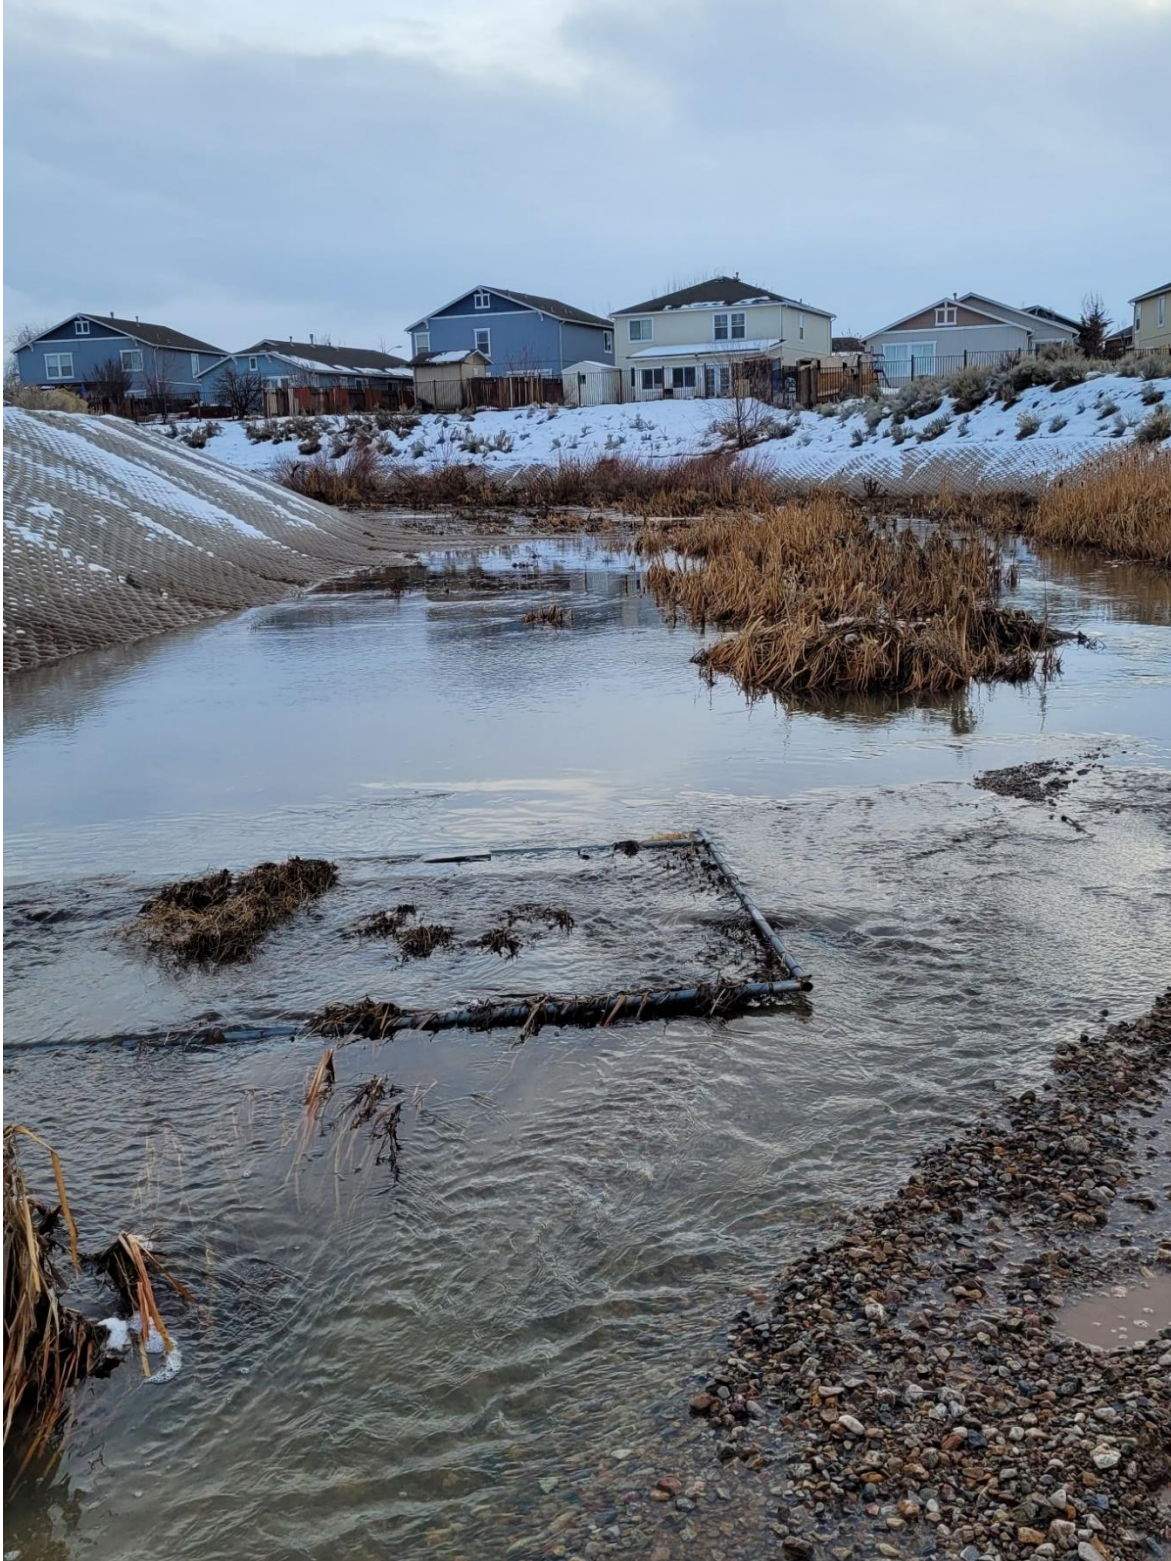
Inspection Site 5) Picture at the confluence of Lemmon and Military Rd. drainage channels, looking towards Lemmon Valley Road. Some debris present however the channel is functioning as designed and is not in danger of overtopping. (1/11/2023)

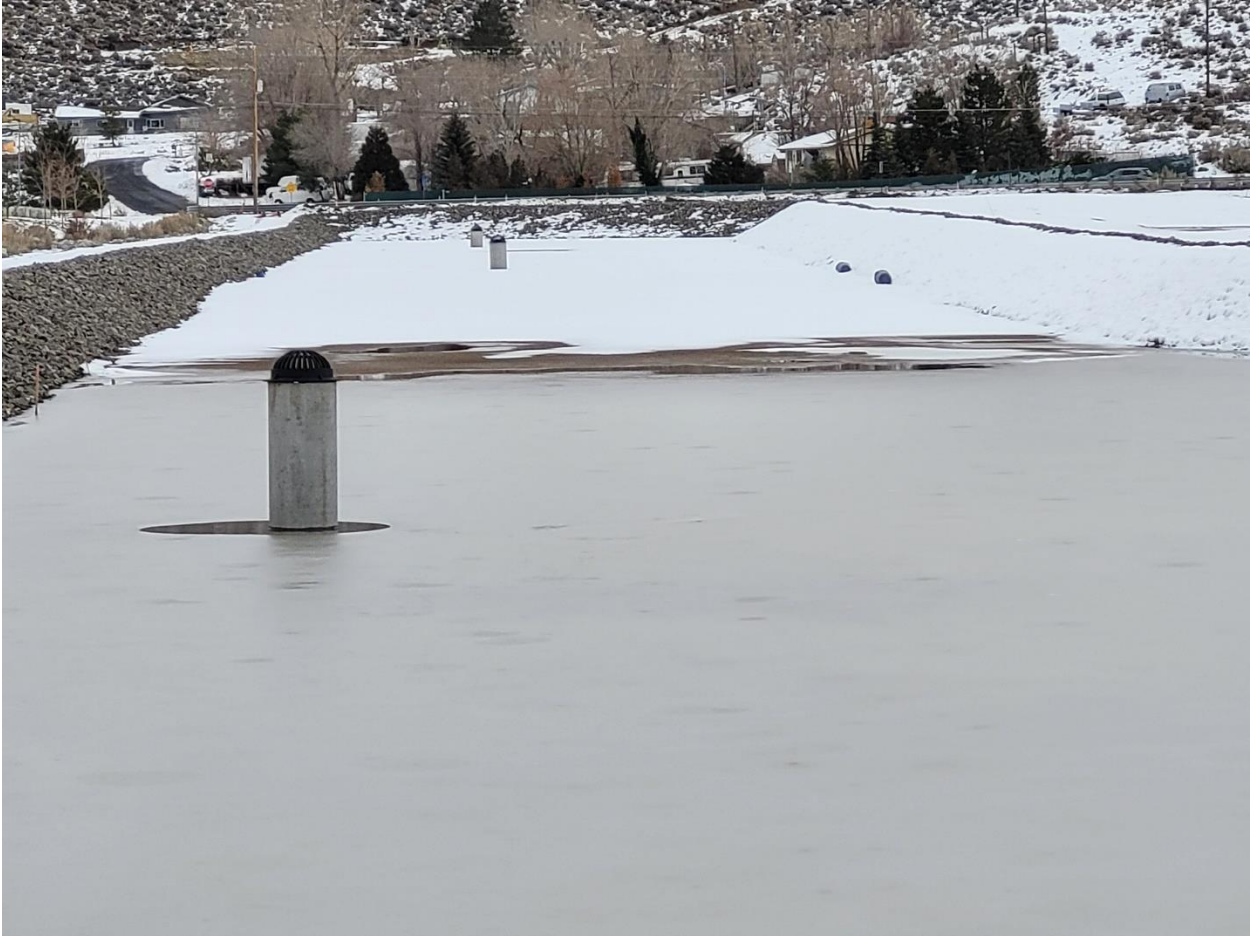
Inspection Location 6) Construction site south of 8730 Military Rd. This retention area is still under construction and no danger of overtopping. (1/11/2023)

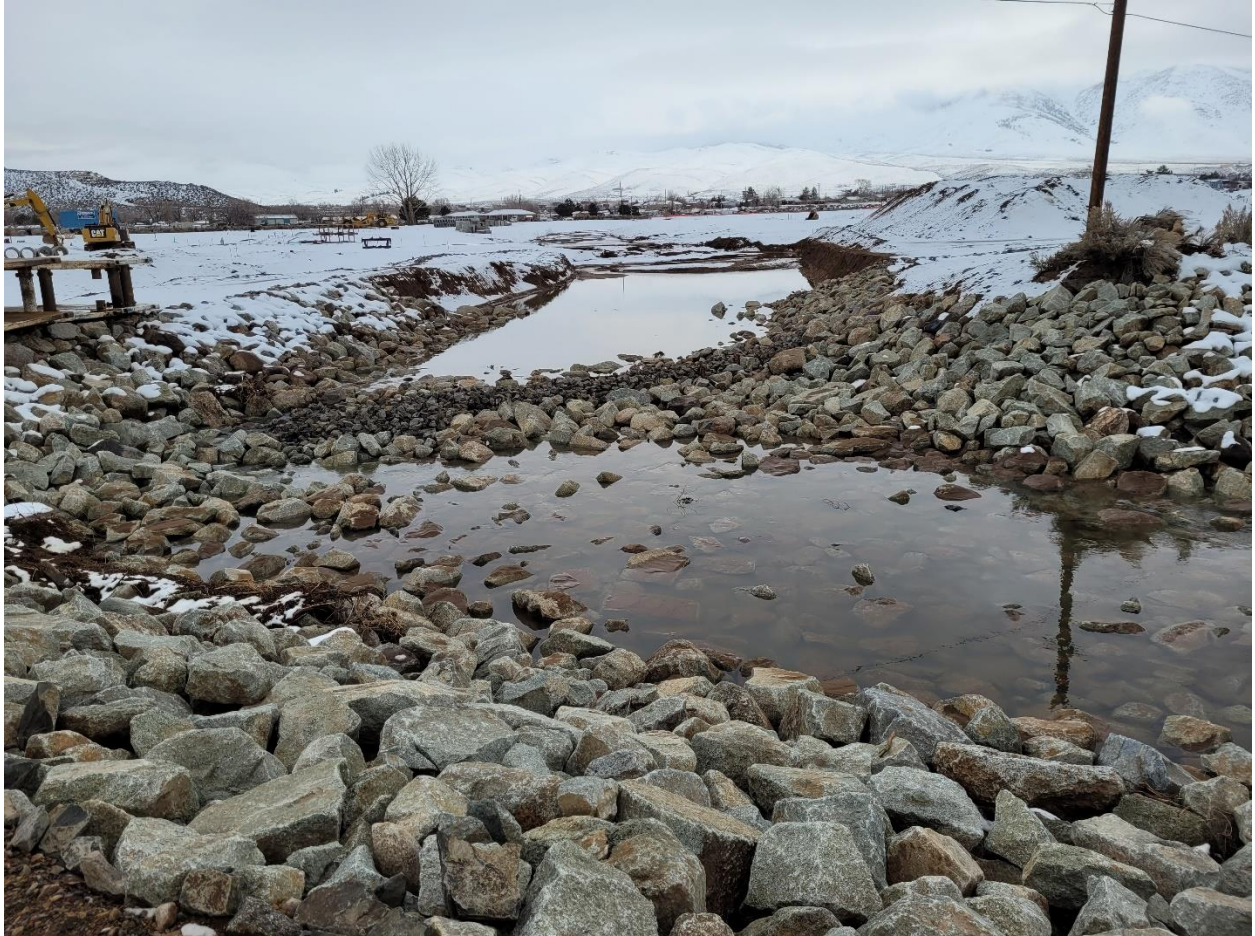
Inspection Site 7) Drainage from the construction site on the west side of Military Rd., across Military from Tulare St. The contractor has begun to install the riprap along the channel but has not completed the installation. The standing water is not causing any damage and there is no concern about overtopping the ditch. (1/11/2023)

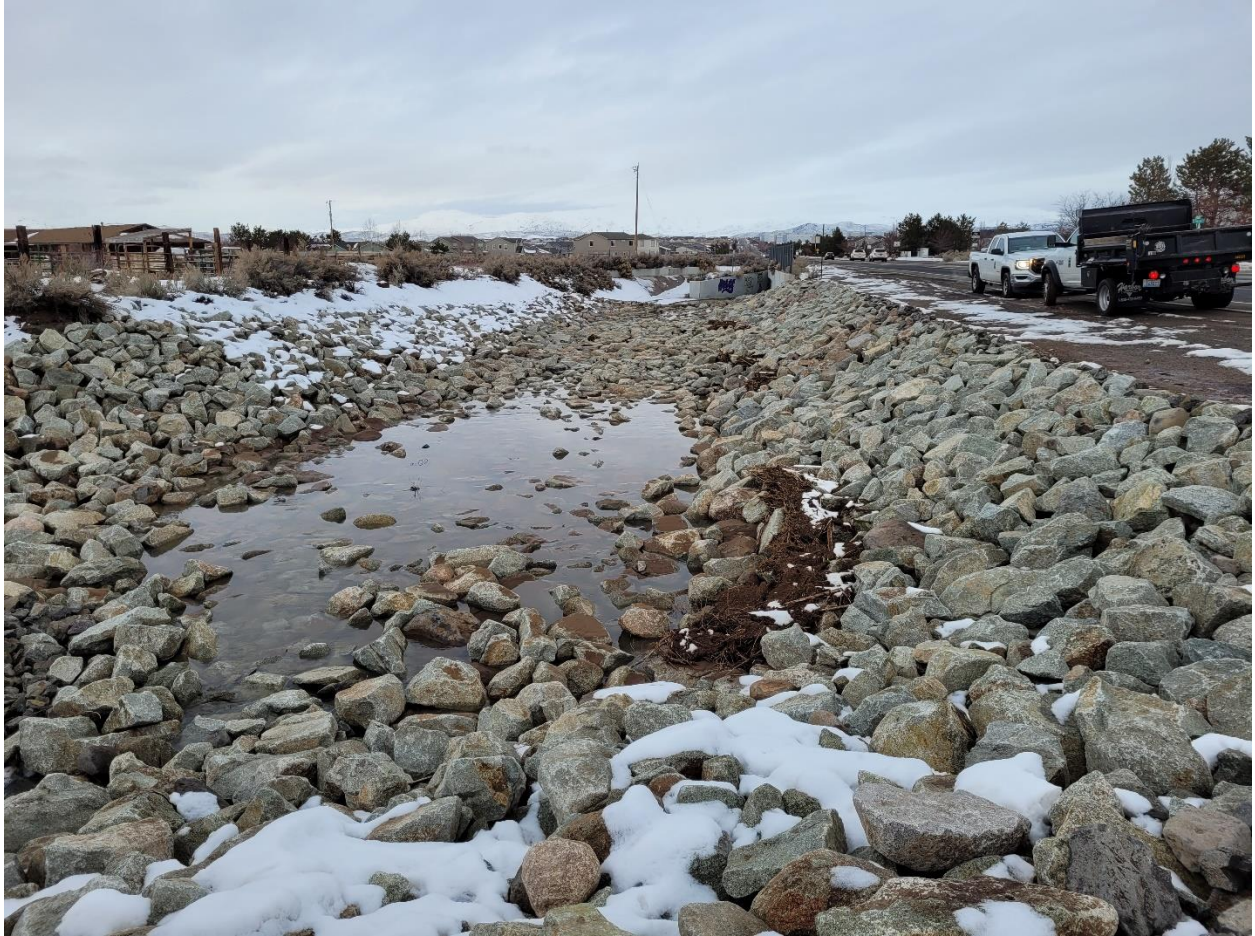
Inspection Site 7) Completed channel downstream of the construction site heading toward Military Rd. It is clean with no obstructions to impede water. (1/11/2023)

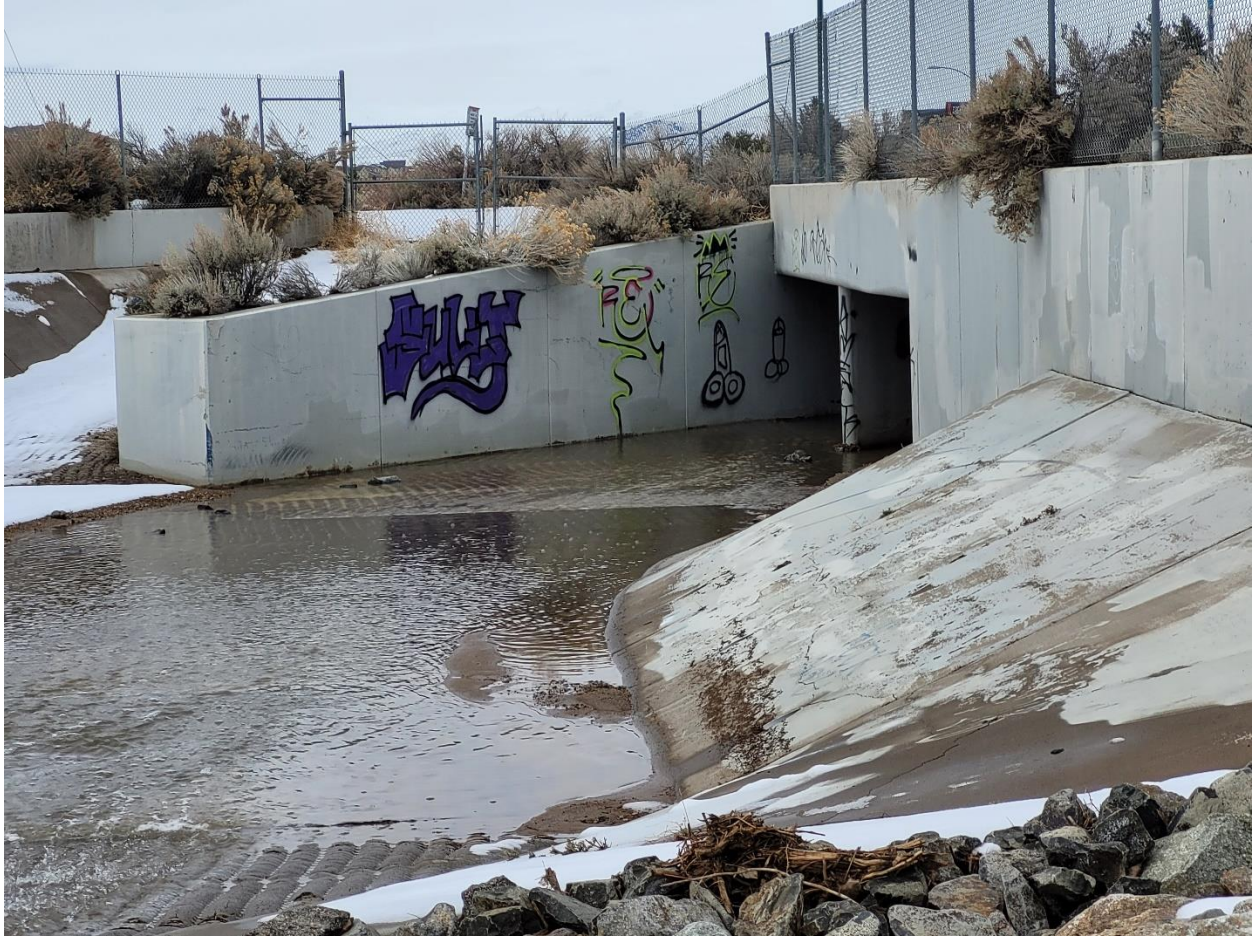
Inspection Site 8) Road crossing at Military Rd. is clean with no obstructions to impede water. (1/11/2023)

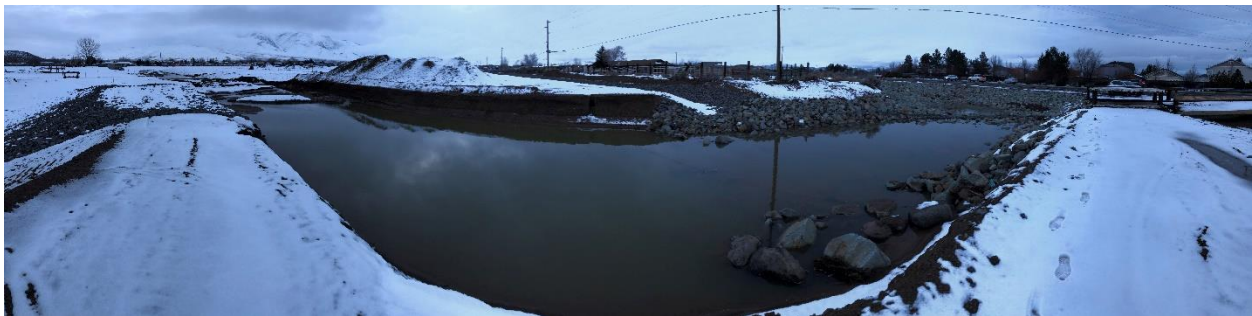
Inspection Site 8) Channel leading into the road crossing at Military Rd. is clean with no obstructions to impede water. It is clear of debris and functioning as designed. (1/11/2023)

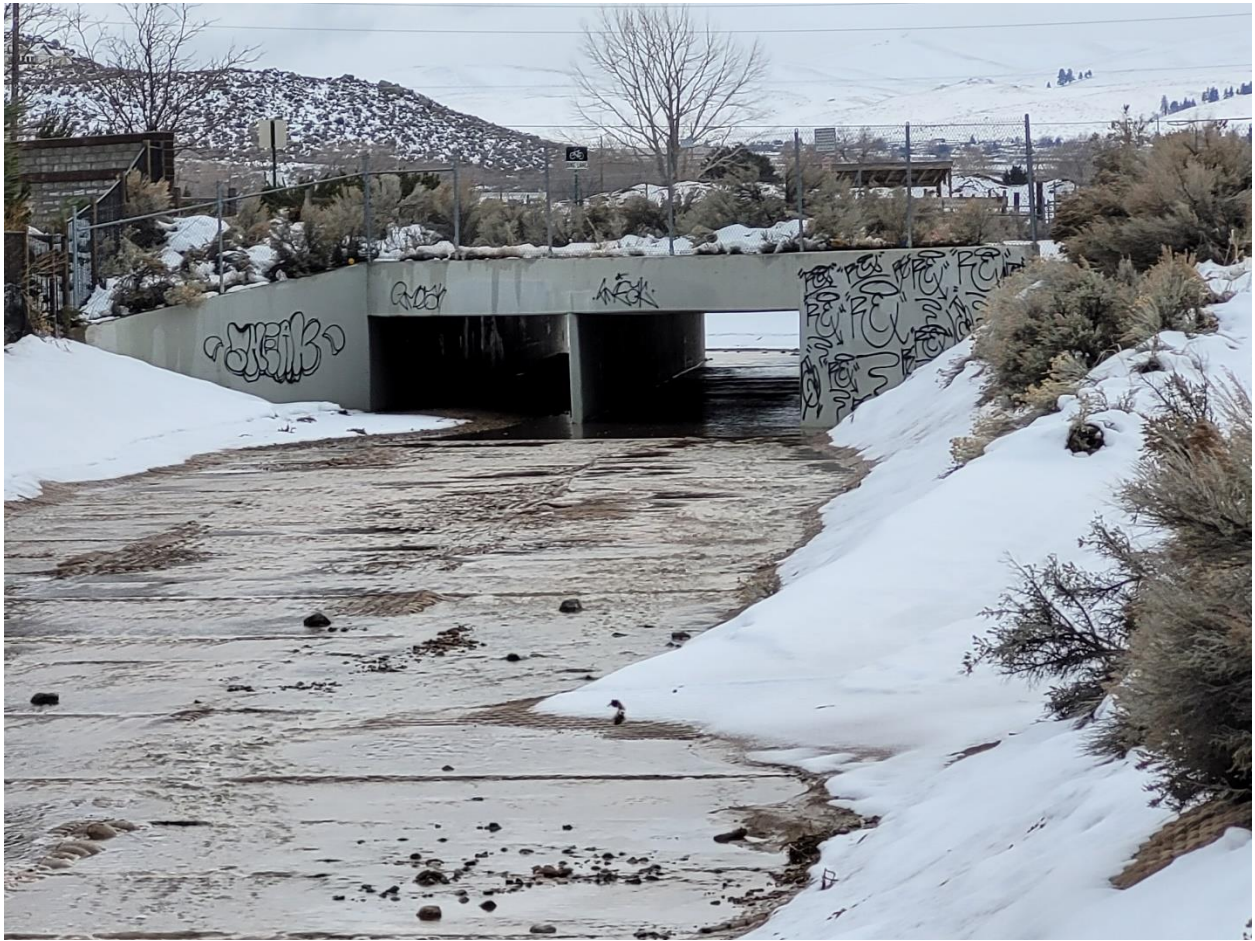
Inspection Site 9) Drainage ditch north of Tulear St. This is the road crossing under Military Rd. It is clear of debris and flowing without obstruction. (1/11/2023)

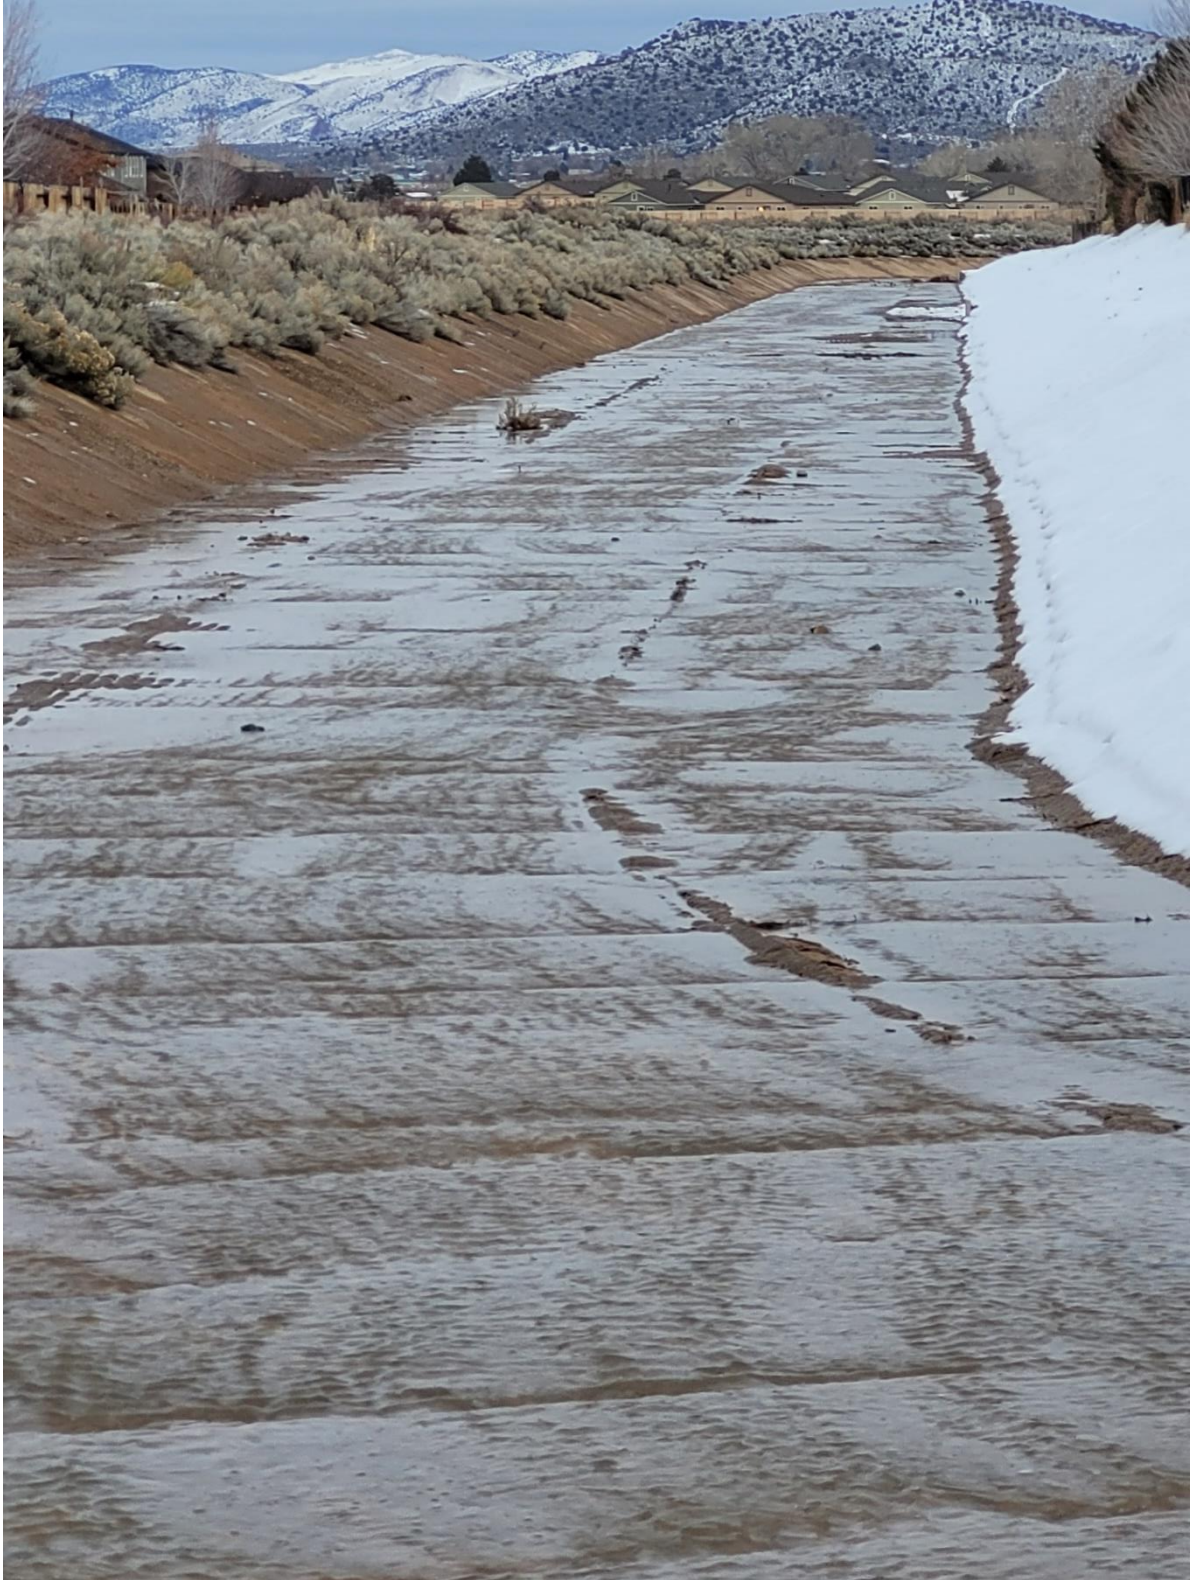
Inspection Site 10) Downstream channel running toward Swan Lake. It is clean with no obstructions to impede water. (1/11/2023)

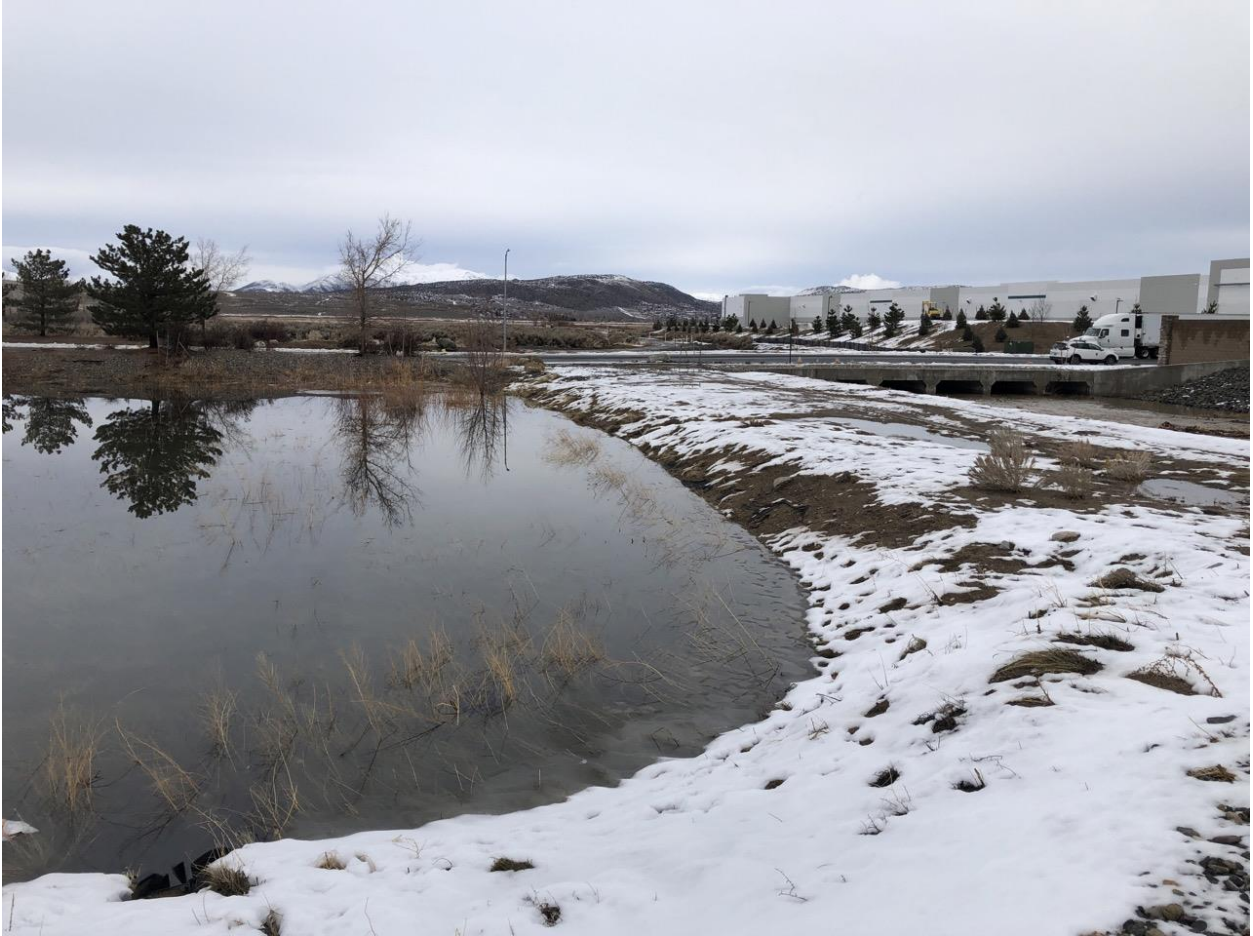
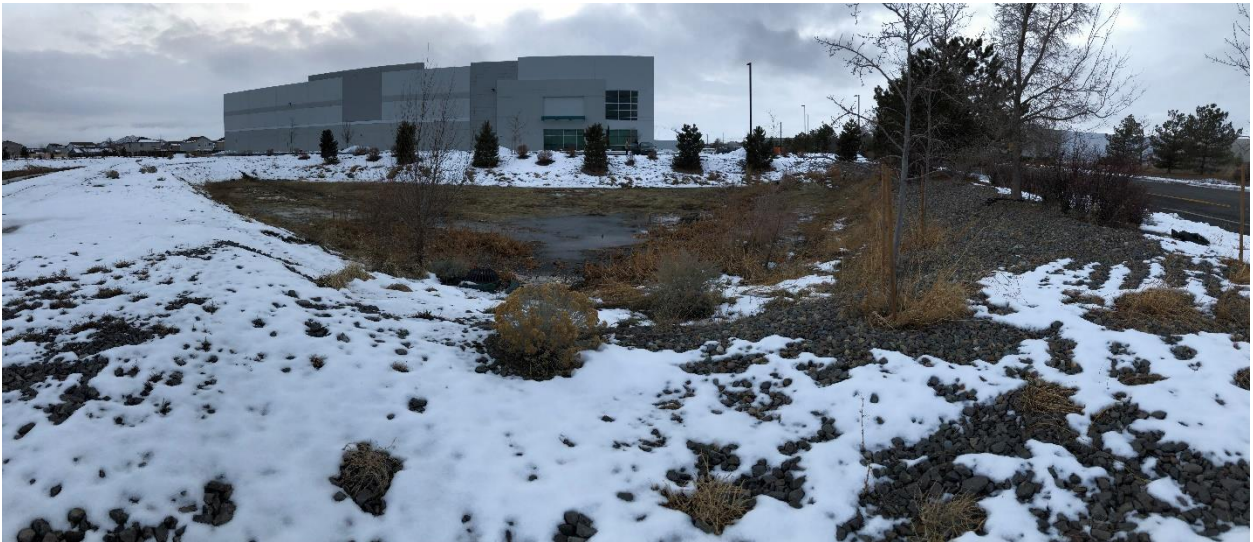
Inspection Site 11) Pictures taken on Monday 1/9/23 (top) and Wednesday 1/11/2023 (bottom) of the detention basin on the south side of Lear Blvd. This detention basin was nearly full on Monday, 1/9/23. The basin is functioning correctly, as it is almost empty in the picture taken on the following Wednesday inspection. (1/11/2023)

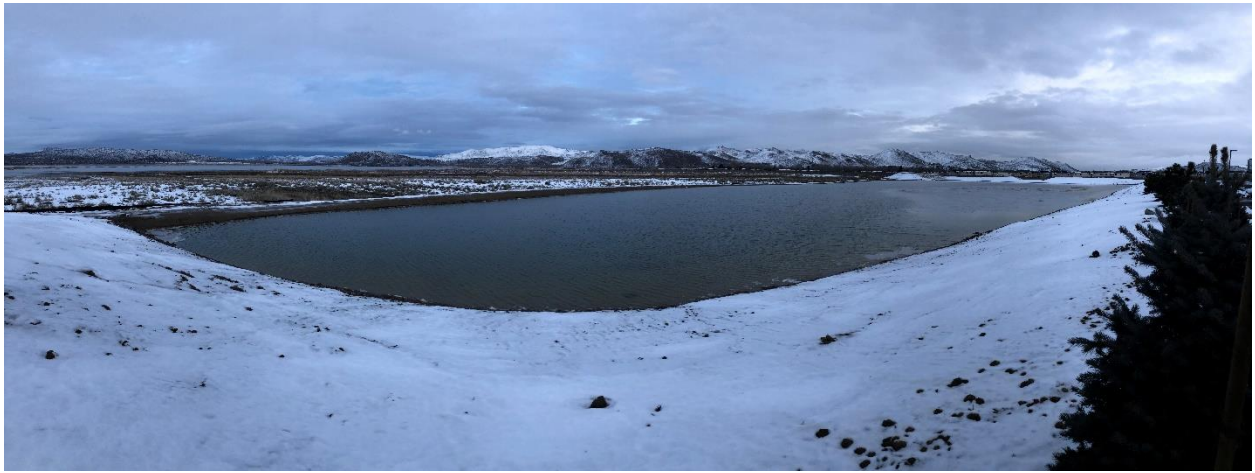
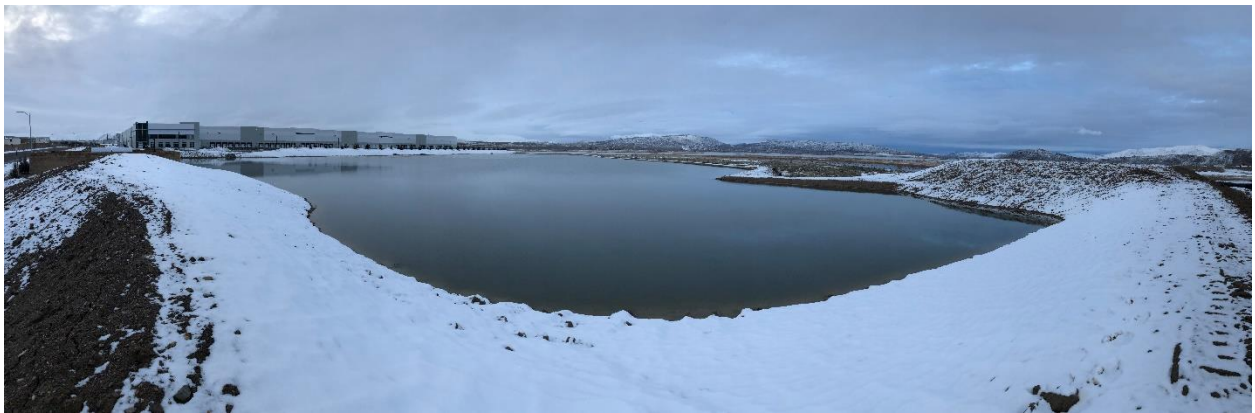
Inspection Site 12) This retention basin is designed to retain or hold water that will infiltrate into the ground and is functioning properly. Note that ‘retention’ basins function differently from ‘detention’ basins. Retention basins hold water. Detention basins are designed to slowly release water through a conveyance system. (1/11/2023)

Per the Truckee Meadows Regional Drainage Manual (TMRDM), all retention basins must infiltrate ponded water within 7 days. Due to continued storm events and snowfall, Utility Services staff will re-inspect all identified retention basins (both city and privately owned) within the Swan Lake watershed once the continued precipitation ceases, and notify any basin owners requiring corrective action by March 31, 2023.
