DATE: February 28, 2023
TO: Honorable Mayor and City Council
THROUGH: Doug Thornley, City Manager Approved Electronically
FROM: Trina Magoon, Director of Utility Services
SUBJECT: **January 2023 Storm Event: Status of City Maintained Retention, Detention, and Flood Control Channels in the Swan Lake Watershed**

NORTH VALLEYS FIELD INSPECTION REPORT CONDUCTED JANUARY 11, 2023

CITY OF RENO - UTILITY SERVICES AND MAINTENANCE AND OPERATIONS DEPARTMENTS
Site Inspections Performed / Photos By: Norman Nash and Tim Lovett

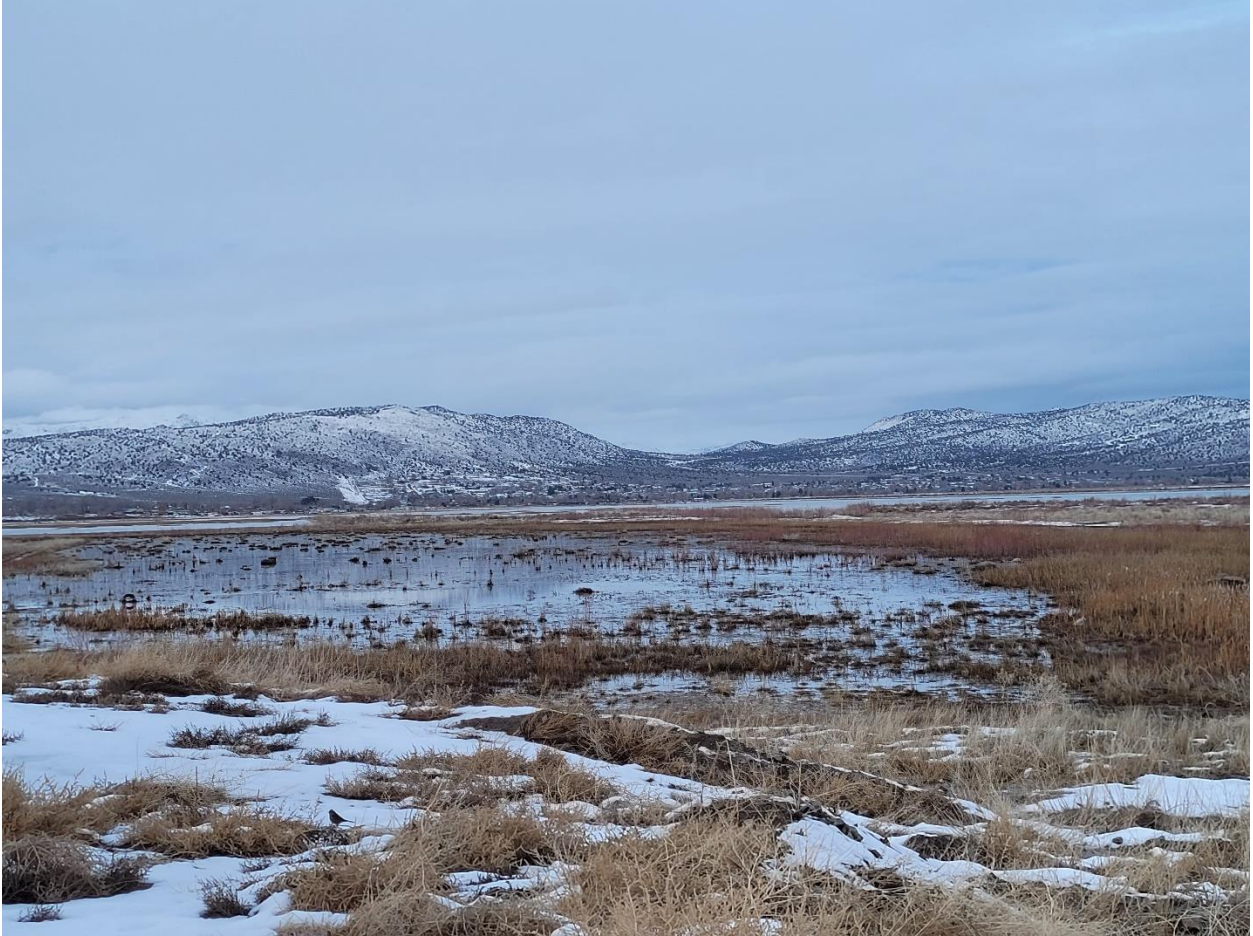
Inspection Site 13) Drainage from Military Rd. and Lemmon Dr. entering into Swan Lake. It is clear of any debris and there are no obstructions to impede water (1/11/2023)
